## County of Bruce

### Class Environmental Assessment Durham Street Bridge, Walkerton Third-Party Review

Triton Engineering Services Limited and Burgess Engineering Inc.

February 20, 2024

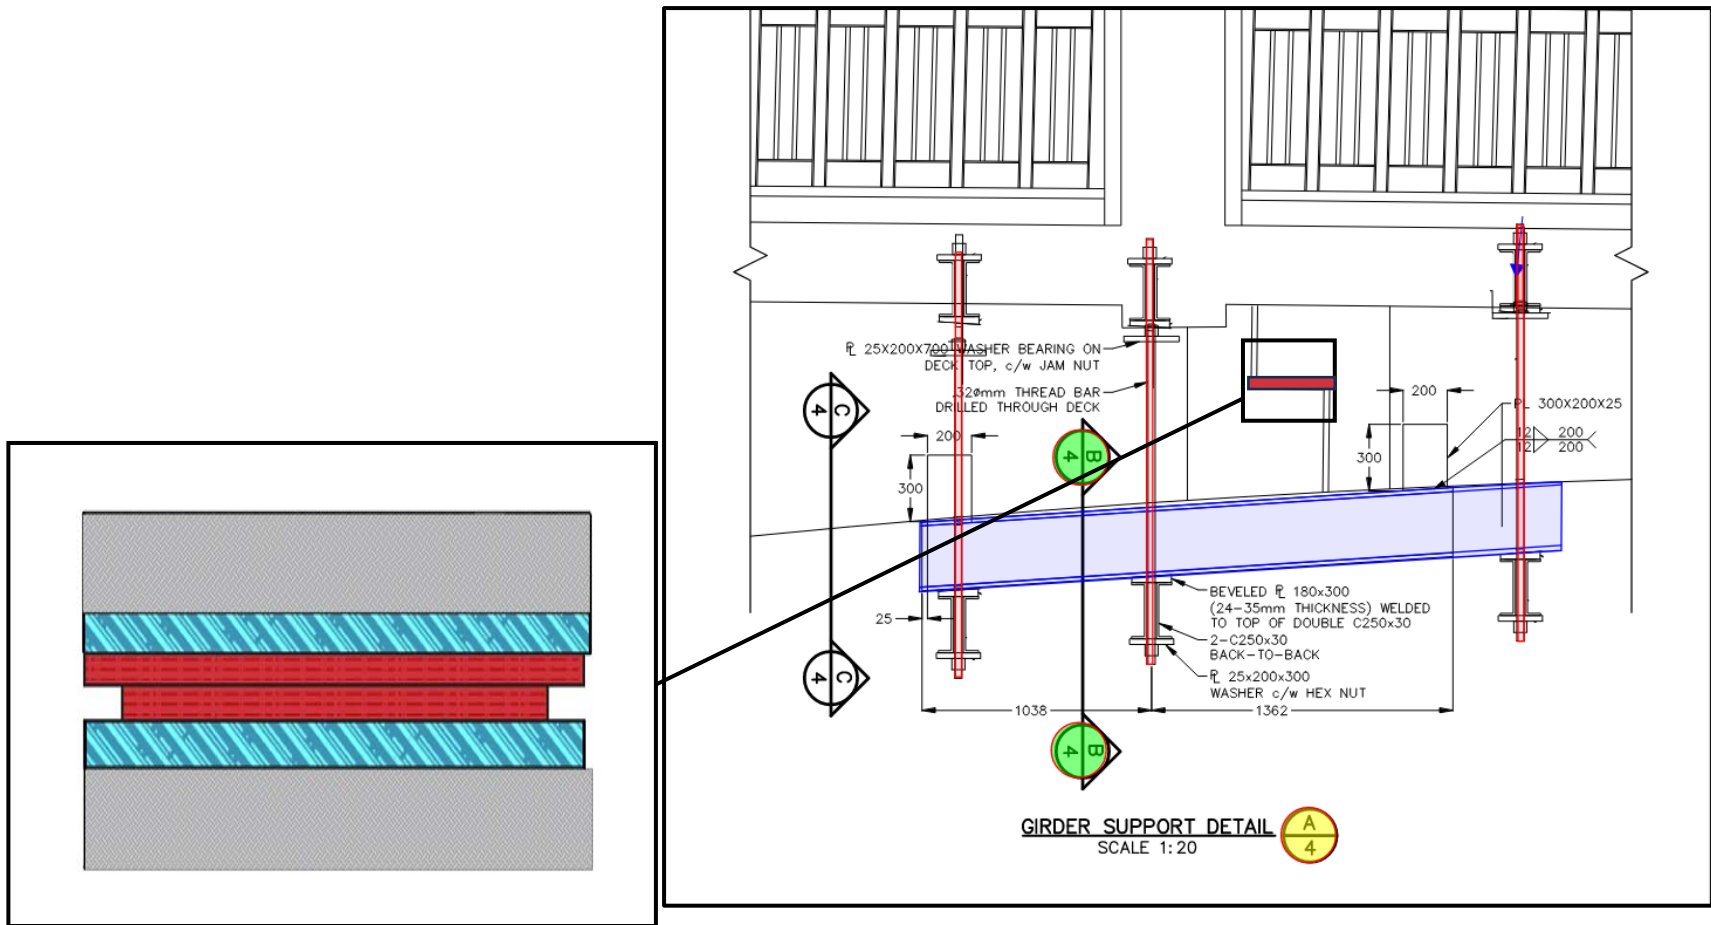
**Figure 1:** Provides an example of half-joint repair to replace the internal concrete and metal elements and by use of a temporary girder support system.

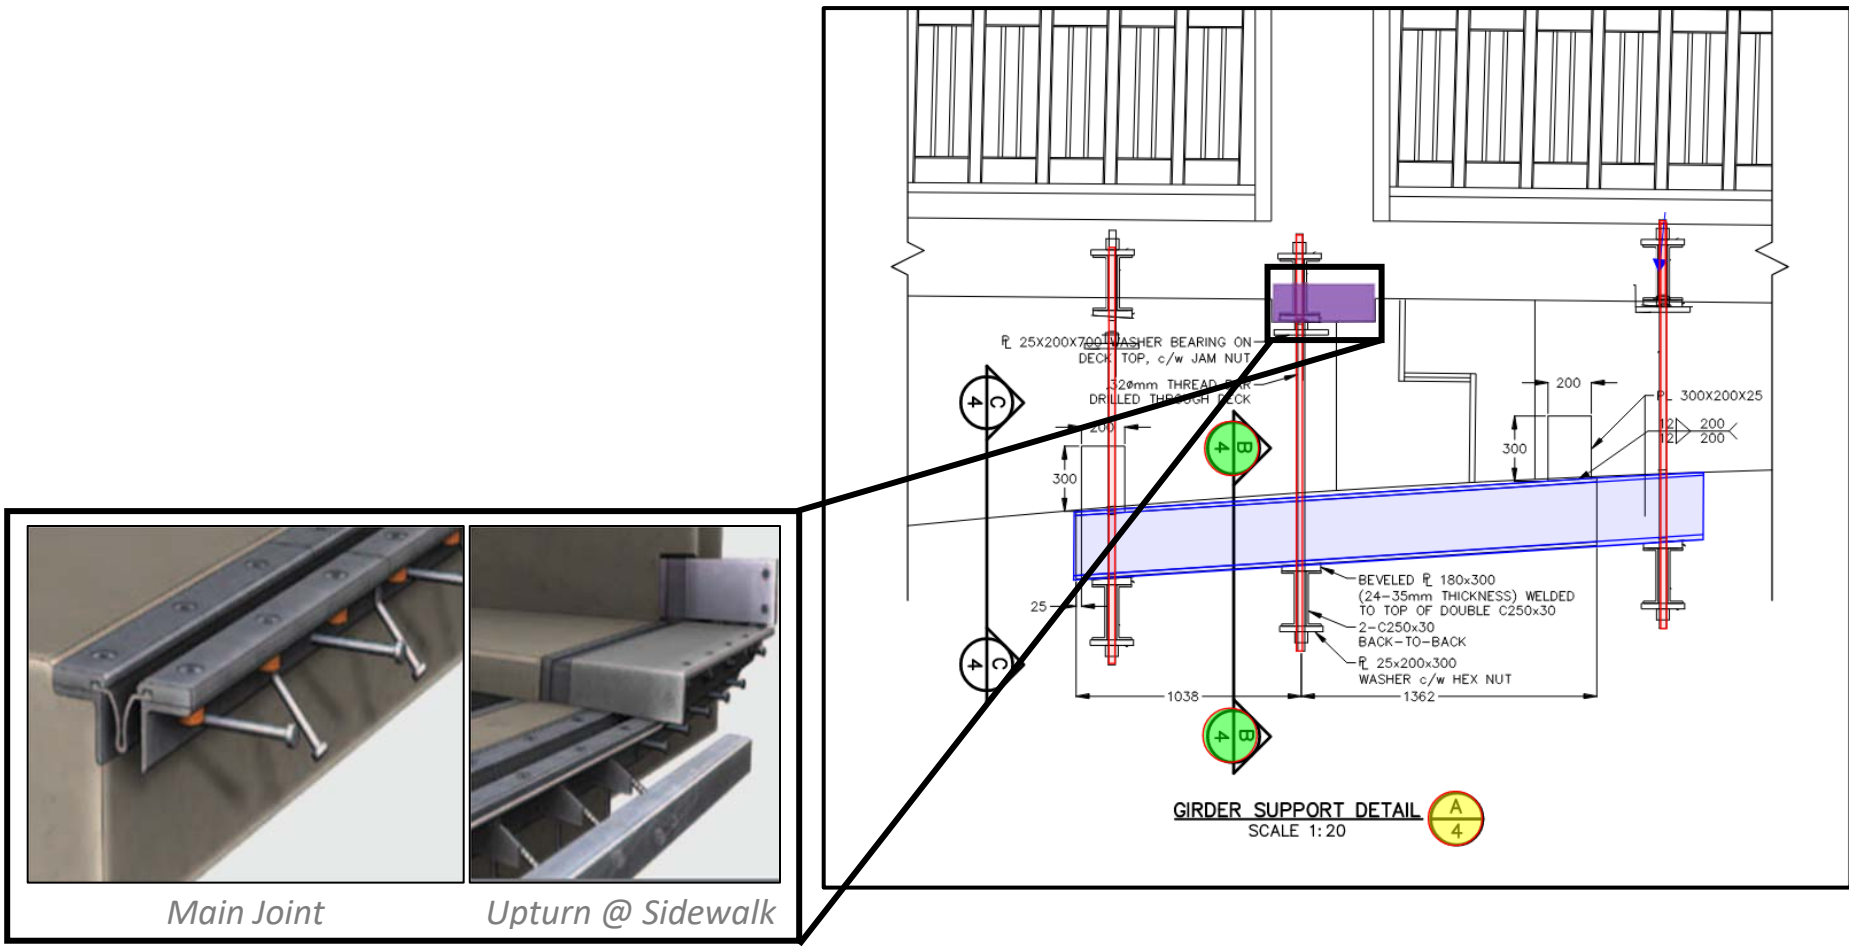
**Figure 2:** Provides an example of expansion-joint repair by use of a girder support system.

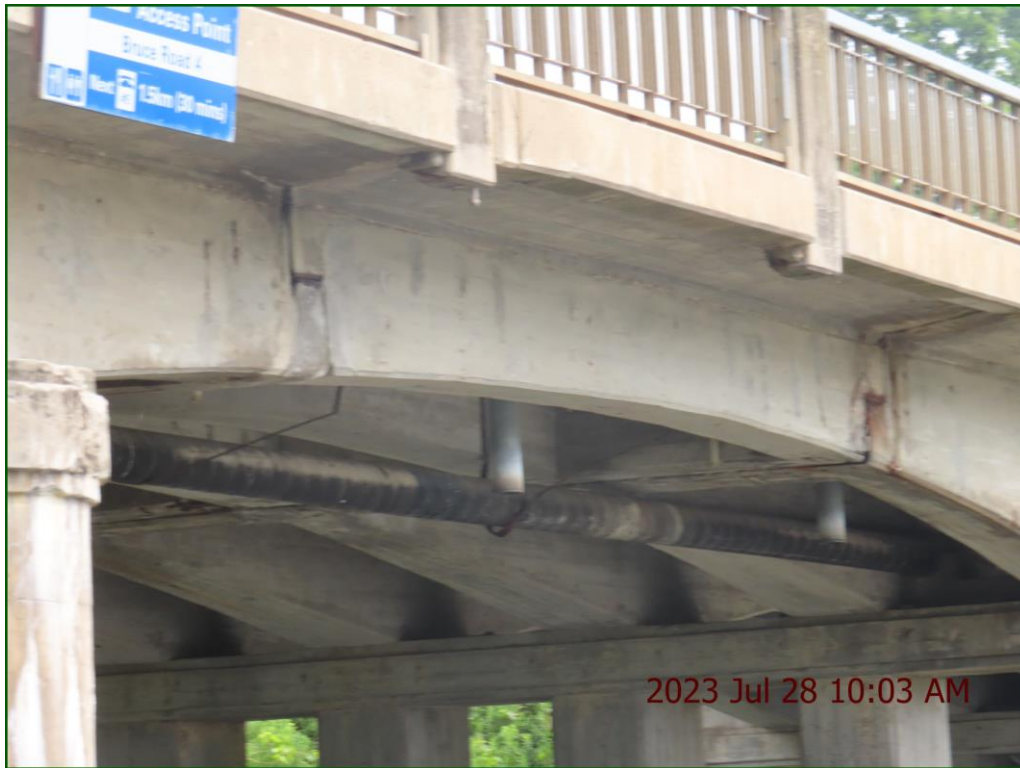
Description: Soffit (ext): Wide cracking and delamination at posts.

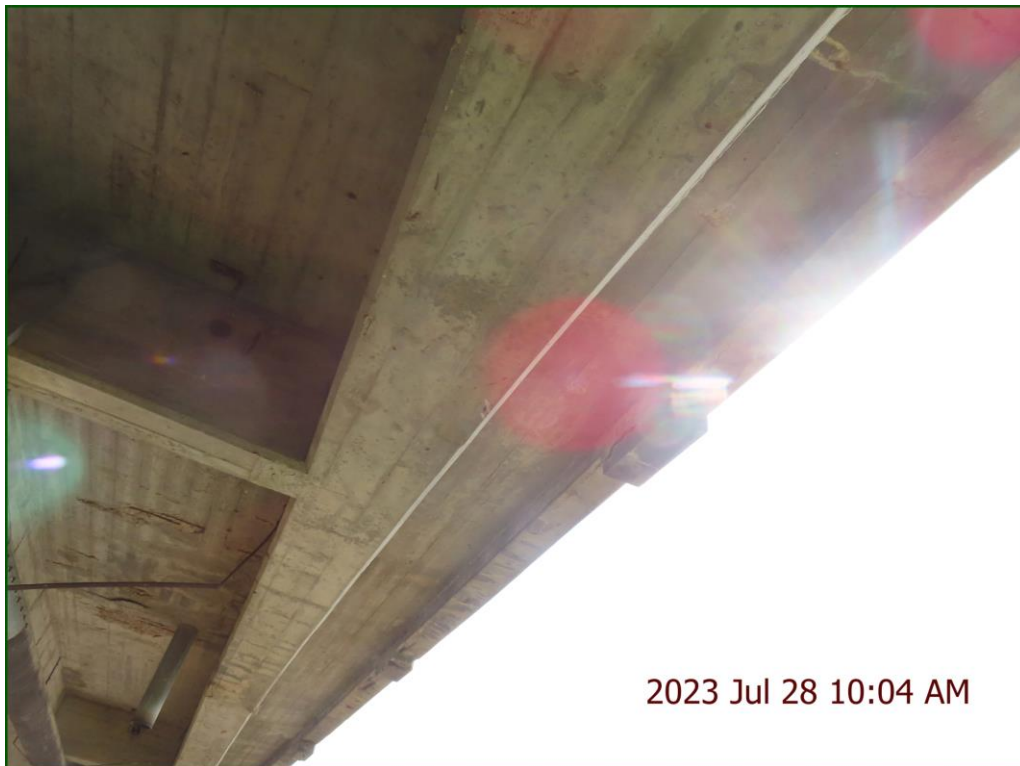
Description: Soffit (ext): Wide cracking and delamination at posts.

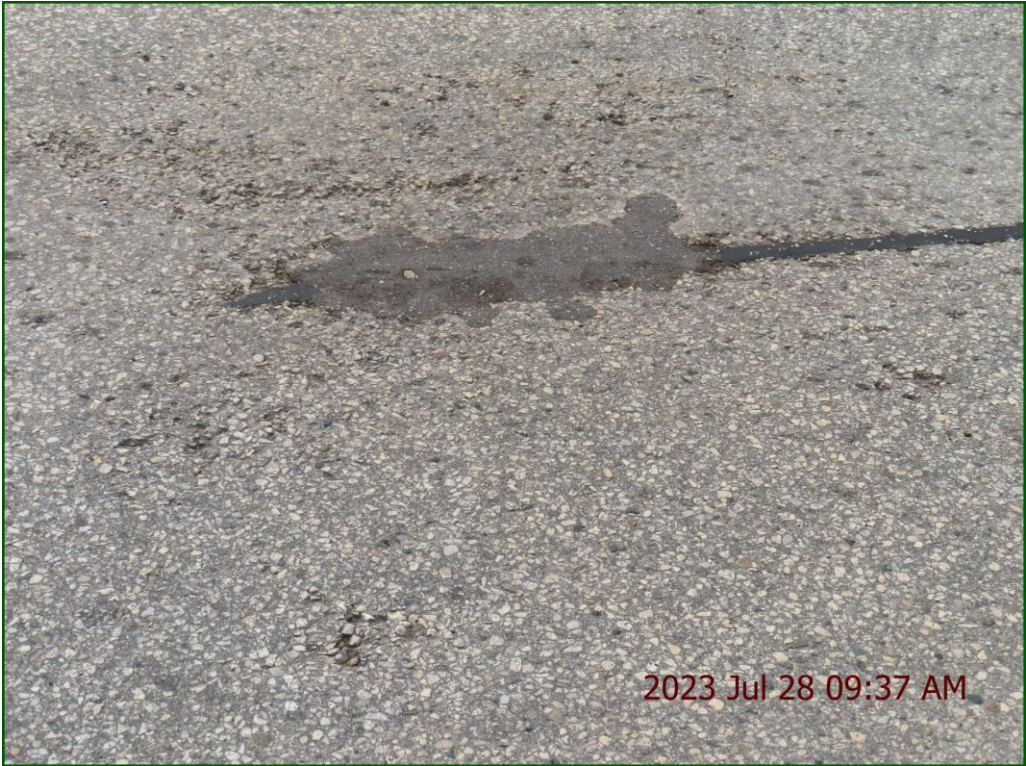
Description: Deck Wearing Surface: Light cracknig.

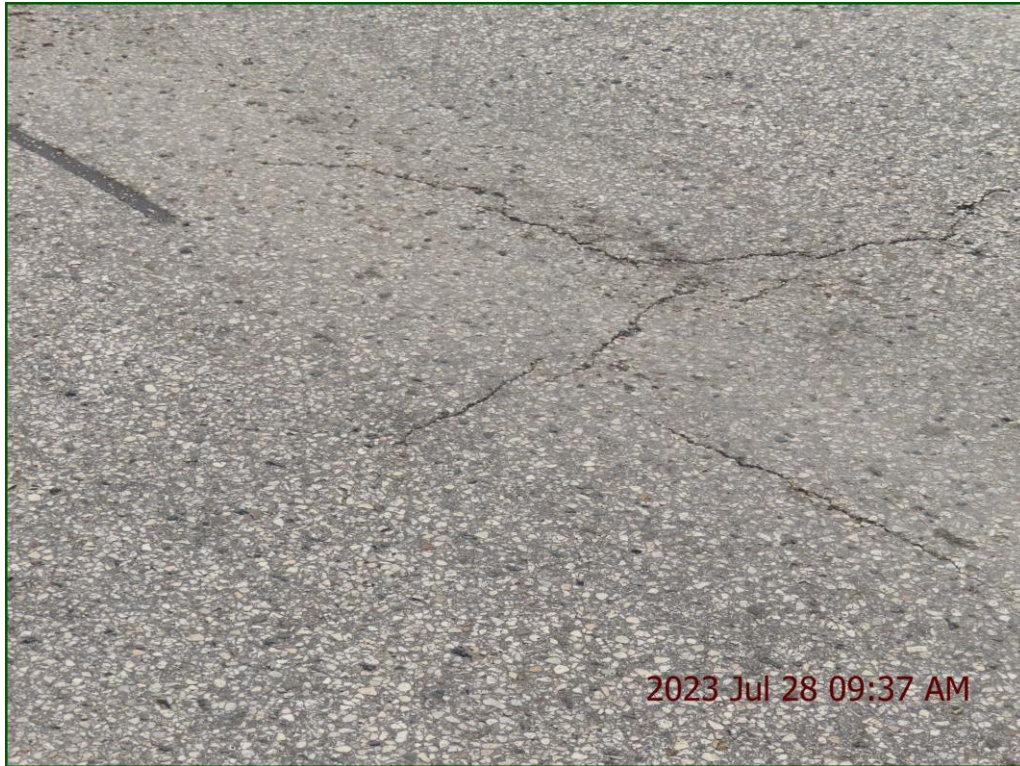
Description: Deck Wearing Surface: Light ravelling

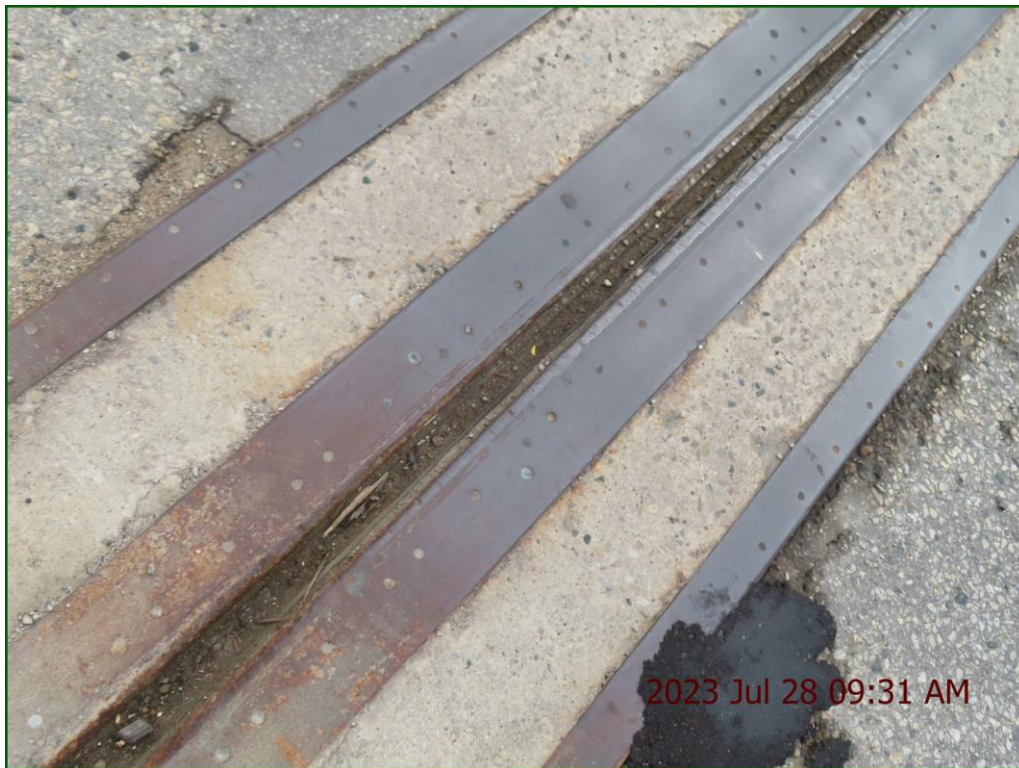
Description: Joint Armouring: Areas of wide cracking.

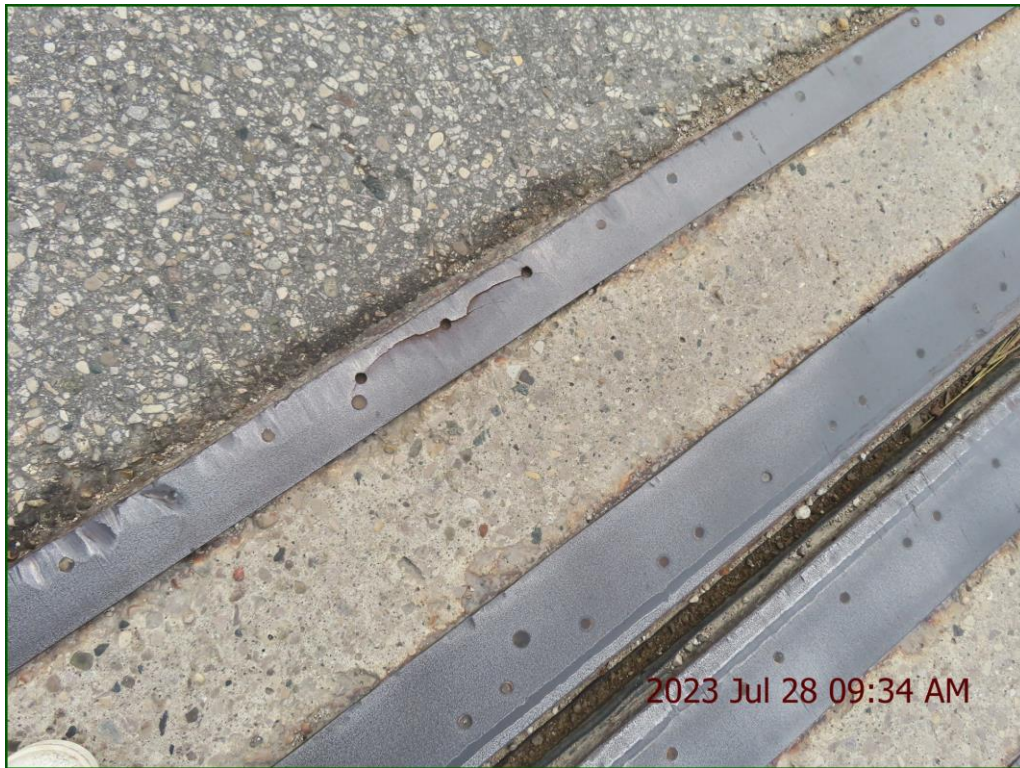
Description: Joint Armouring: Missing sections.

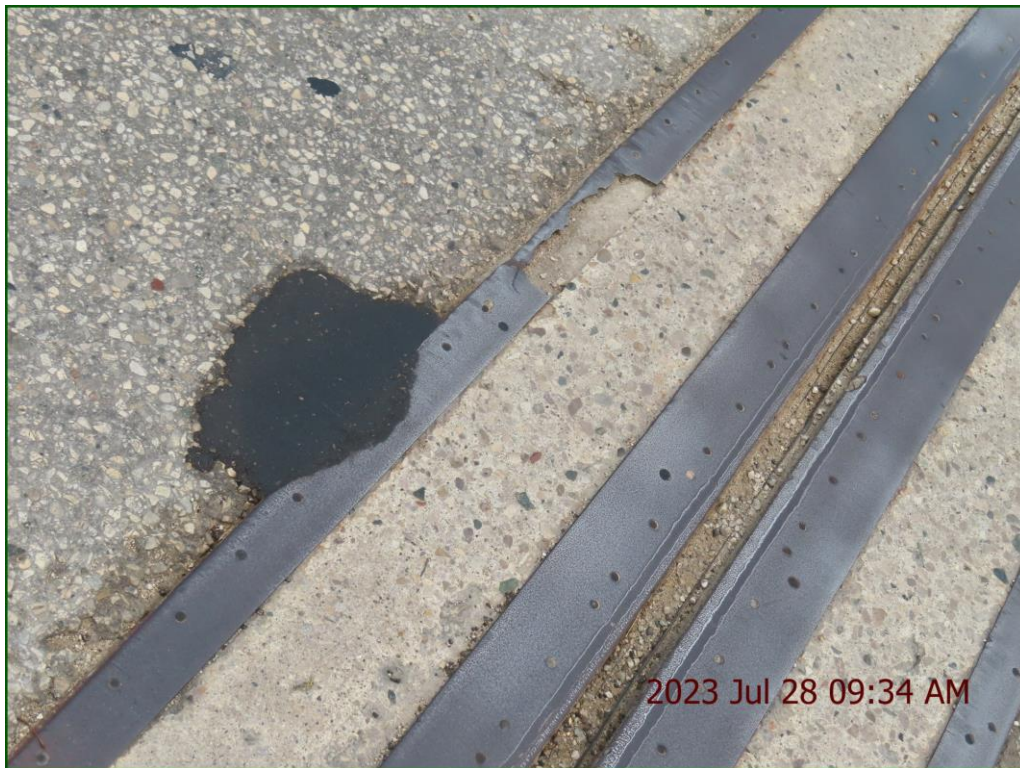
Description: Joint End Dams: Shallow popouts adjacent to armouring.

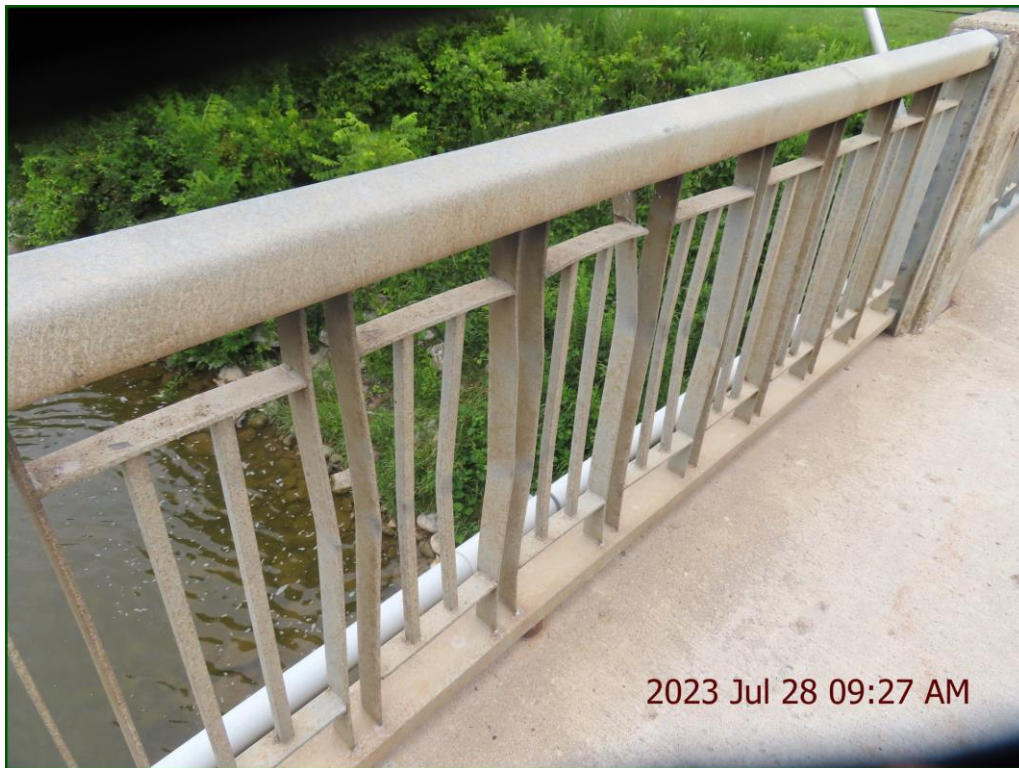
Description: Railing System: Major impact damage NW.

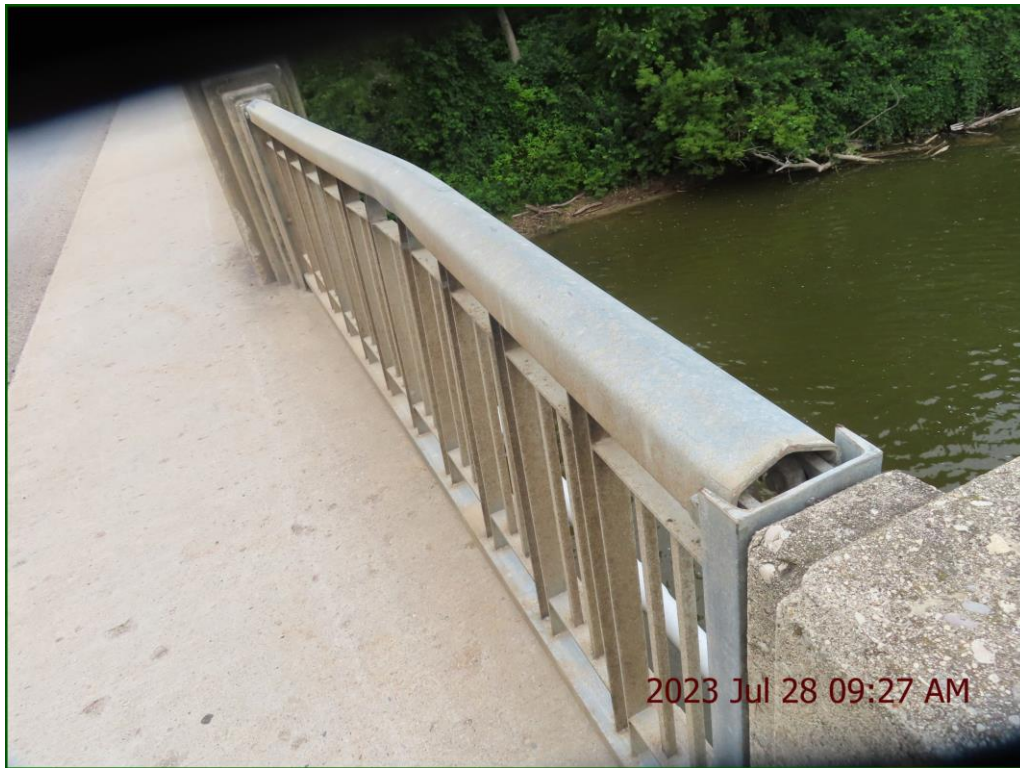
Description: Railing System: Added structural reinforcing.

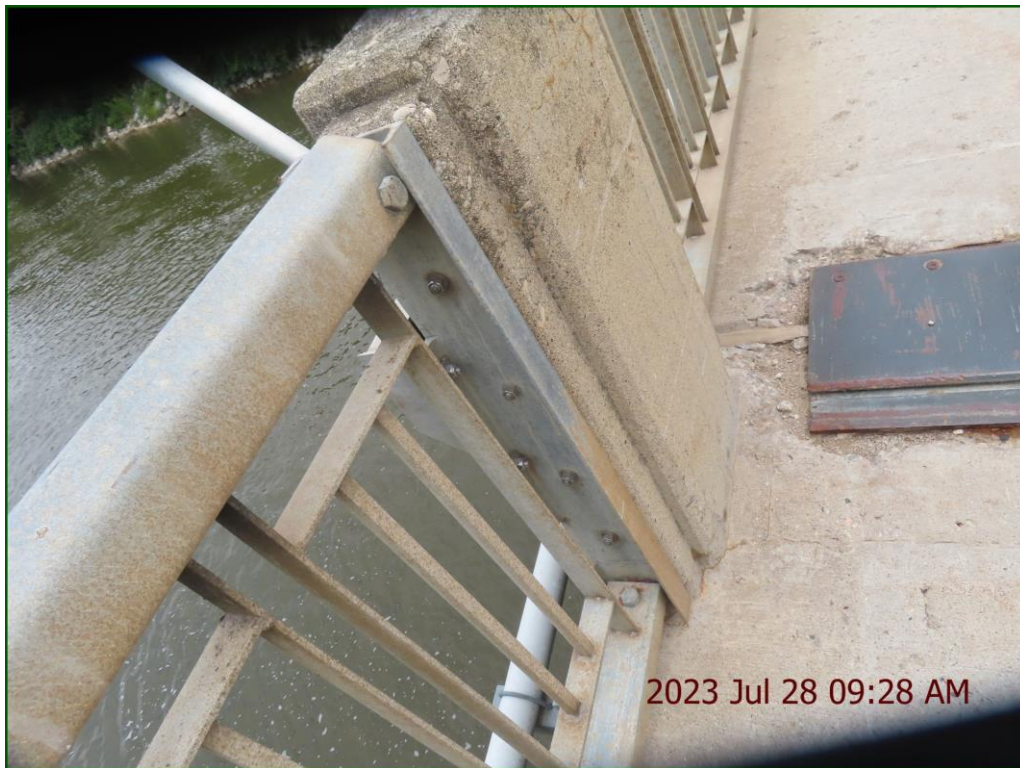
Description: Railing System: A couple replaced sections.

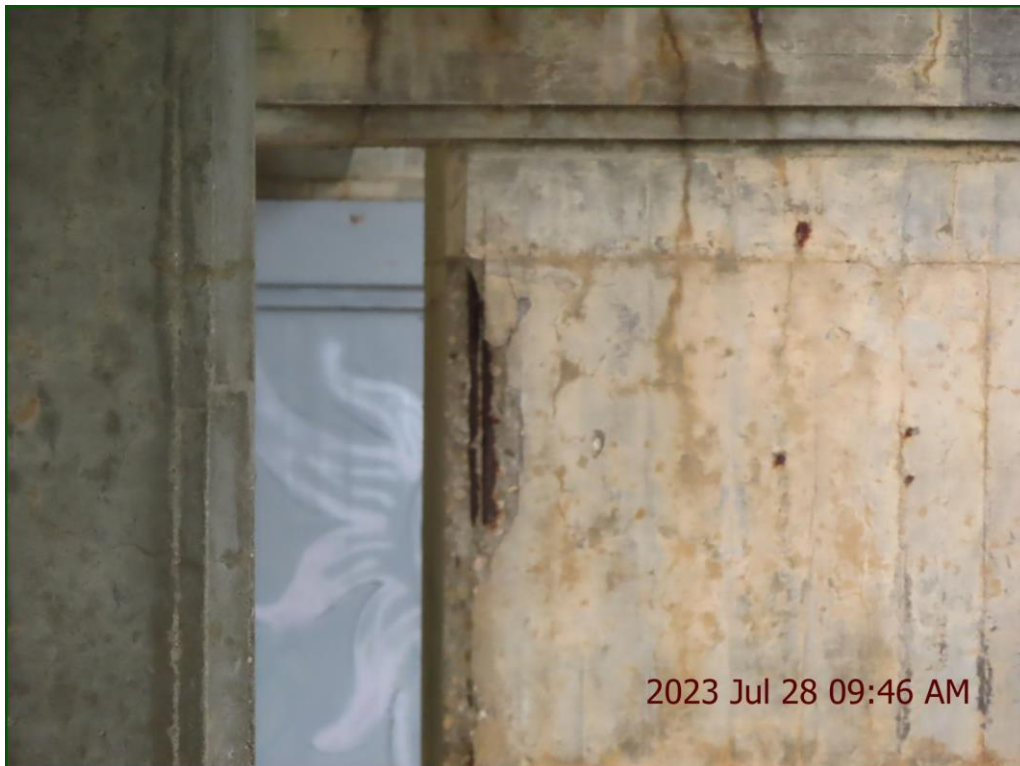
Description: Piers Shafts: A couple spalls with exposed reinforcing.

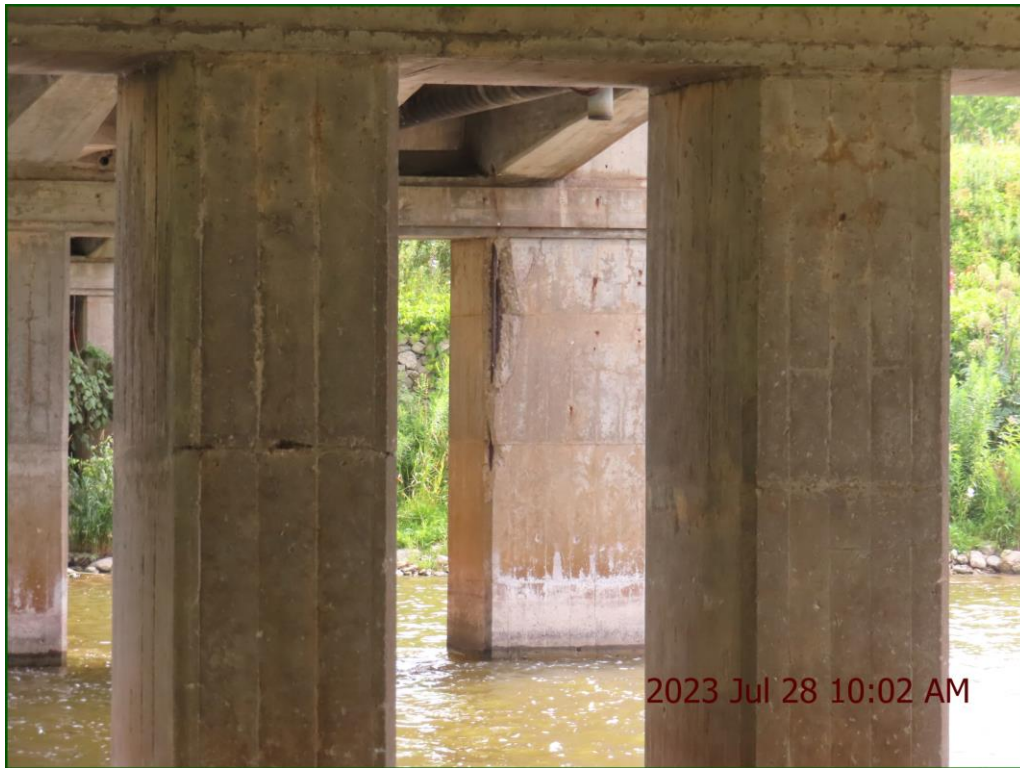
Description: Diaphragms: Shallow delaminations throughout.

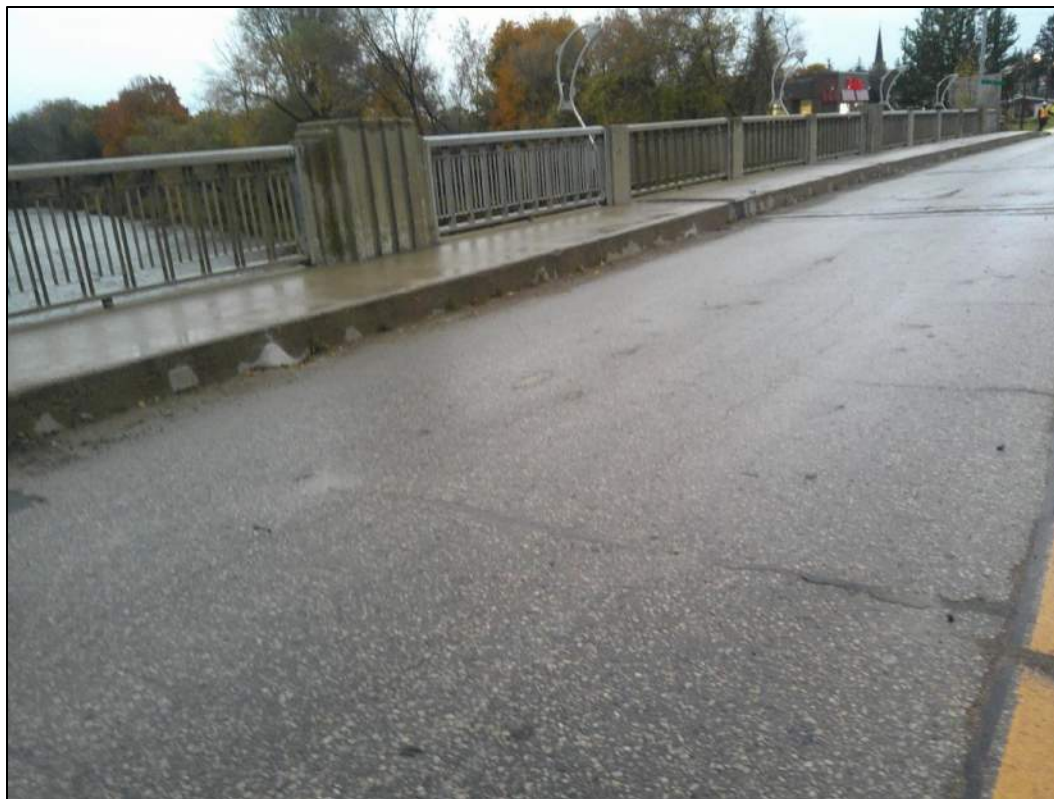
**Photo P5 – Asphalt Wearing Surface** (good condition – sealed/unsealed cracks, light ravelling, light rutting and patched areas)

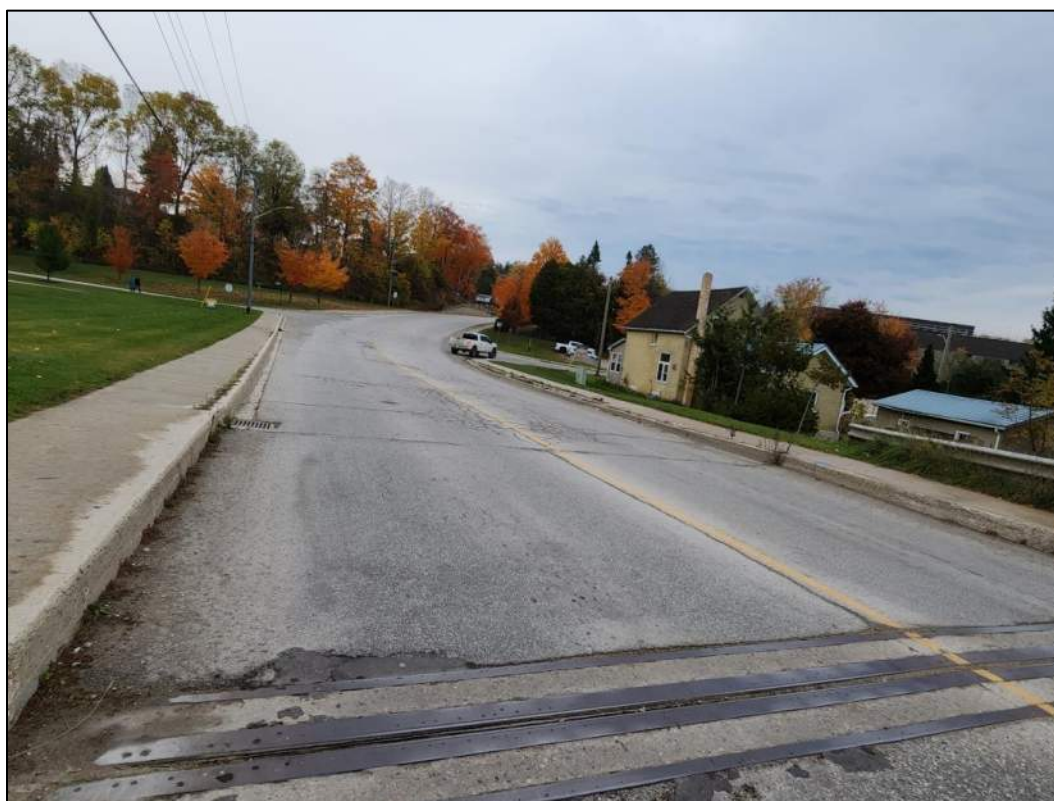
**Photo P6 – East Approach Wearing Surface** (good condition – unsealed cracks, patches and light ravelling)

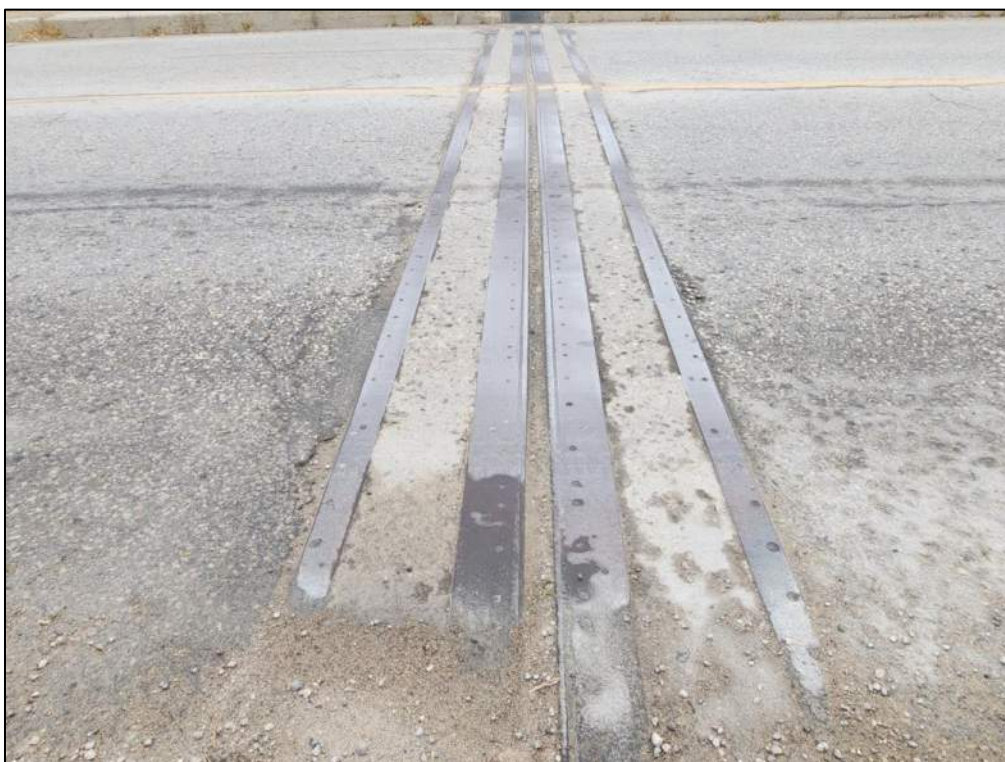
**Photo P8 – West Expansion Joint** (strip seal joint, light rusting on the steel armoring angles; seals covered with dirt and debris; cracks, spalls and scaling at concrete end dams-gap dimensions vary from 40mm to 45mm)

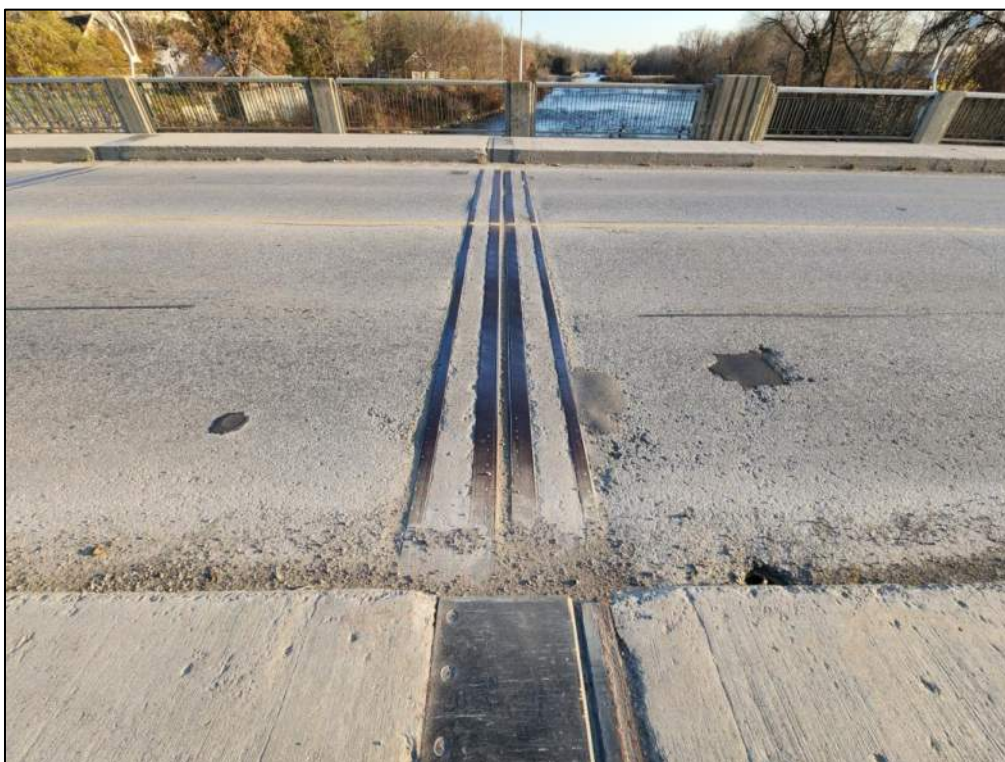
**Photo P10 – West Intermediate Expansion Joint** (strip seal joint, light rusting on the steel armoring angles; seals covered with dirt and debris; cracks, spalls -gap dimensions are 50mm at north corner and 55mm at centre and south cor gap dimensions vary from 50mm to 55mm)

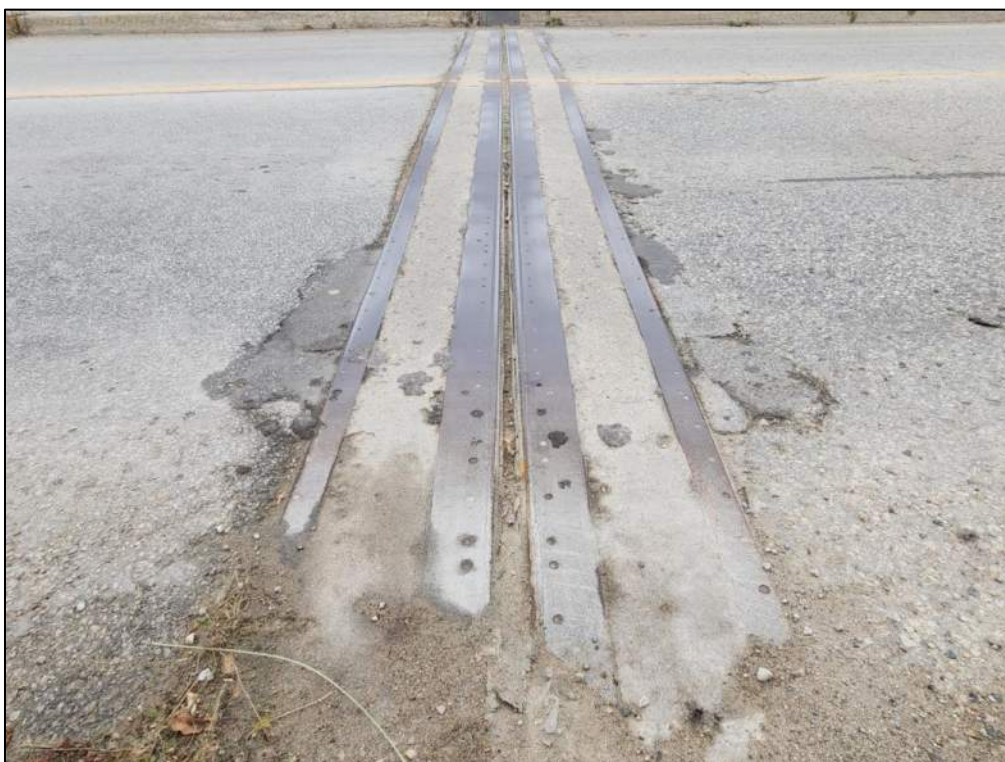
**Photo P12 – East Expansion Joint** (strip seal joint; light rusting on the steel armoring angles; seals covered with dirt and debris; cracks, spalls and scaling at concrete end dams- gap dimensions 45mm throughout)

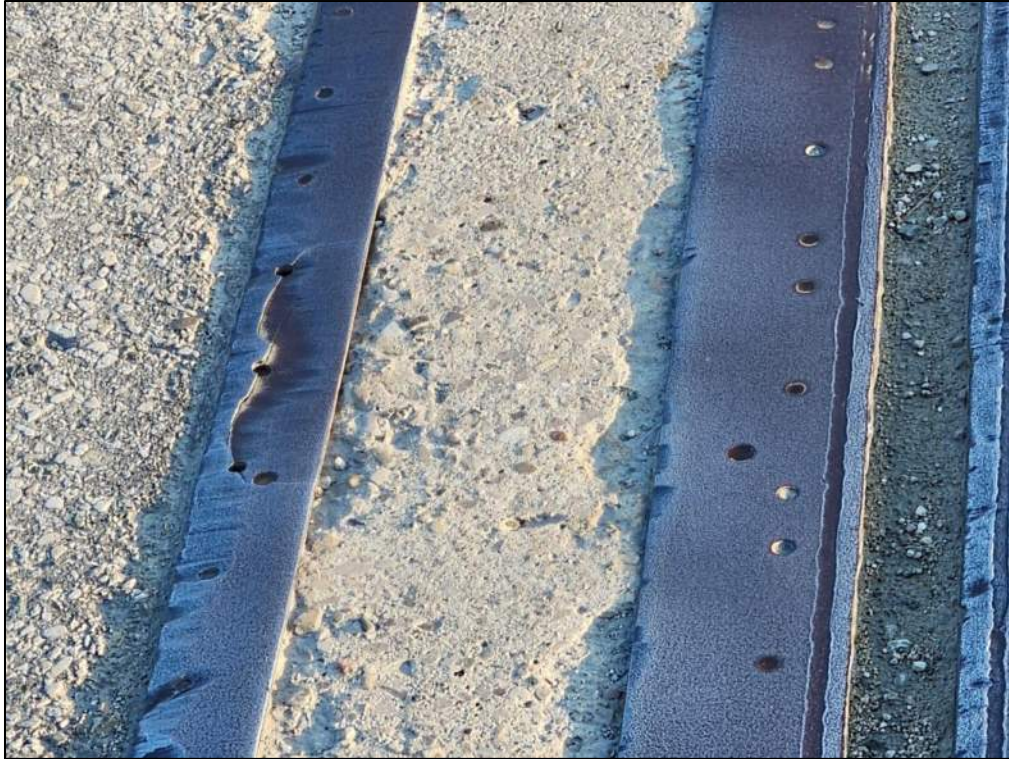
**Photo P15 – East Intermediate Expansion Joint** (damaged steel armoring angles; seals covered with dirt and debris; cracks, spalls and scaling at concrete end dams)

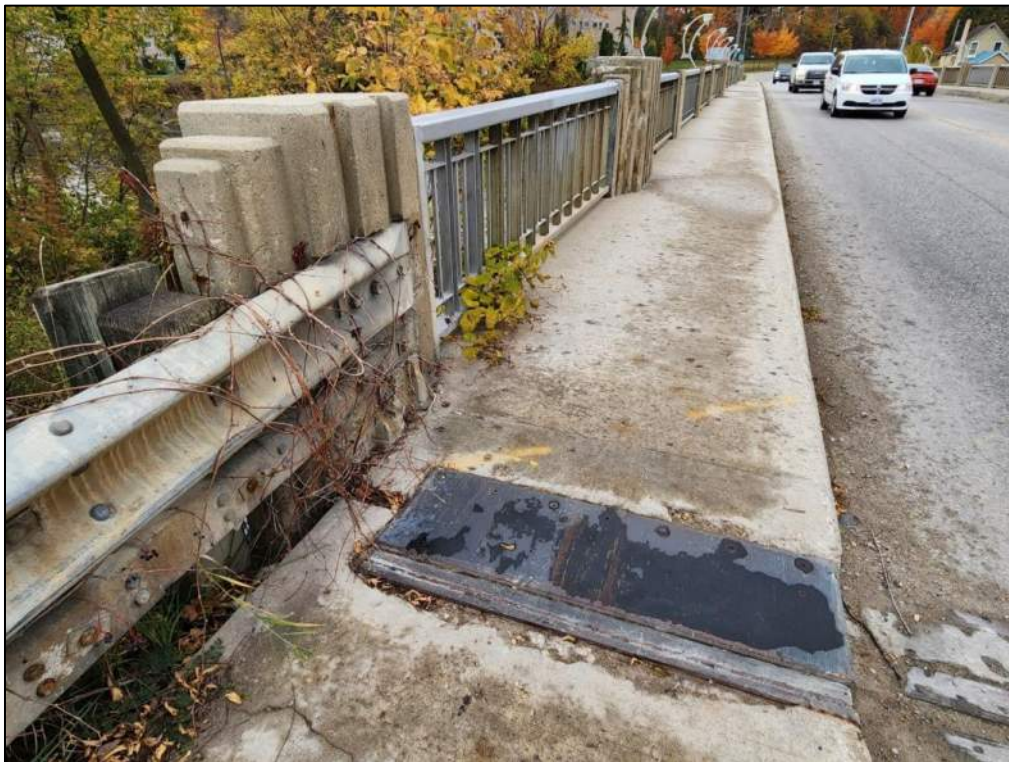
**Photo P16 – North Sidewalk** (good condition – crack, spalls delamination and shallow pop-outs) **and Steel Handrail** (fair to good condition – impact damage)

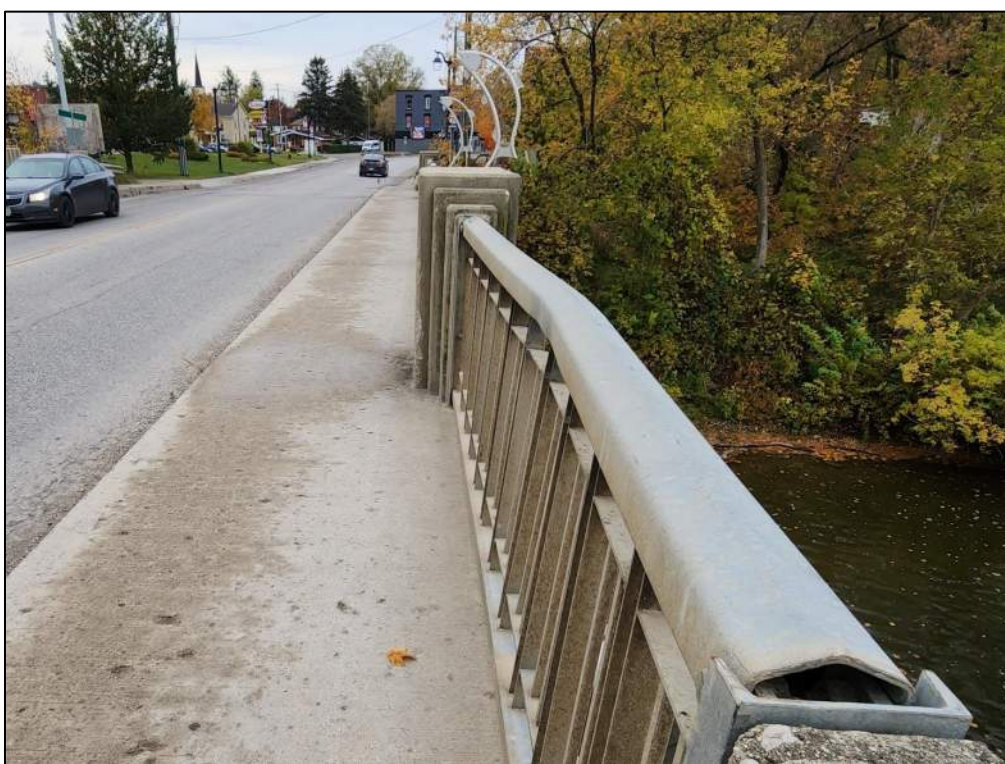
**Photo P18 – North Steel Handrail (impact damage, bent railings) and Sidewalk (pop-outs)**

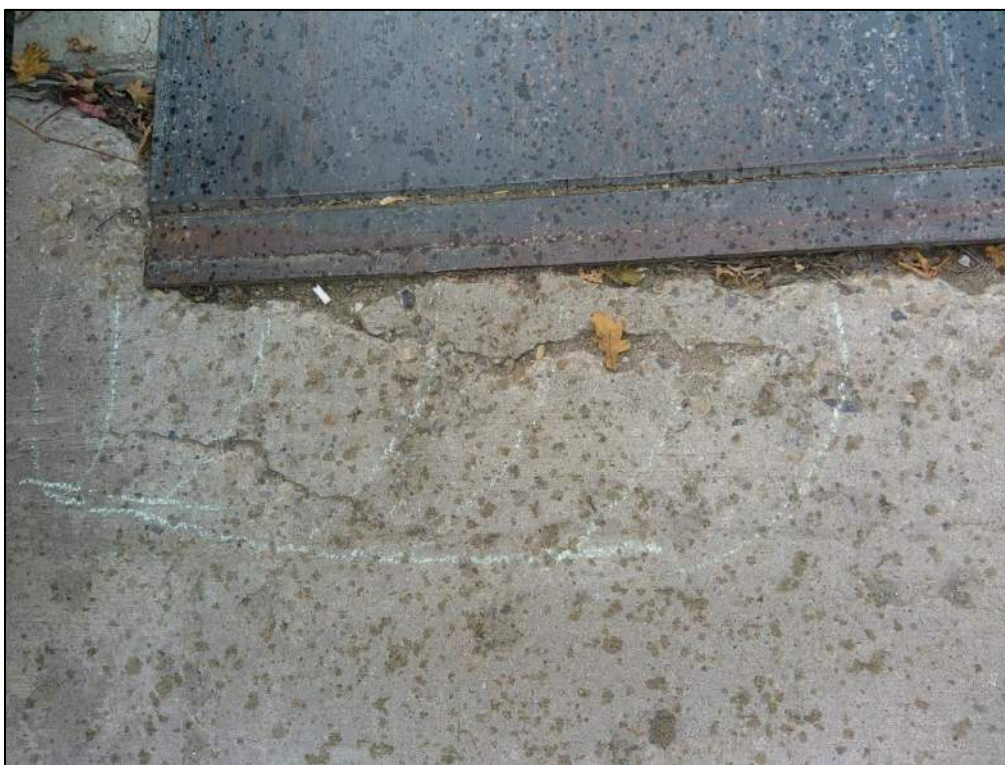
Photo P22 – South Sidewalk (crack and delamination)

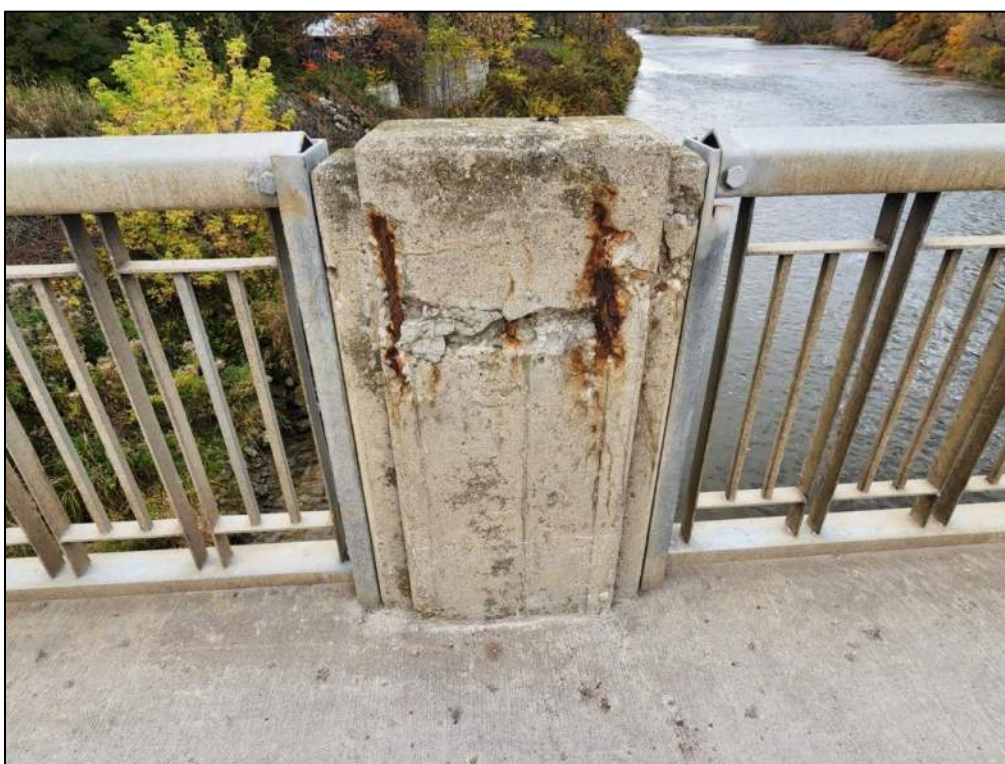
Photo P24 – South Concrete Post (spalls with exposed corroded rebar)

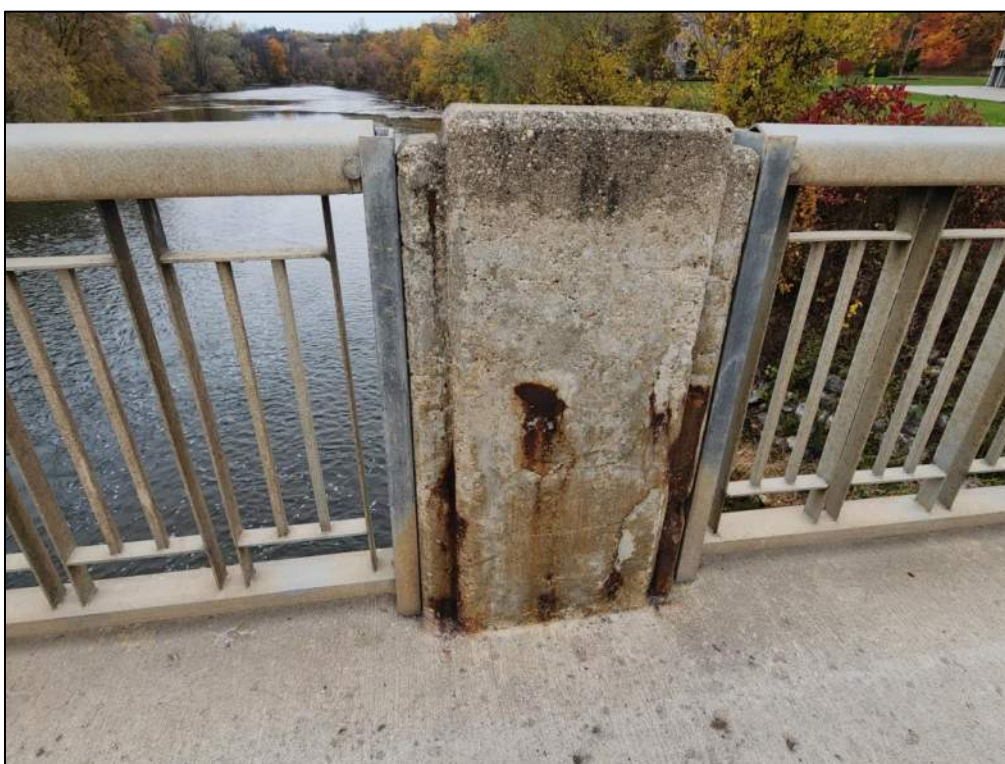
Photo P26 – North Concrete Post (severe rust stains)

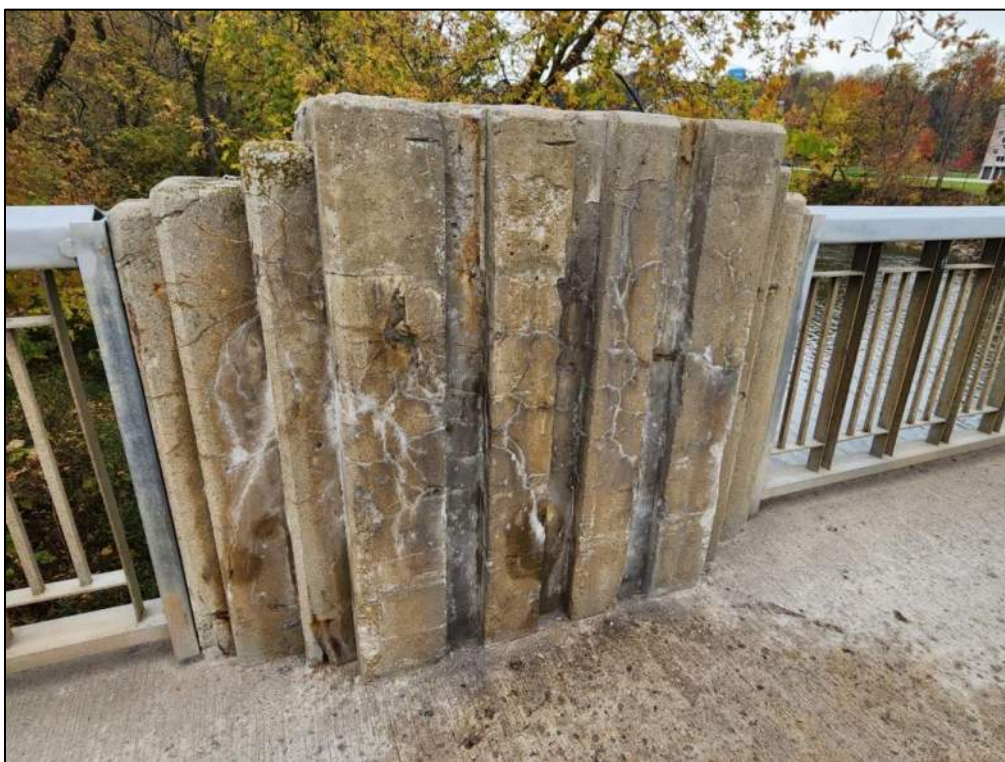
Photo P28 – North-West End post (severe AAR, cracks)
