## County of Bruce

### Class Environmental Assessment Durham Street Bridge, Walkerton Third-Party Review

Triton Engineering Services Limited and Burgess Engineering Inc.

February 20, 2024

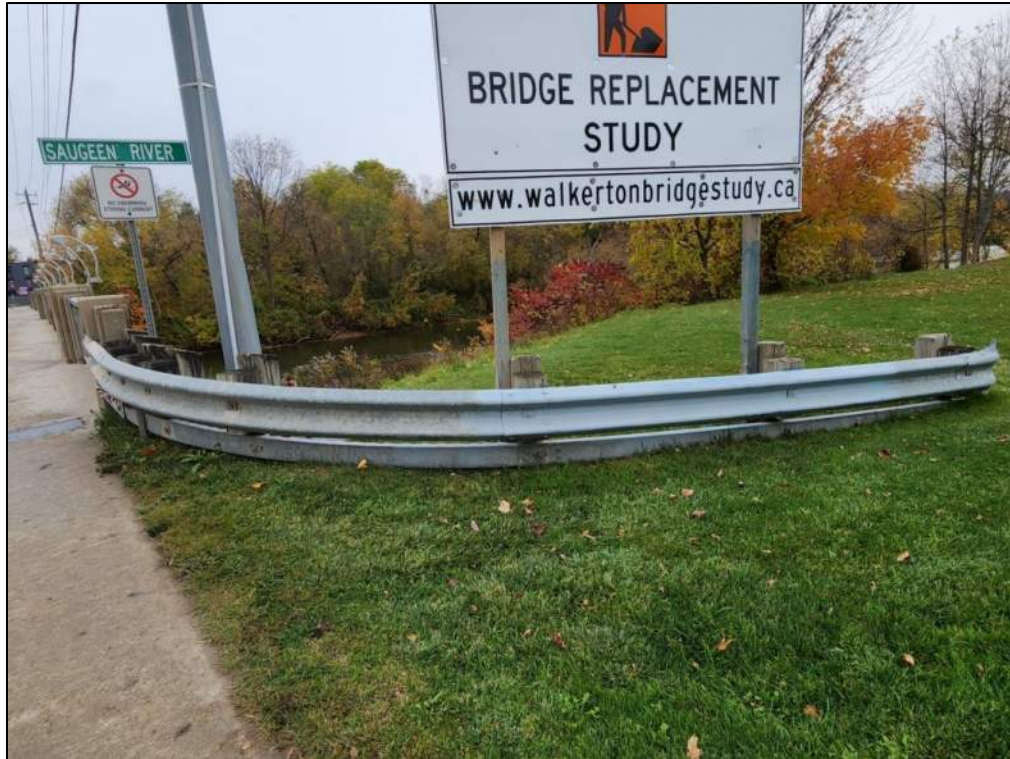
Photo P31 – North-East Guiderail (good condition – splits on wooden posts)

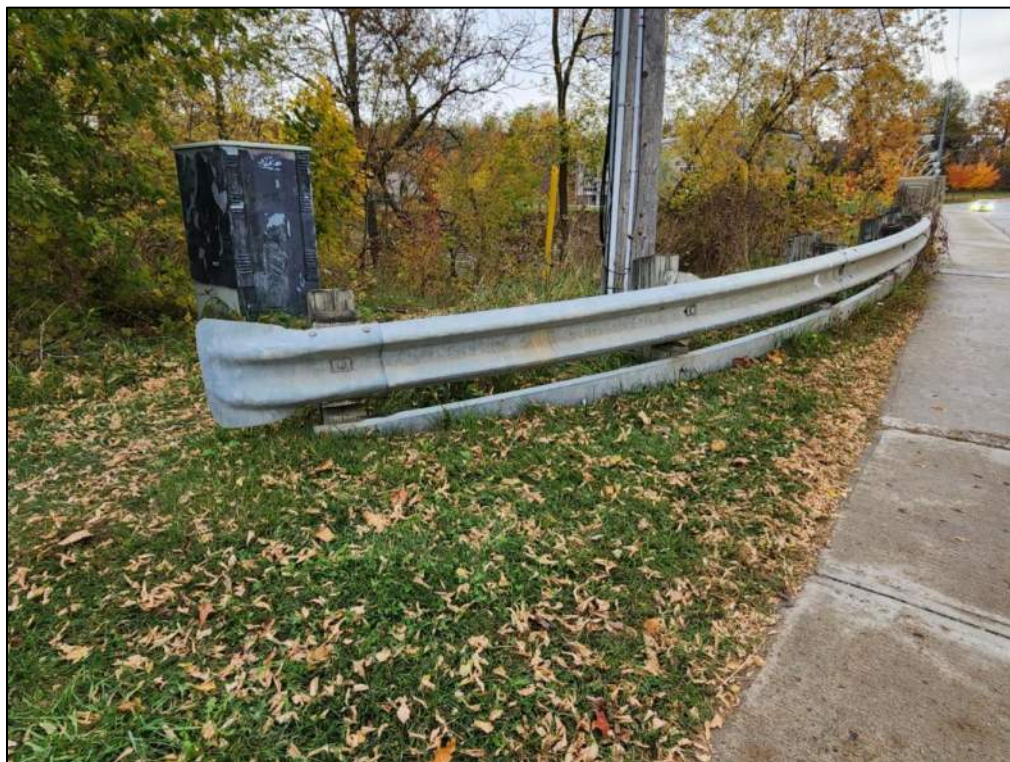
Photo P32 – North-West Guiderail (good condition – splits and rot on wooden posts)

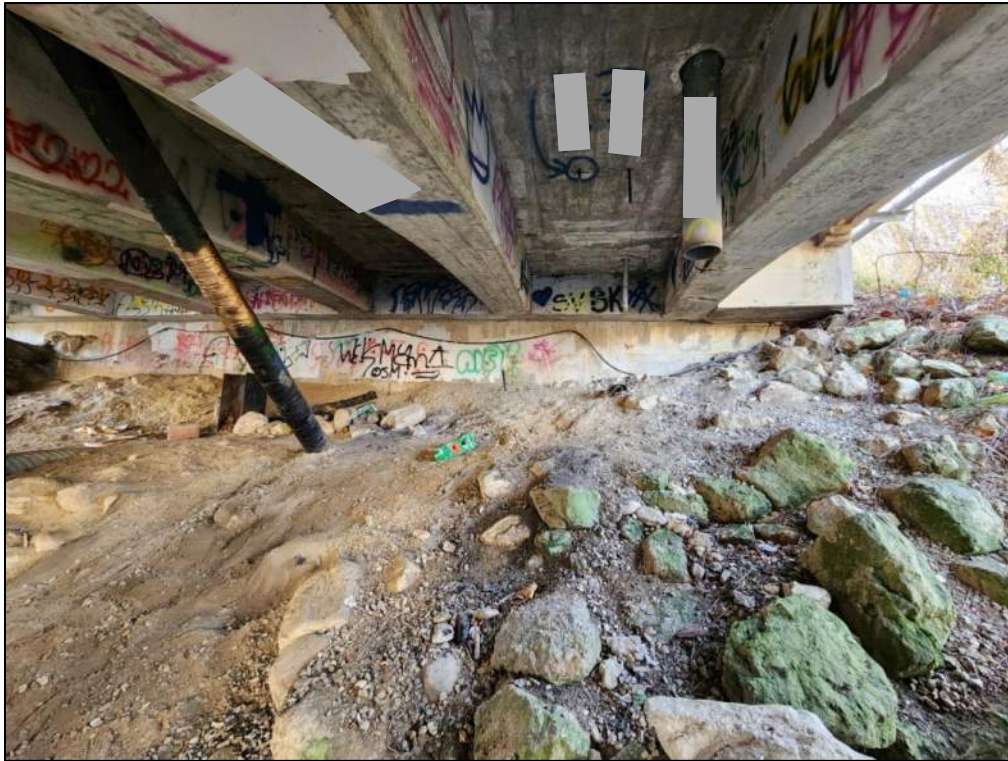
**Photo P37 – West Abutment (good condition) and Embankment (fair to good condition – erosion, loss of rock protection)**

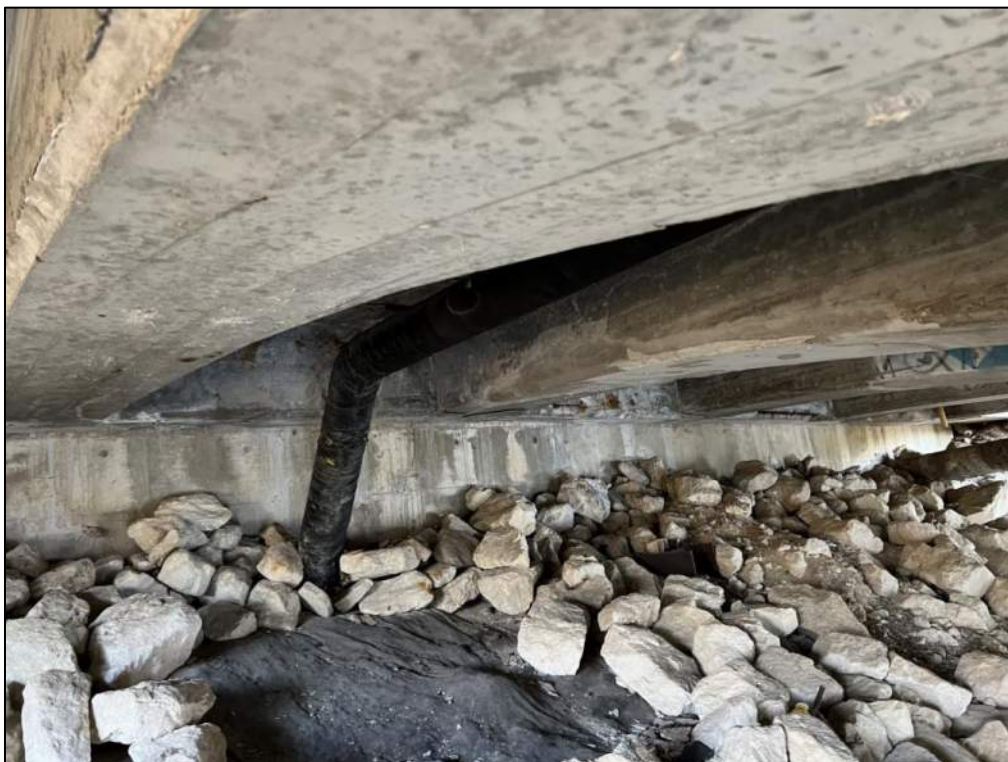
**Photo P38 – East Abutment (good condition) and Embankment (fair to good condition – erosion, loss of rock protection)**

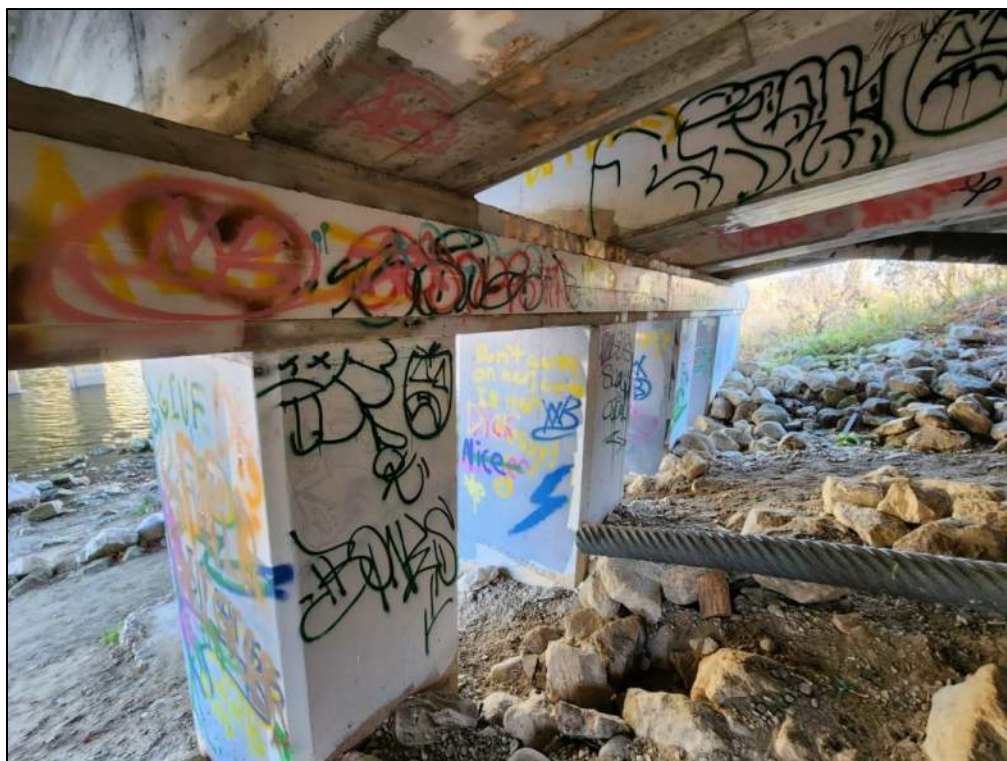
Photo P39 – Pier 1 – West Face (spalls with exposed corroded rebar)

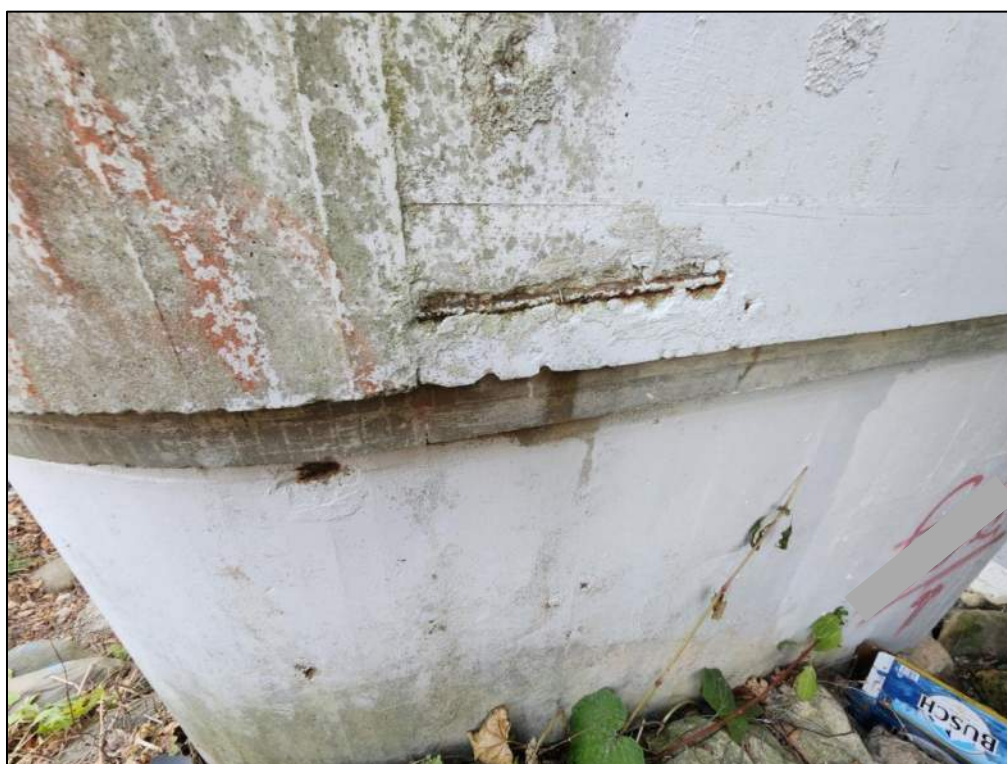
Photo P40 – Pier 1 – West Face (exposed corroded rebar)

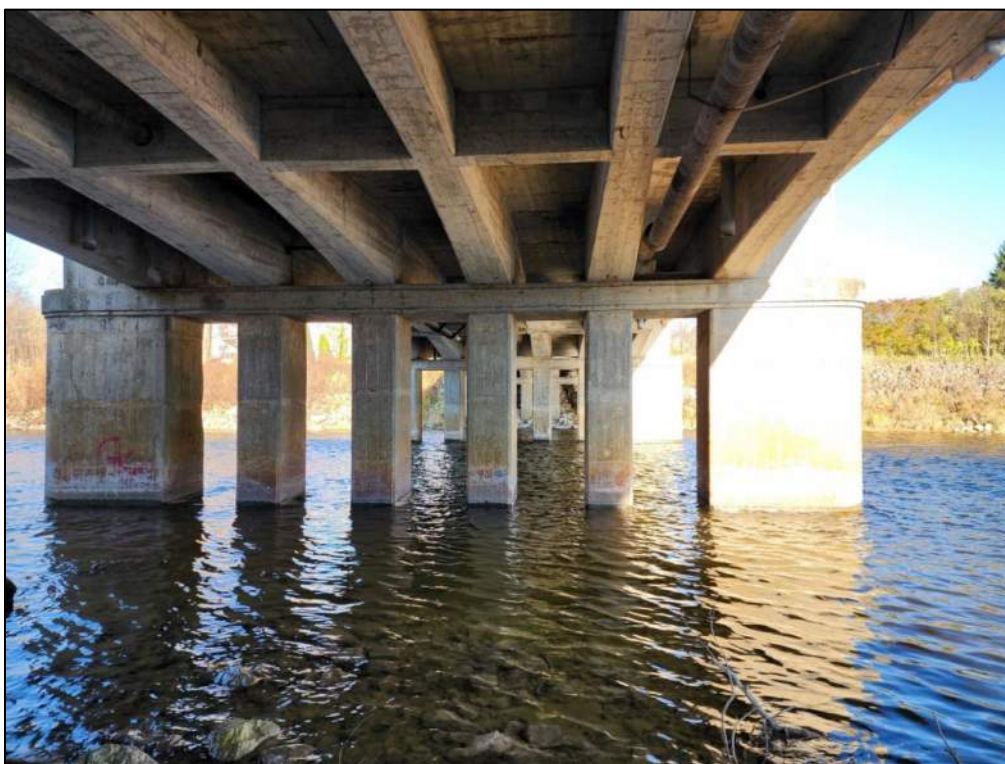
Photo P44 – Pier 2 – West Face (crack and light scaling)

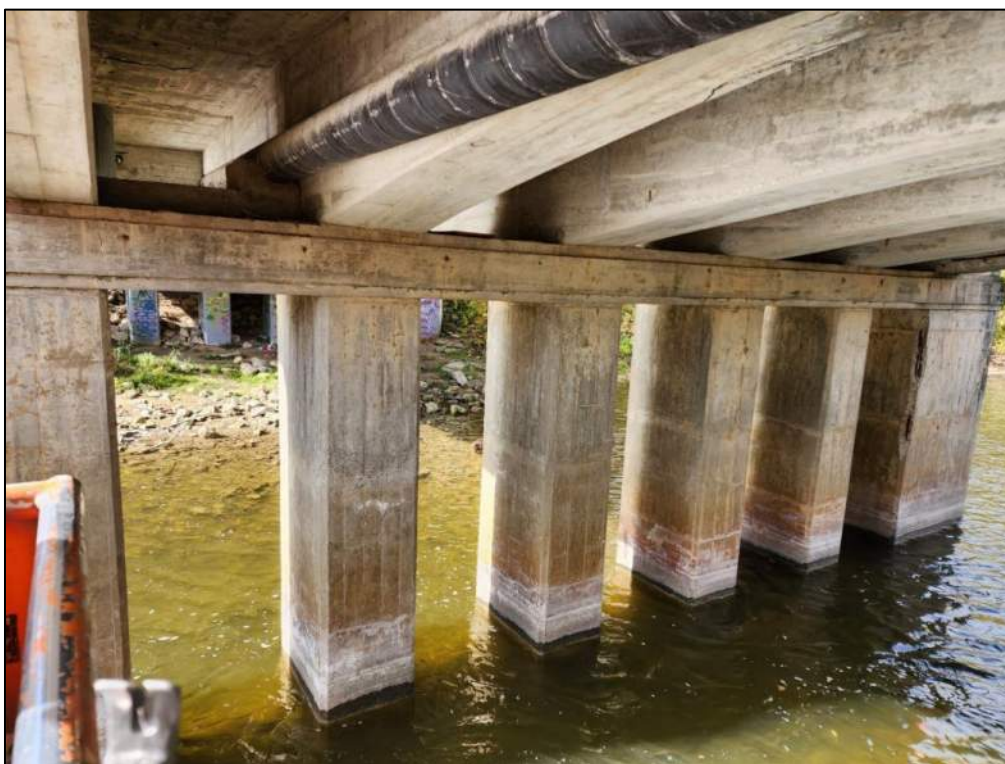
Photo P46 – Pier 2 – East Face (spall, delamination and hairline to narrow efflorescence stained cracks, light pattern cracks)

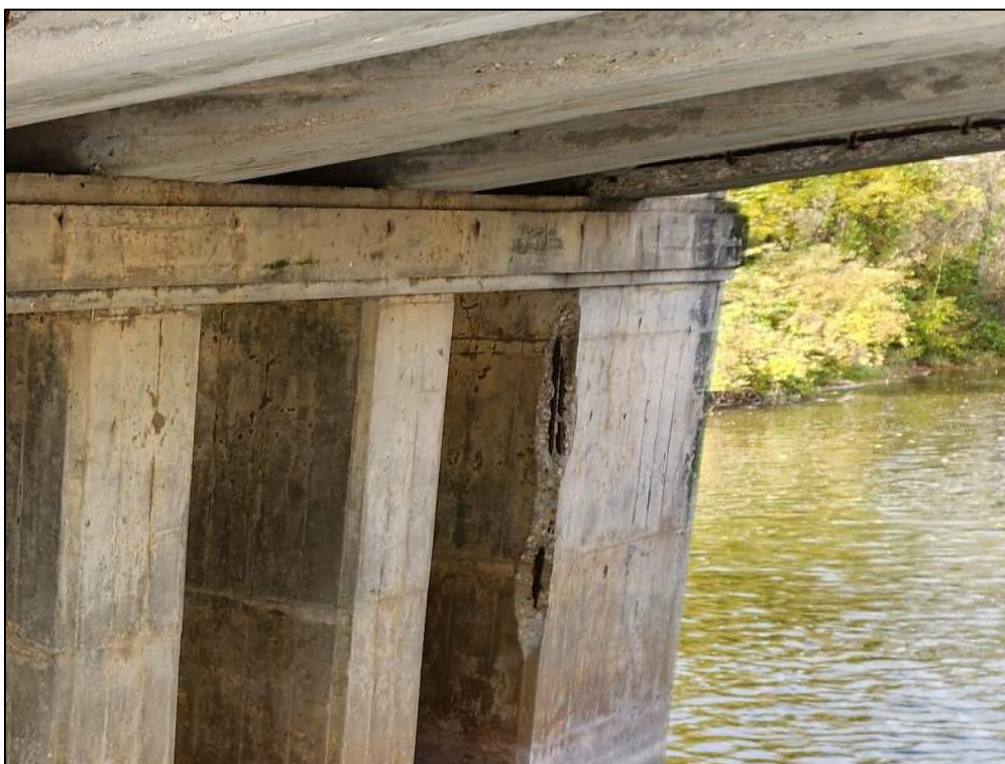
Photo P48 – Pier 2 – East Face (spall with exposed rebar)

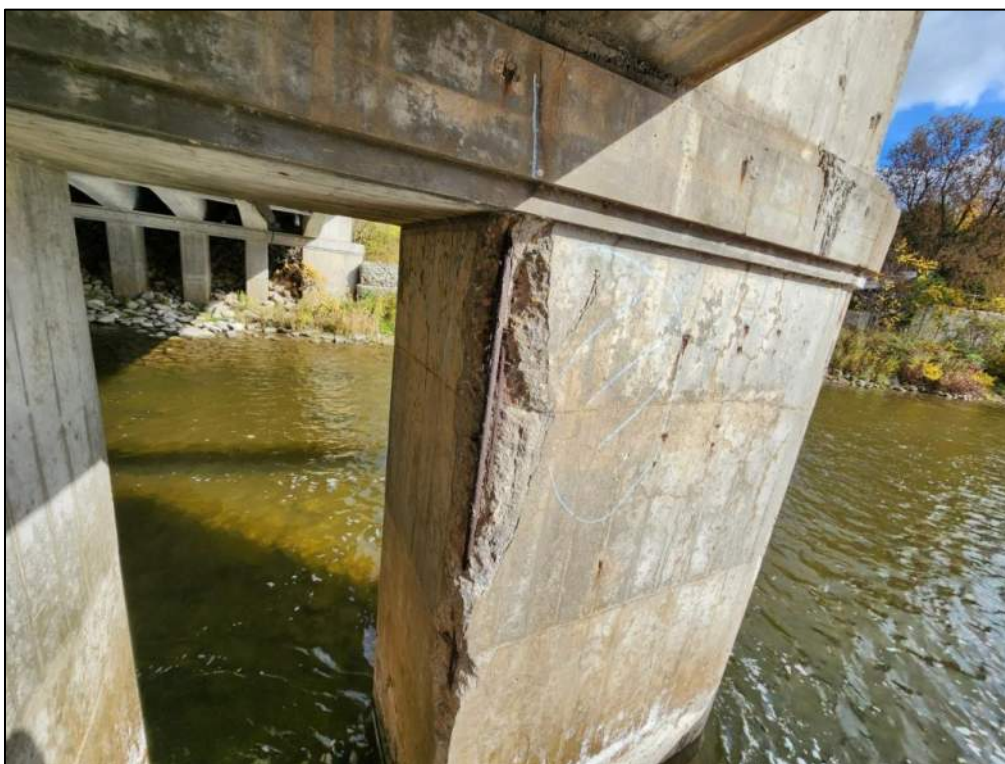
Photo P50 – Pier 3 – West Face (light pattern cracks, spall with exposed corroded rebar and delamination)

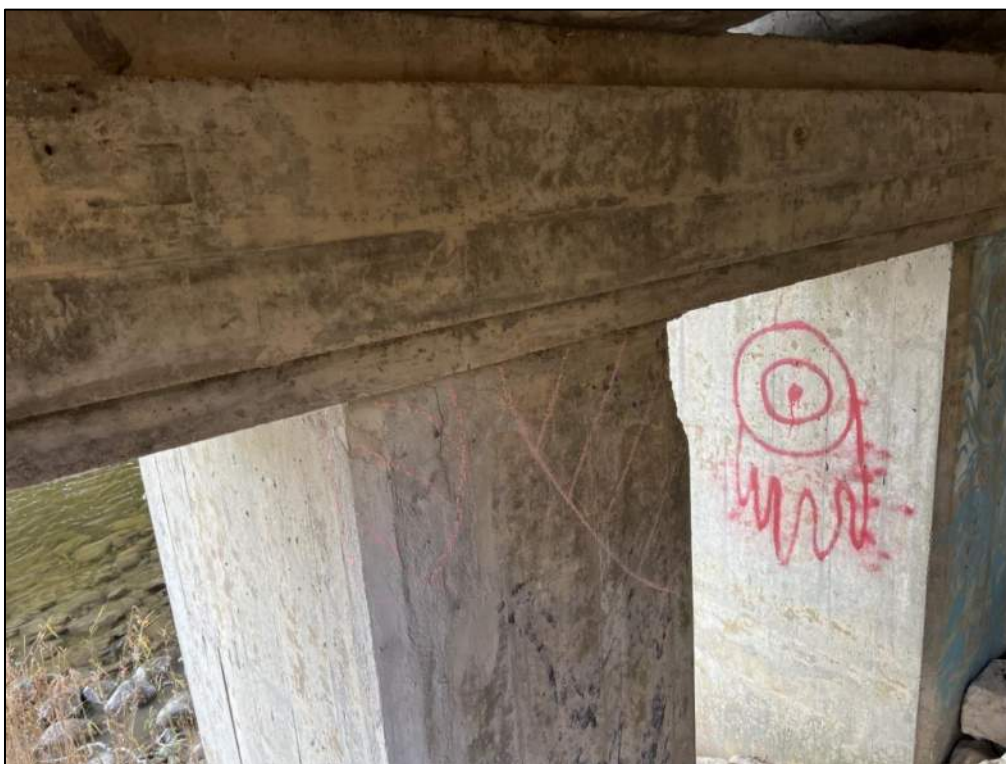
Photo P54 – Pier 4 – East Face (spall and delamination)

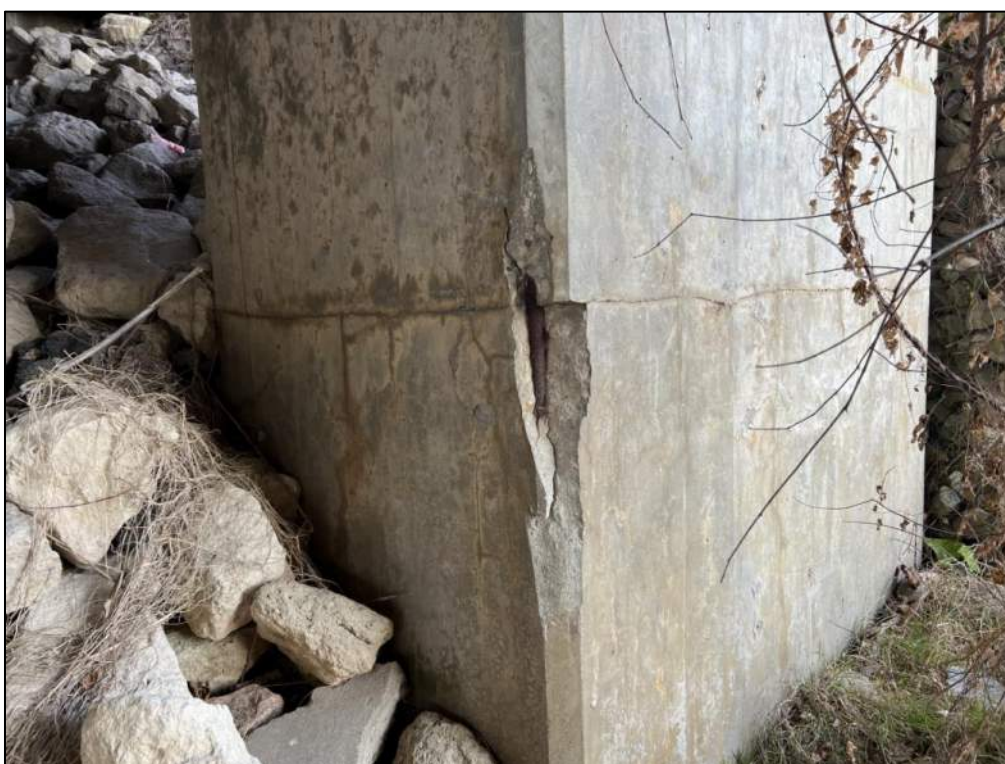
Photo P56 – Pier 4 – West Face (spall, delamination, and light scaling)

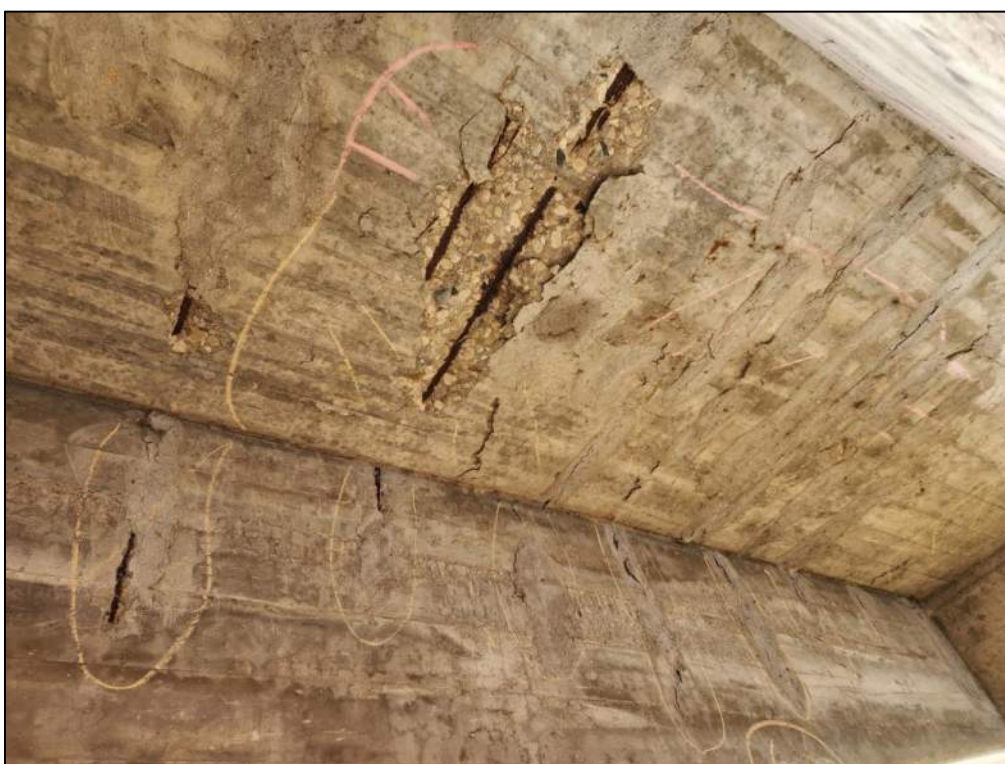
Photo P60 – Soffit between Pier 1 to Pier 2 (spall with exposed rebar, delamination and patched area) and Girder (delaminations and patched area)

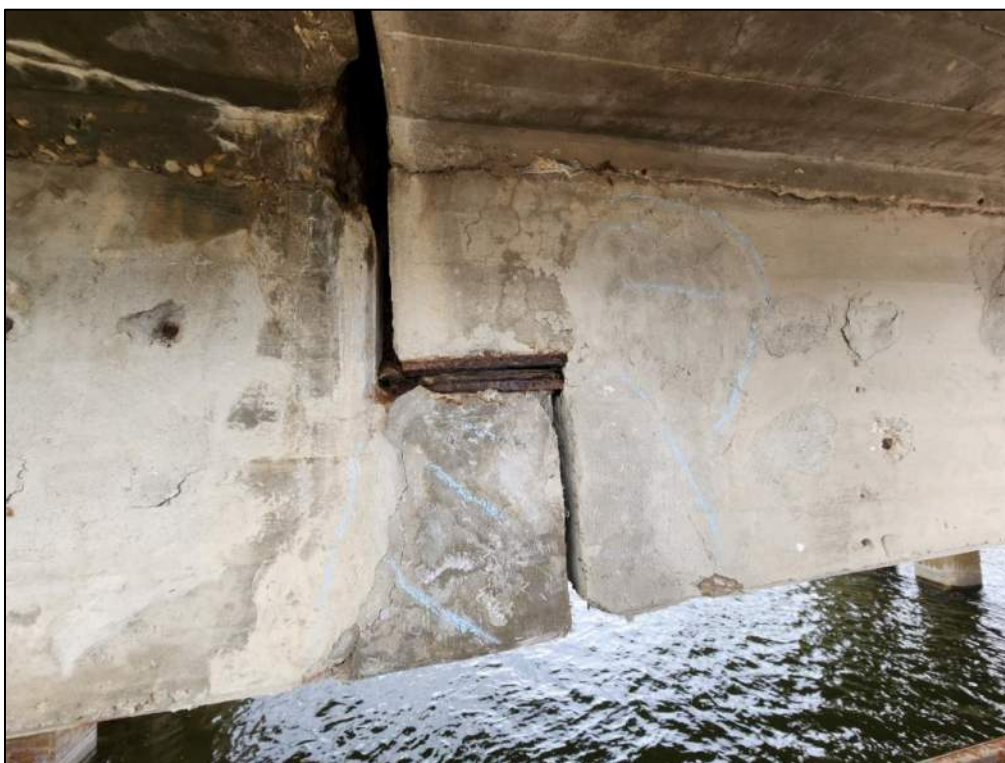
Photo P64 – Soffit between Pier 2 to Pier 3 (delamination, spall and rust staining at drop in span joint-severe rust on bearing plates; evidence of leakage)

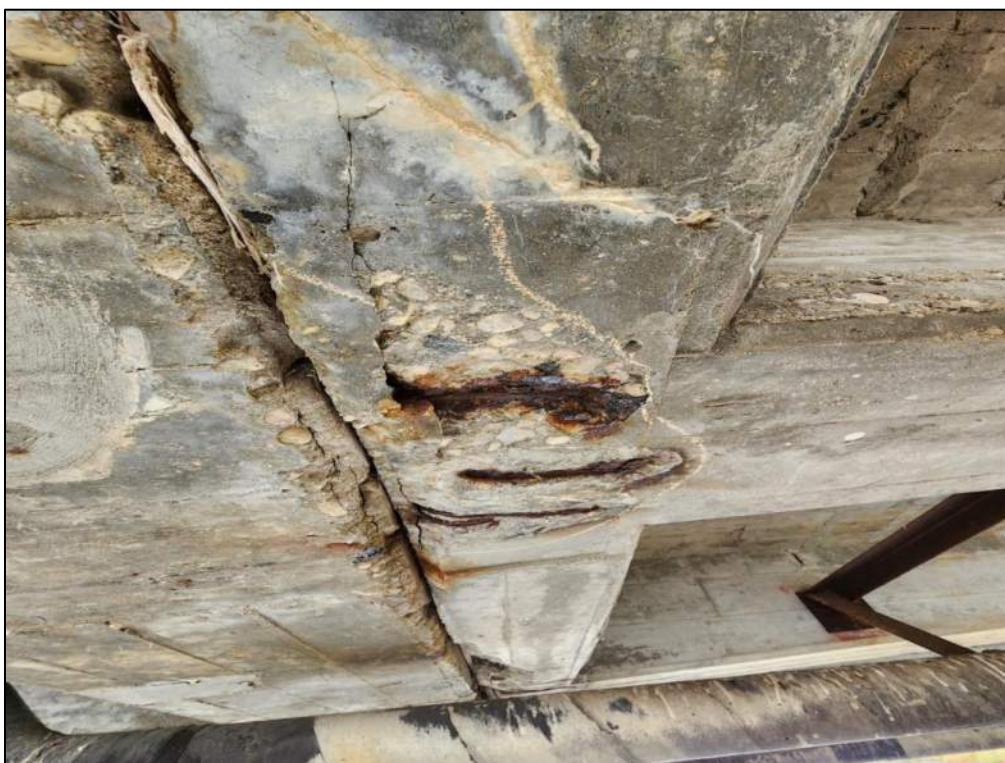
**Photo P66 – Soffit between Pier 2 to Pier 3 (spall with exposed corroded rebar and delamination at bottom face of diaphragm; evidence of leakage)**

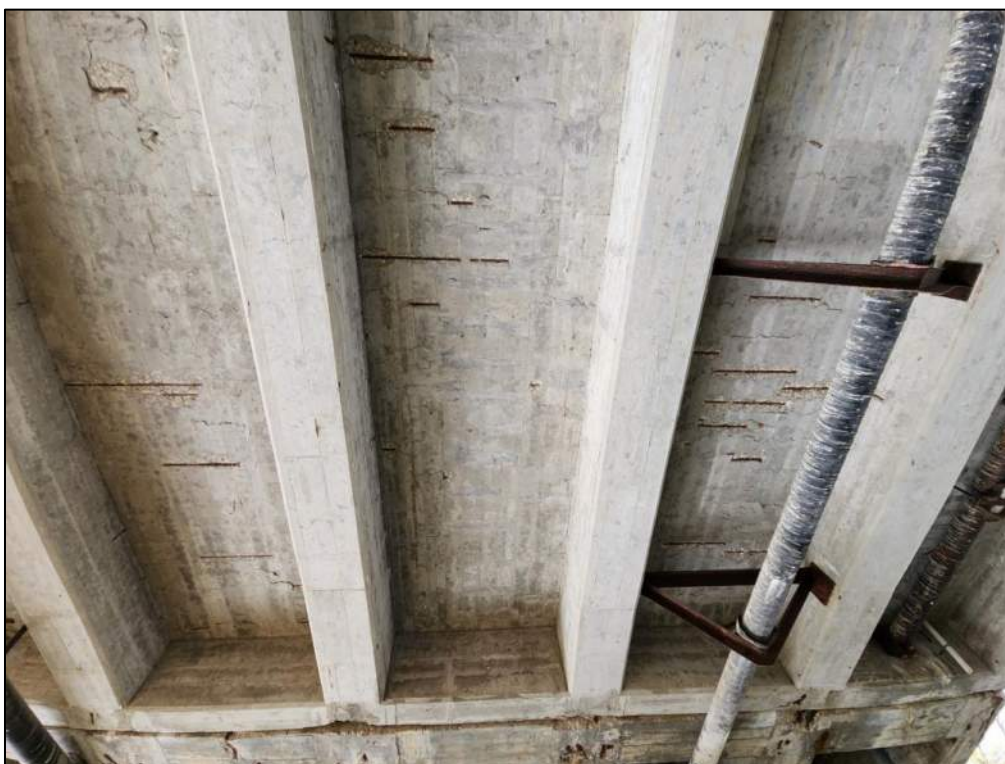
**Photo P68 – Soffit between Pier 2 to Pier 3 (spall with exposed corroded rebar, delamination and patched areas) and Girder (delaminations and patched area)**

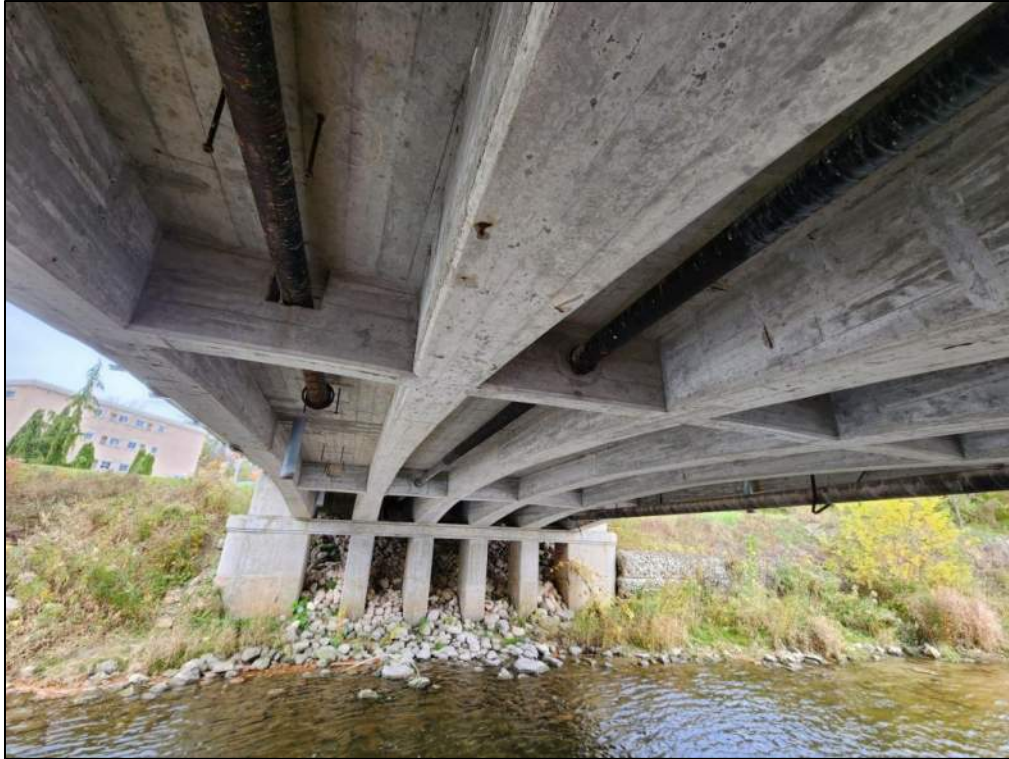
**Photo P69 – Soffit between Pier 3 to Pier 4 (spalls with exposed rebar, delaminations and patched areas) and Girder (delaminations and patched areas)**

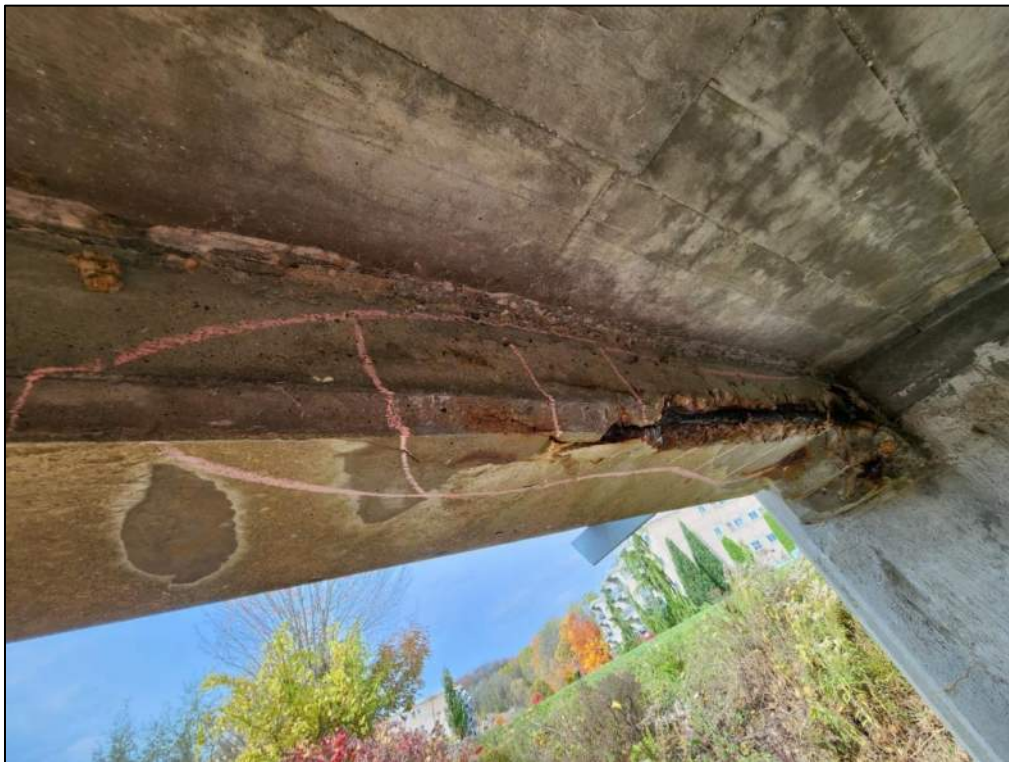
**Photo P70 – Girder between Pier 3 to Pier 4 (spall with exposed corroded rebar, delamination and patched area)**

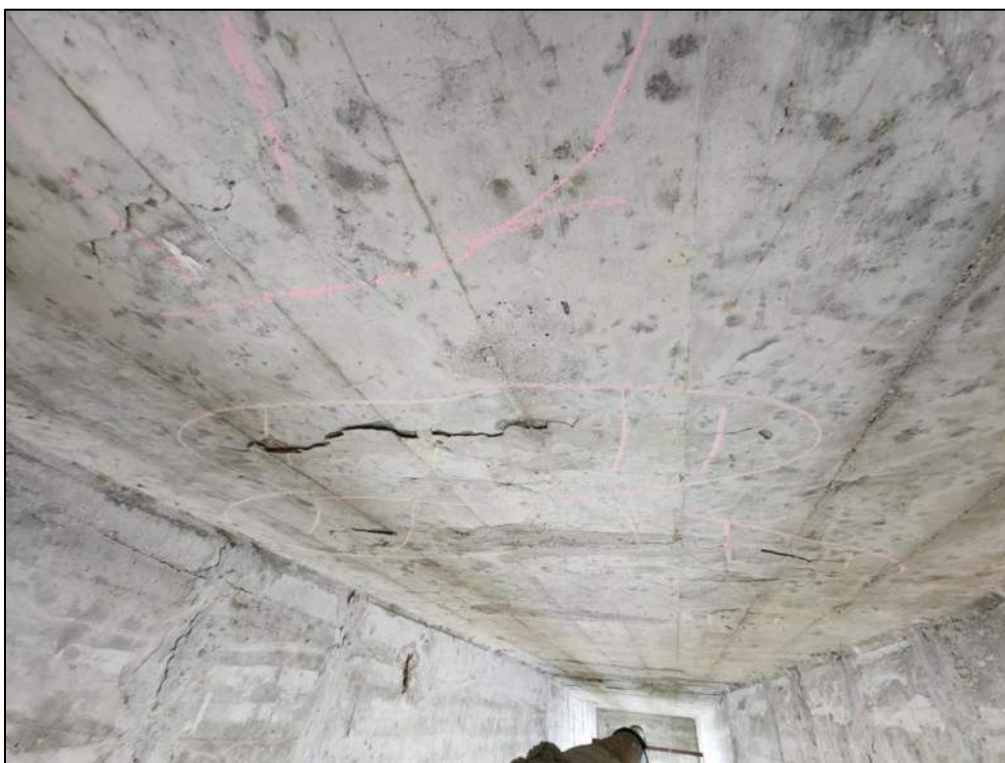
**Photo P72 – Soffit between Pier 3 to Pier 4 (spall with exposed corroded rebar, delamination and patched area)**

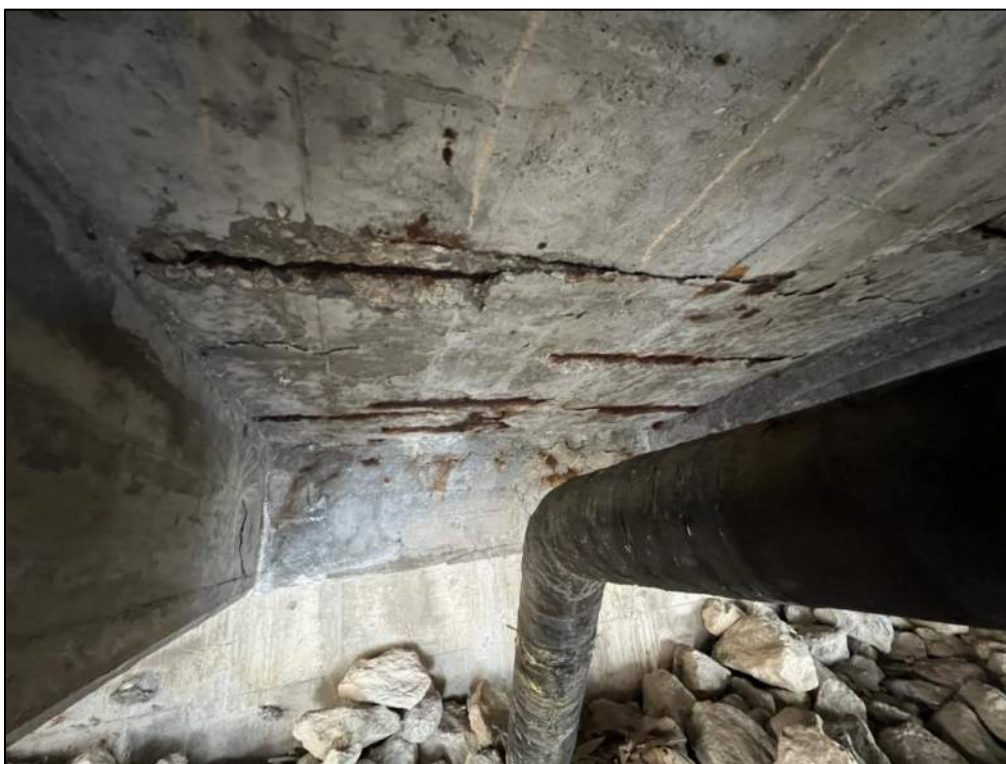
**Photo P74 – Soffit between East Abutment to Pier 4 (spall with exposed corroded rebar, delaminations and patched areas)**

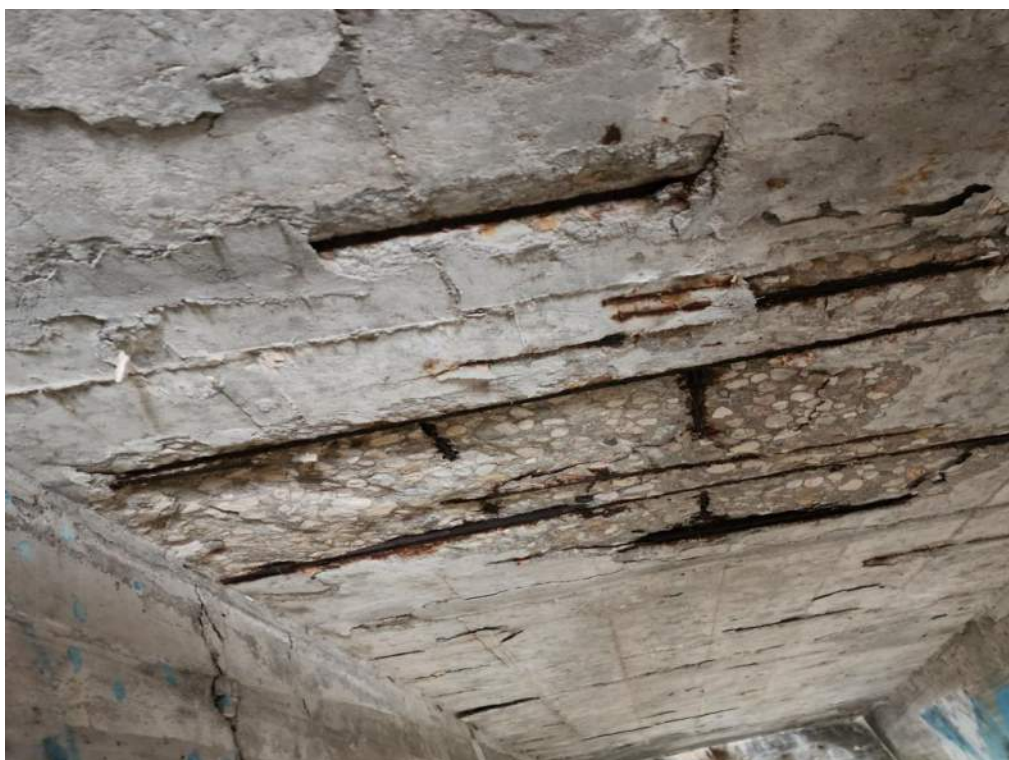
Photo P75 – Soffit between East Abutment to Pier 4 (spalls with exposed corroded rebar, delaminations and patched areas)

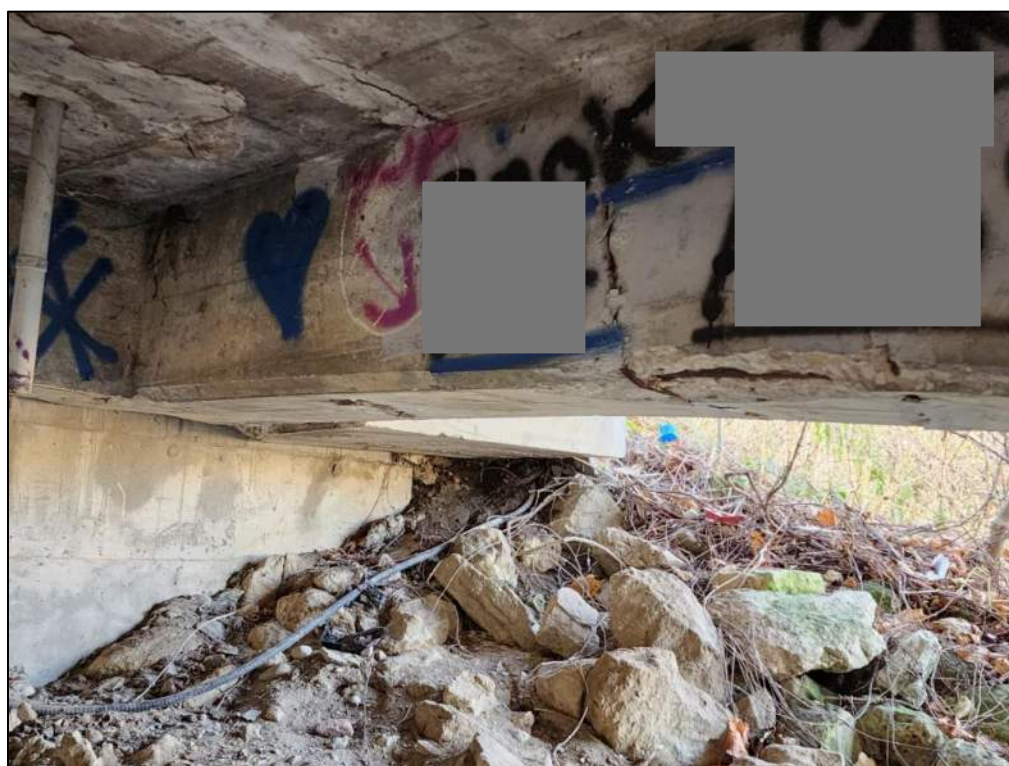
Photo P76 – Girder between West Abutment and Pier 1 (cracks, spall with exposed corroded rebar, delamination)

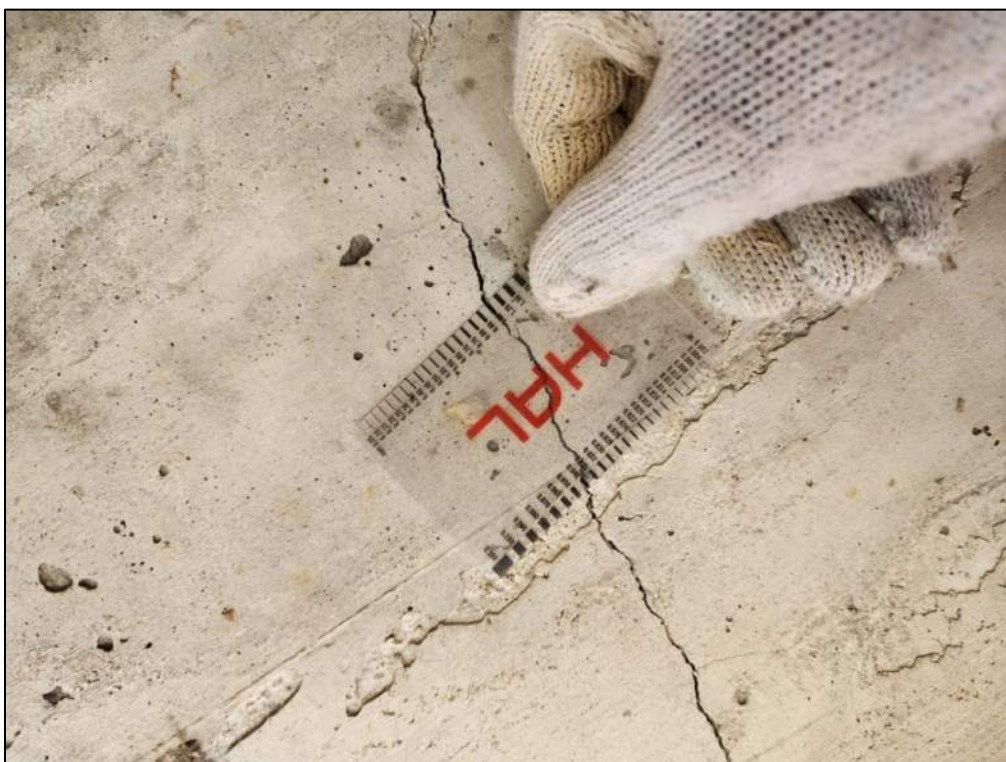
Photo P82 – Girder between Pier 3 and Pier 4 (wide crack)

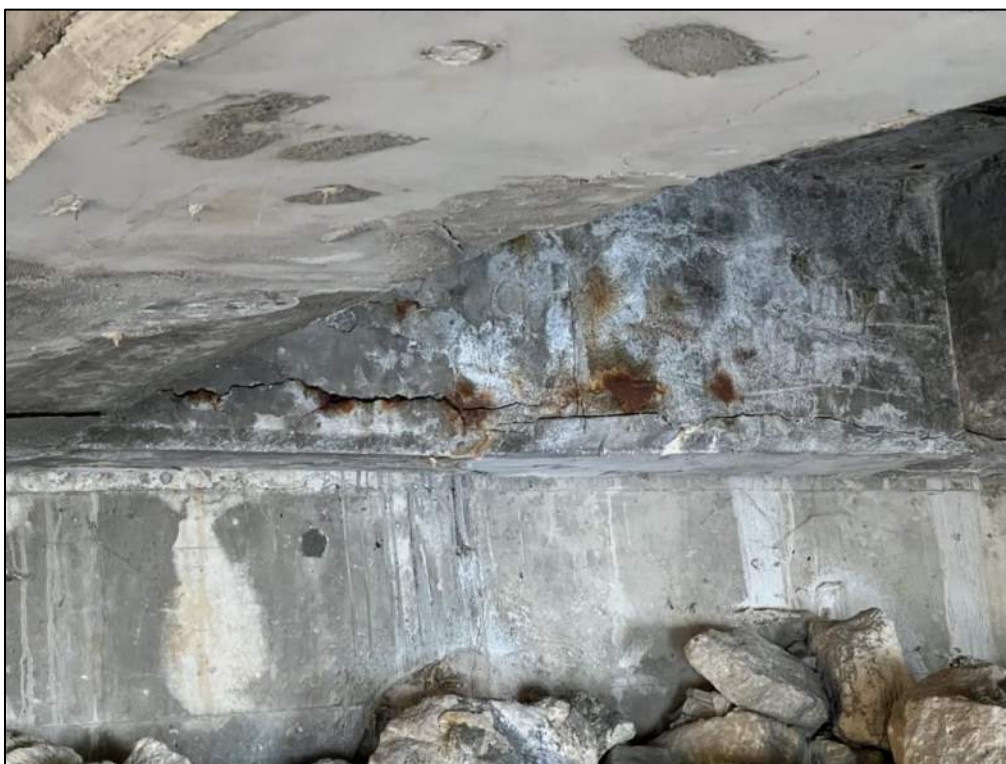
Photo P86 – East Abutment Diaphragm (delamination, rust stains)

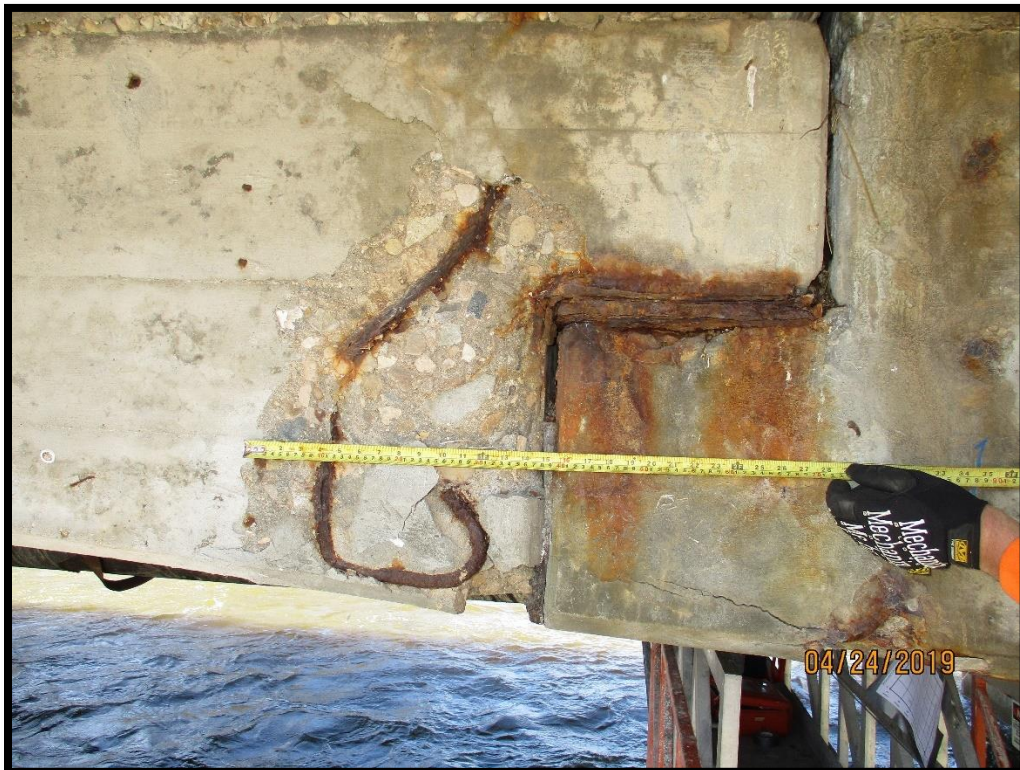
The exterior faces of the edge girders are exposed to salt spray from the open railing system. These areas exhibit the worst of the delaminations due to rust swelling of the reinforcing steel and the bearing plates.

South exterior beam face – after scaling loose concrete
