Staff Report to Council - for Information

Title: Durham Street Bridge - Flooding Impacts on Construction

Report Number: TES-2025-007

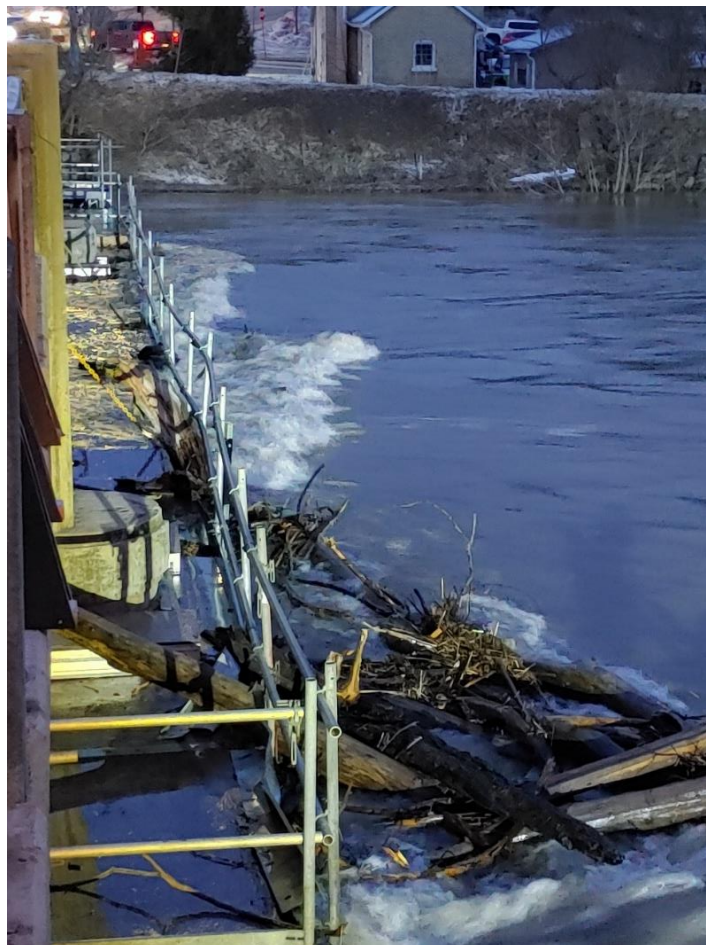
Pictured above, the Saugeen River breached the Centre Span of the construction platform at 5:30am Monday, March 17th, 2025. River Flows recorded upstream by station 02FC002 on Environment Canada's Real Time Hydrometric Flow Data website show a peak flow rate of 377m³/s was reached at 4:10pm Monday, March 17th, 2025. The average flow rate in this location is approximately 30m³/s.

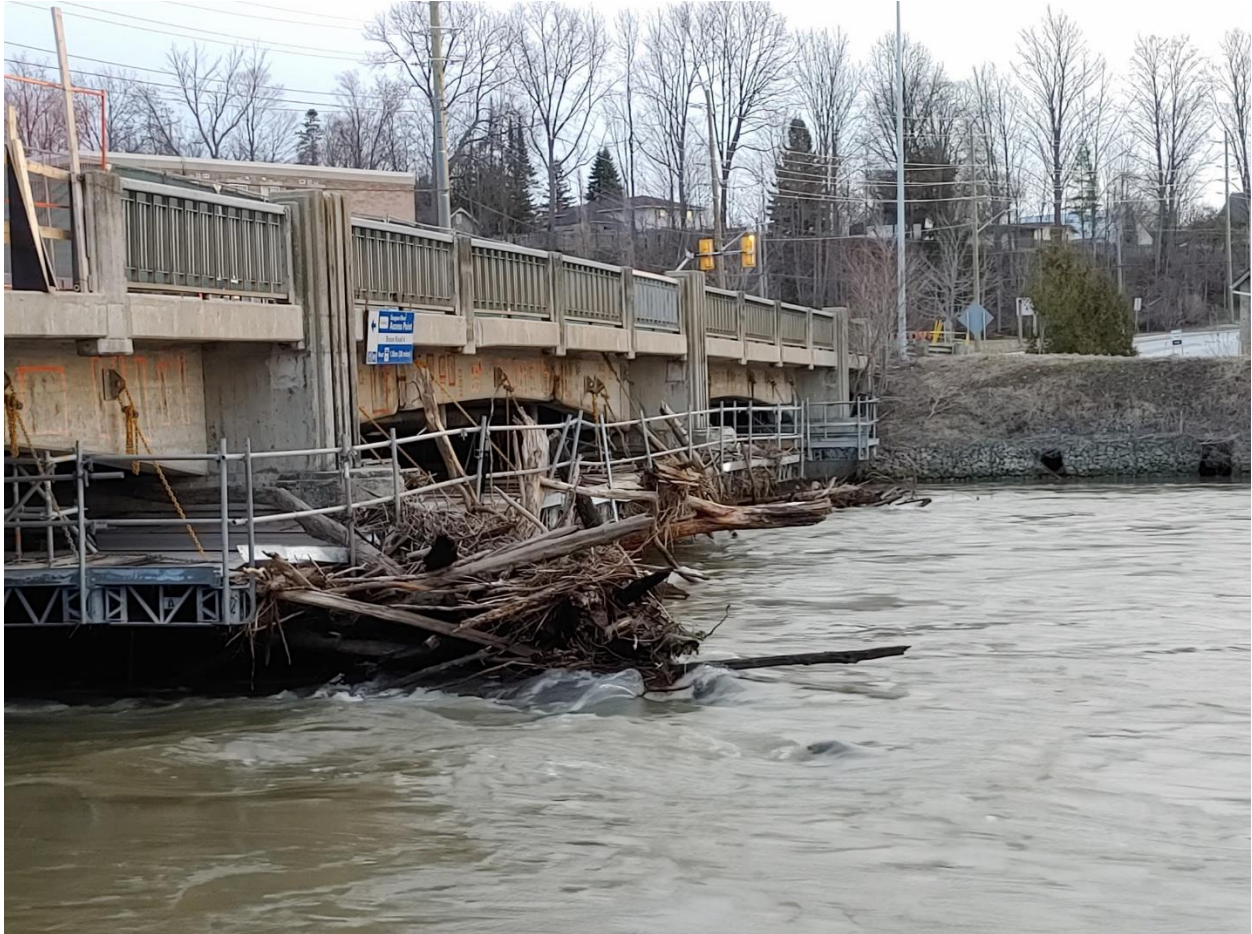
An Engineer's assessment of the bridge structure on March 19th, 2025 concluded that the recent spring thaw did not structurally damage the bridge. However, the centre span of the construction platform underneath the bridge, sustained significant damage from large debris carried downstream. The centre span of the construction platform requires immediate attention before construction activity underneath the bridge can resume. The centre section of platform has been in place since construction began in May of 2024 and is a crucial component to the ongoing work to repair the bridge's half-joints.

Pictured above, the high water levels left significant debris and damage on the Centre span platform as water levels began to recede on Tuesday, March 18th, 2025.

The project team consisting of representatives from Pullman, Triton Engineering and Bruce County's Transportation and Environmental Services team are working on a solution to resolve the damage sustained to the platform. In the meantime, construction on the bridge is on hold.
