## County of Bruce

### Class Environmental Assessment Durham Street Bridge, Walkerton Third-Party Review

Triton Engineering Services Limited and Burgess Engineering Inc.

February 20, 2024

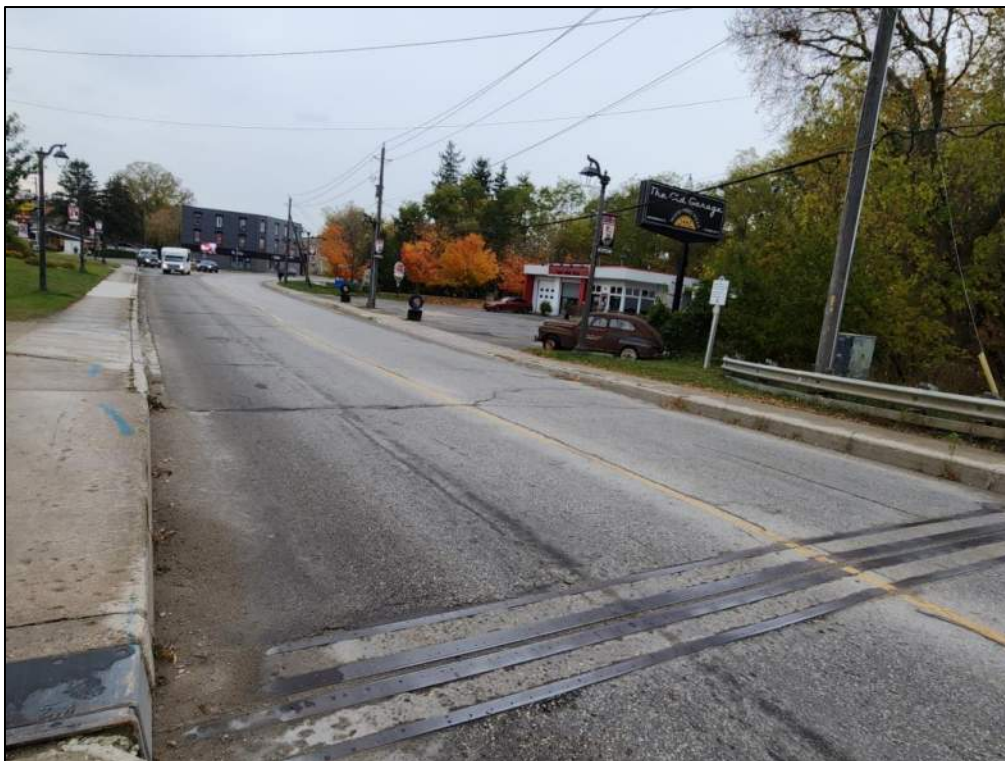
**Photo P7 – West Approach Wearing Surface** (good condition – sealed/unsealed cracks and light ravelling)

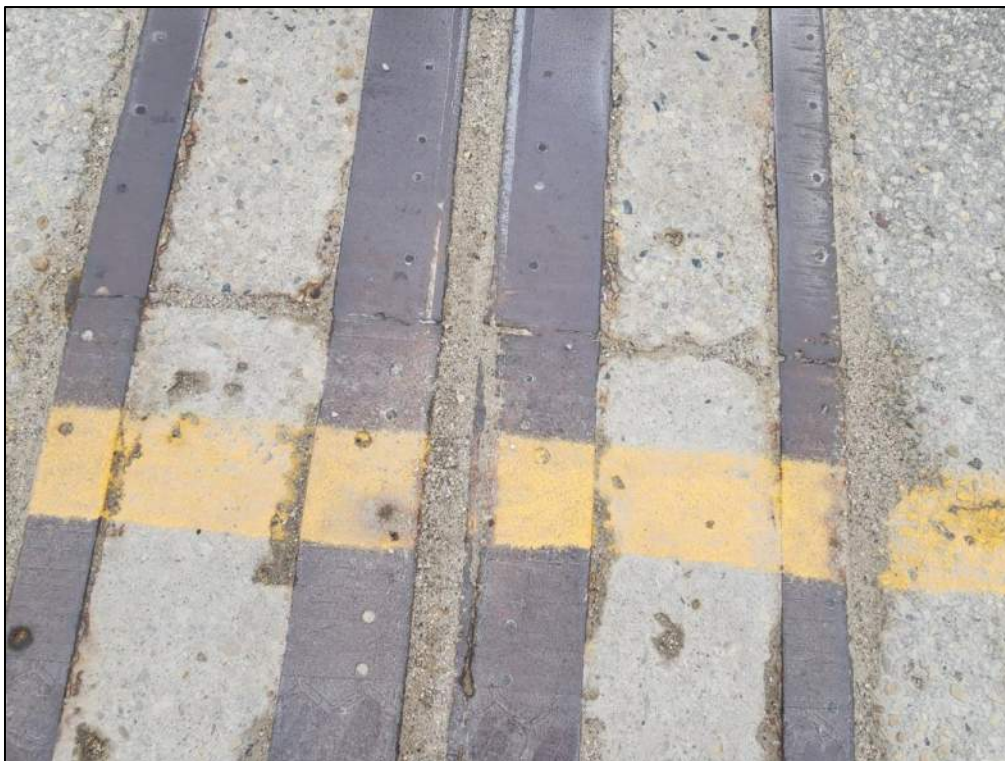
**Photo P9 – West Expansion Joint** (light rusting on the steel armoring angles; seals covered with dirt and debris; cracks, spalls and scaling at concrete end dams)

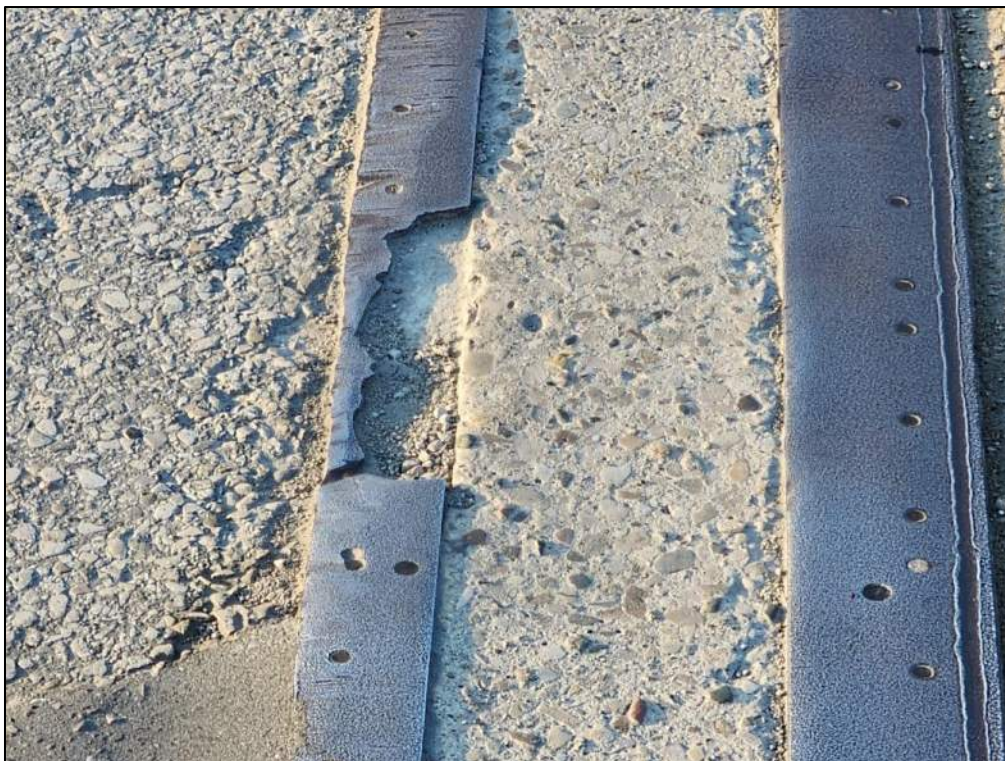
**Photo P11 – West Intermediate Expansion Joint** (damaged steel armoring angles; seals cracks, spalls and scaling at concrete end dams)

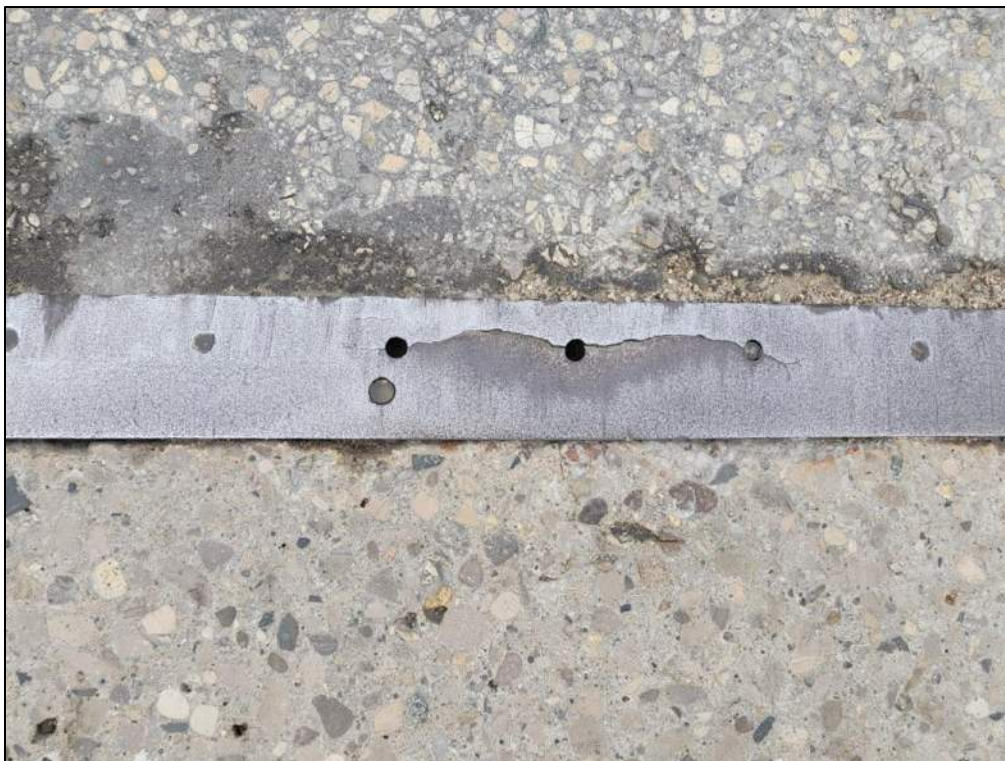
**Photo P13 – East Expansion Joint** (cracks on the steel armoring angles; cracks, spalls and scaling at concrete end dams)

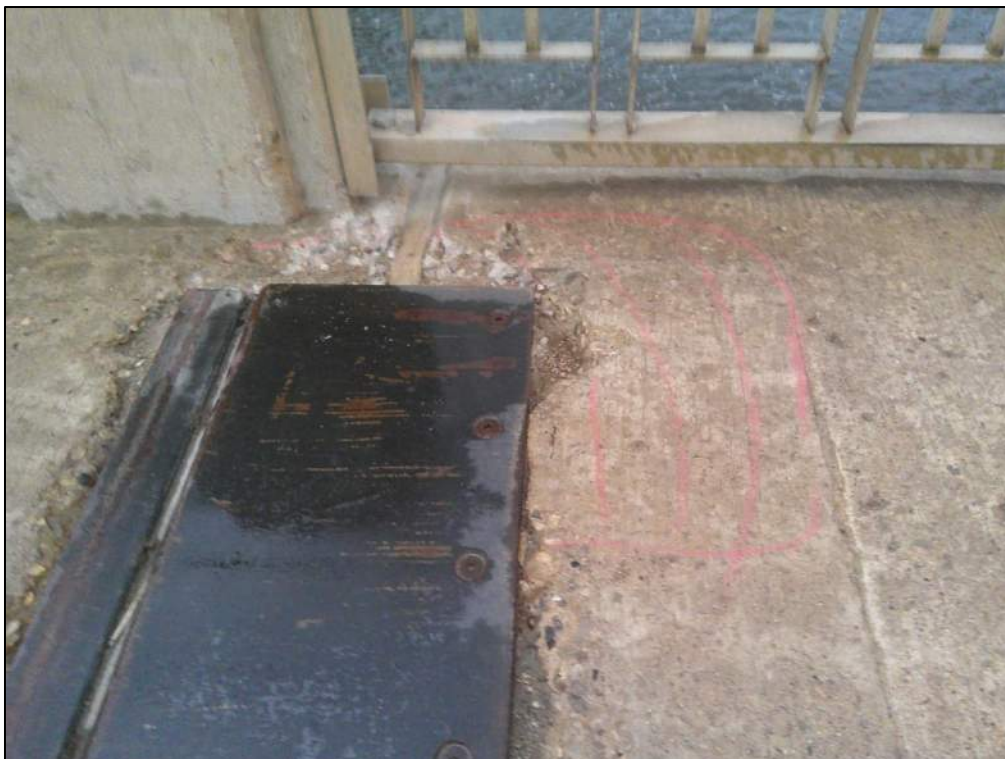
**Photo P17 – North Sidewalk delamination and spall near west intermediate expansion joint)**

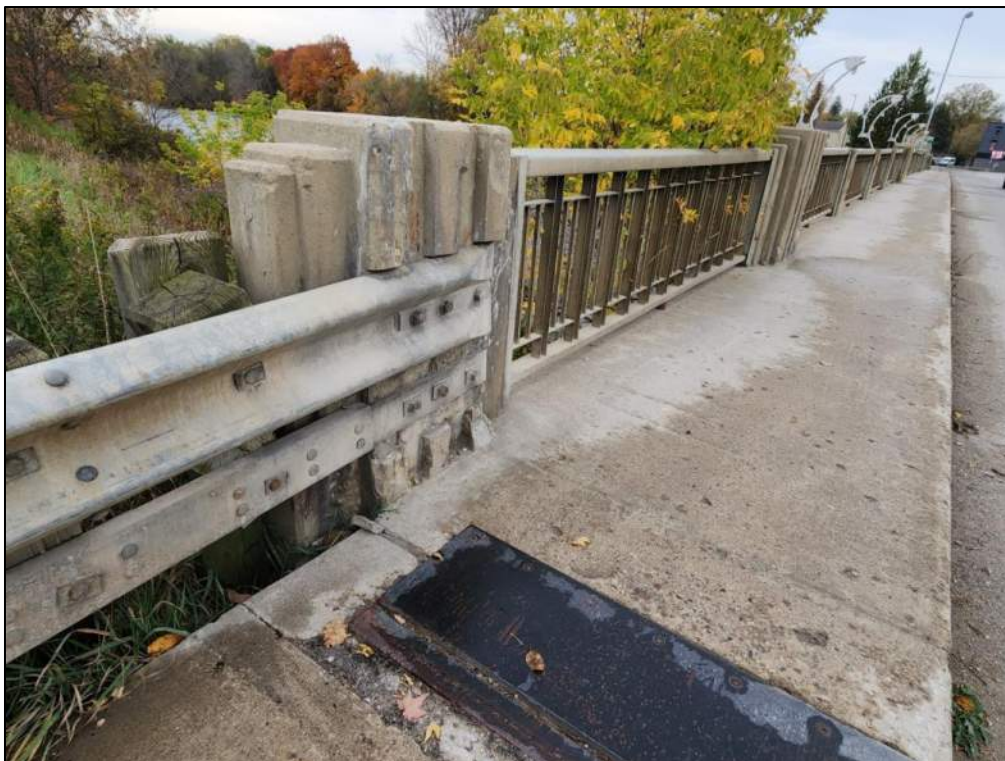
**Photo P19 – South Sidewalk (fair condition – crack, delaminations and shallow pop-outs) and Steel Handrail (fair to good condition – bent railings)**

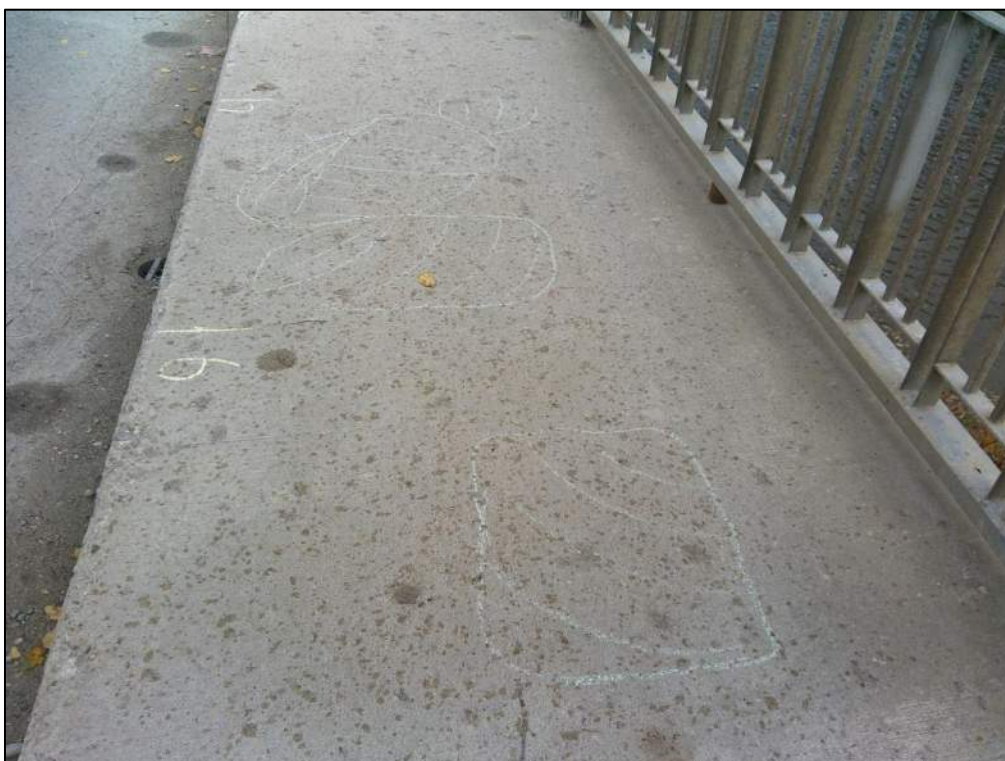
**Photo P20 – South Sidewalk (delaminations)**

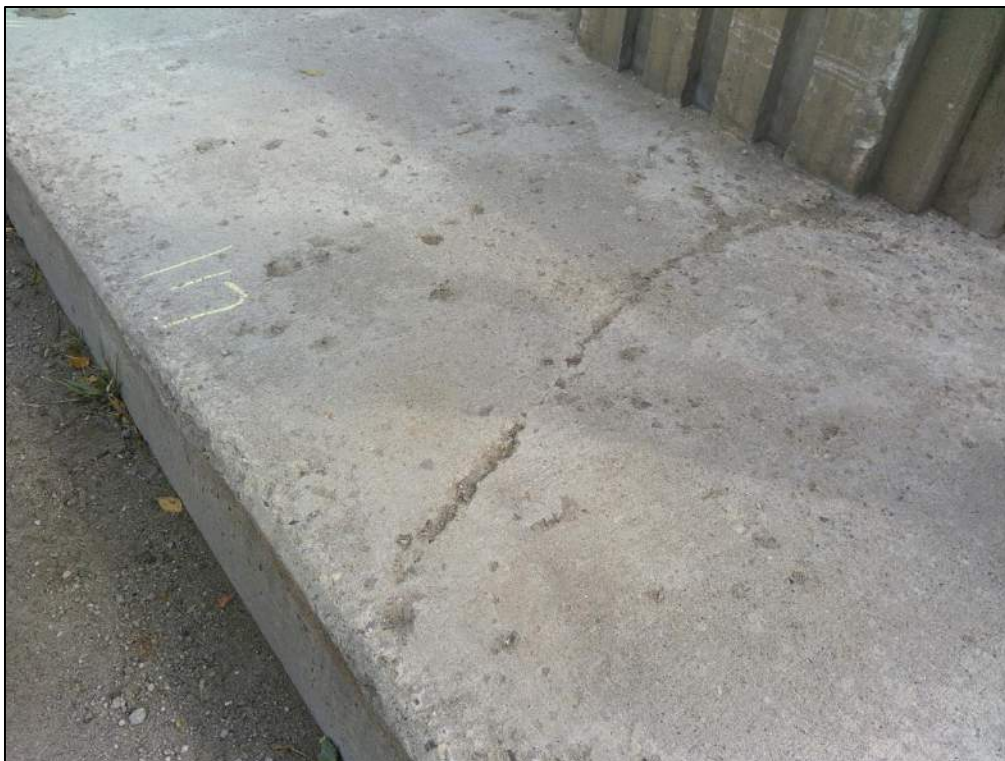
Photo P21 – South Sidewalk (crack above Pier 2, shallow pop-outs – typical)

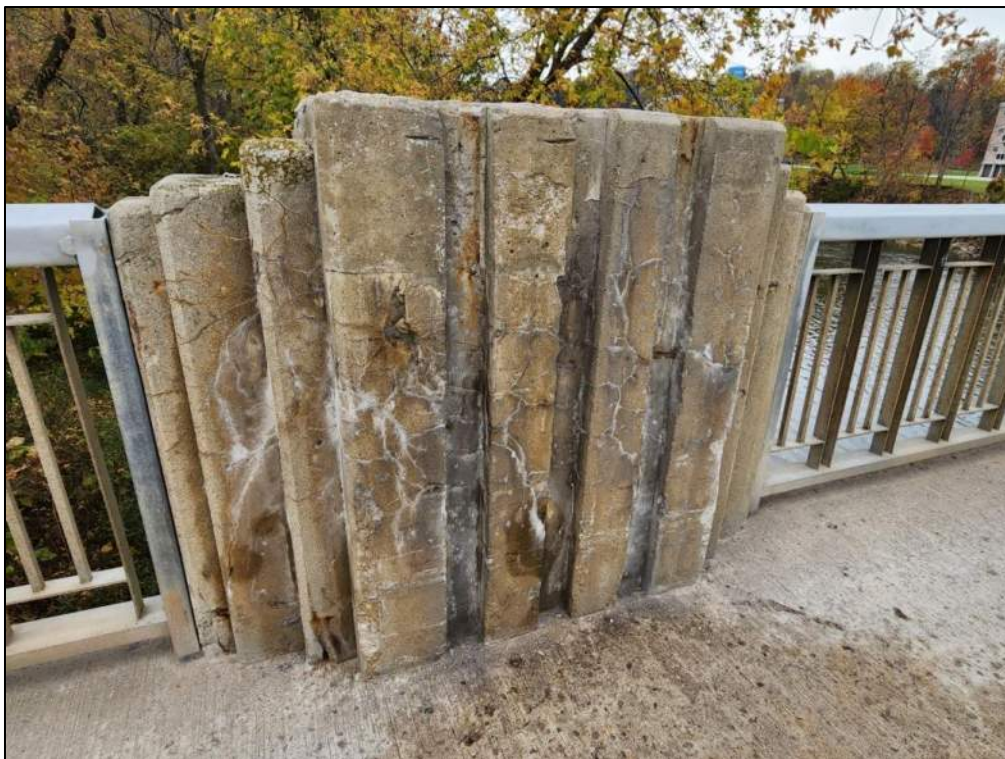
Photo P25 – North Concrete Post (severe AAR, cracks)

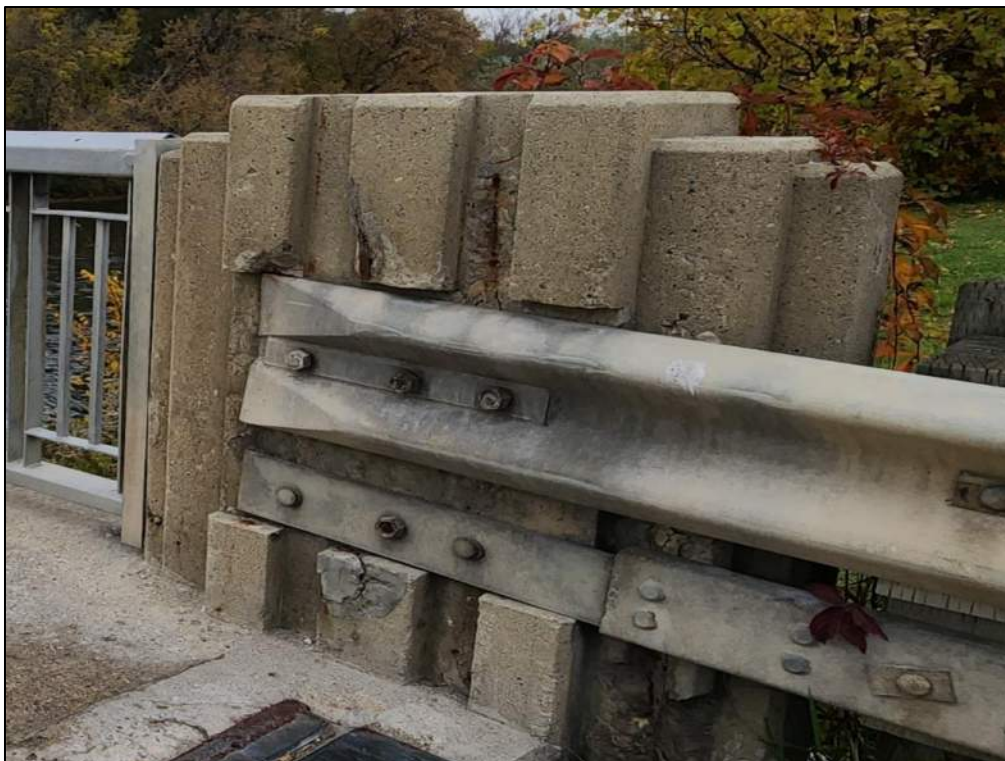
Photo P27 – North-East End post (spalls with exposed corroded rebar, patches)

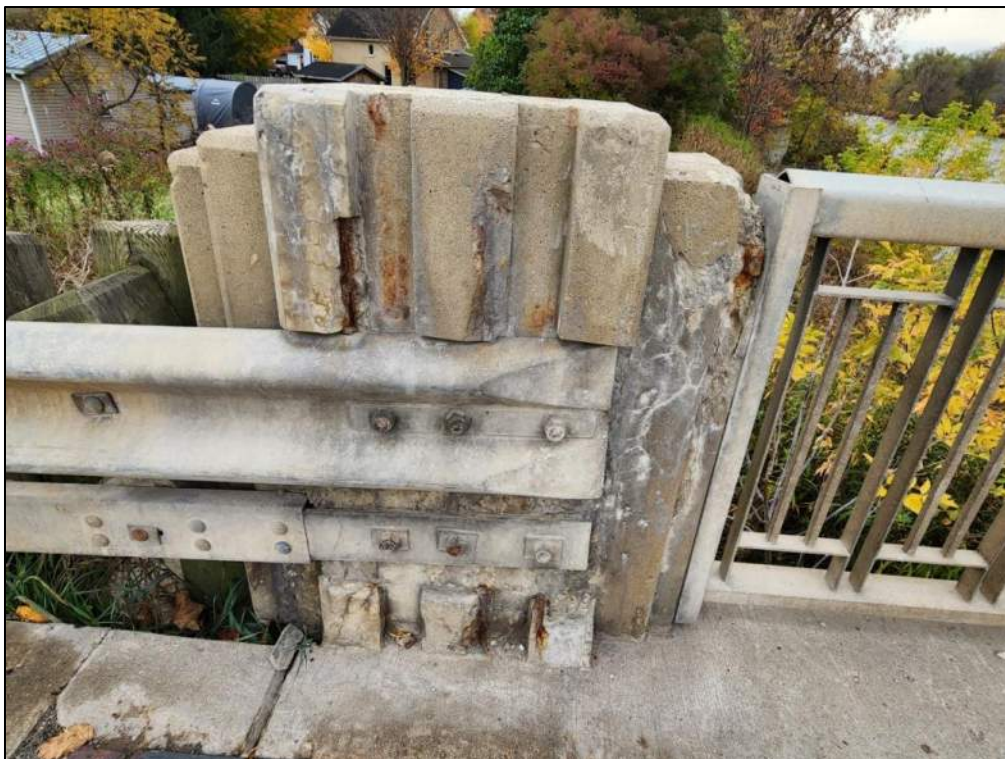
Photo P29 – South-East End post (AAR, spalls with exposed corroded rebar)

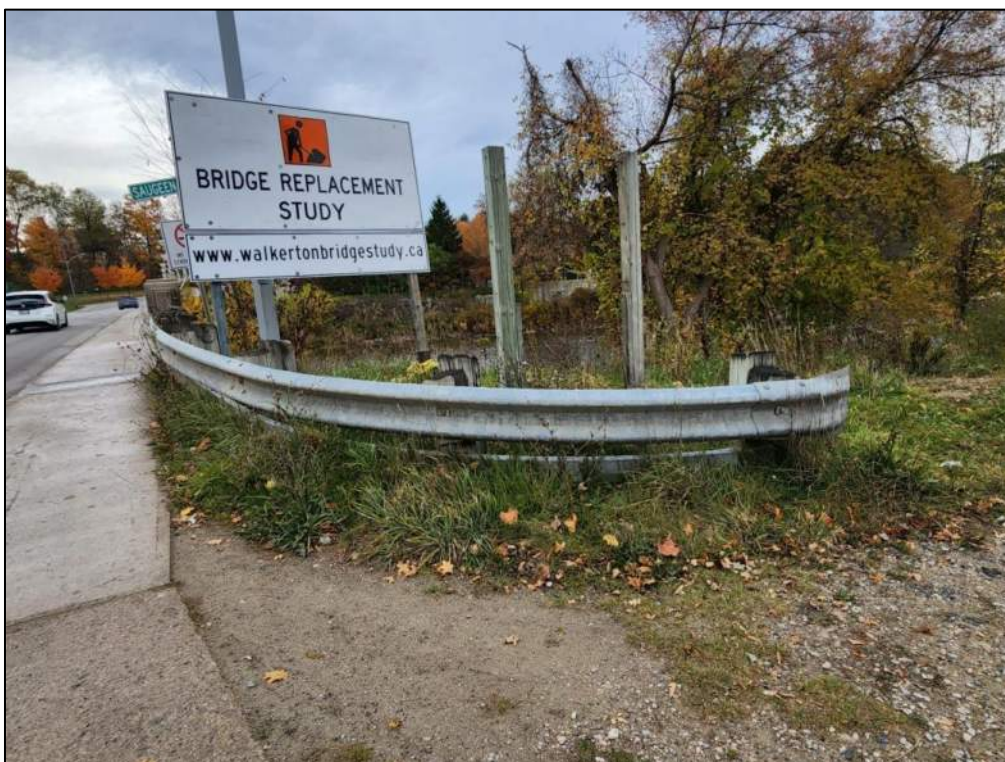
**Photo P34 – South-West Guiderail** (good condition – splits on wooden posts)

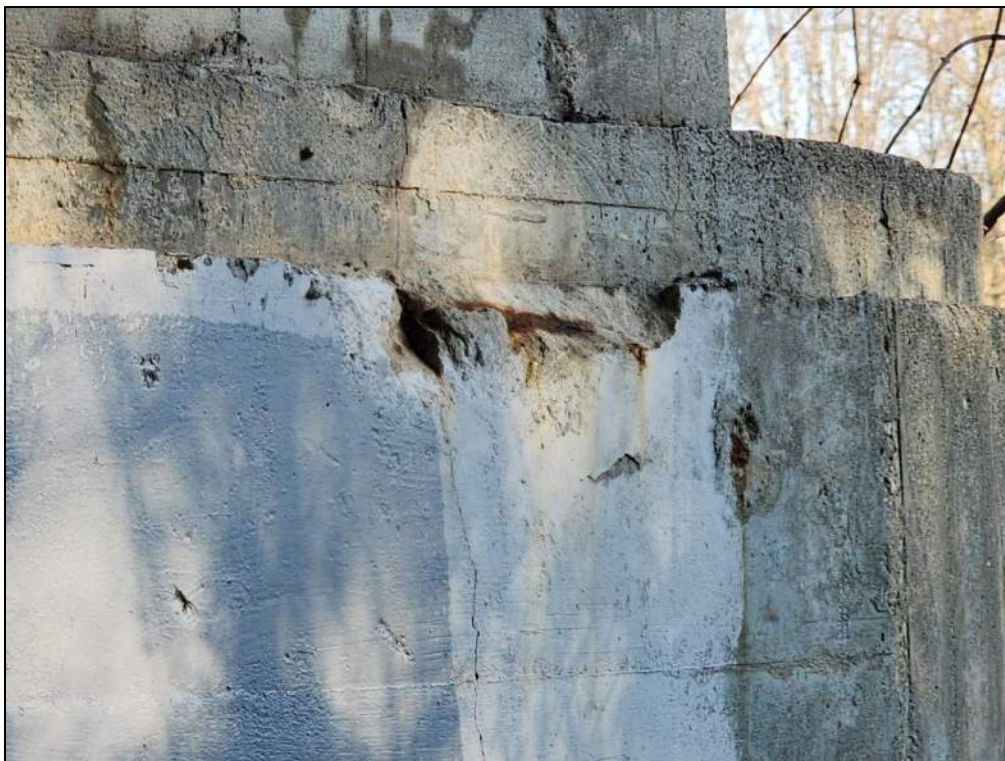
Photo P41 – Pier 1 – West Face (crack, spall with exposed corroded rebar)

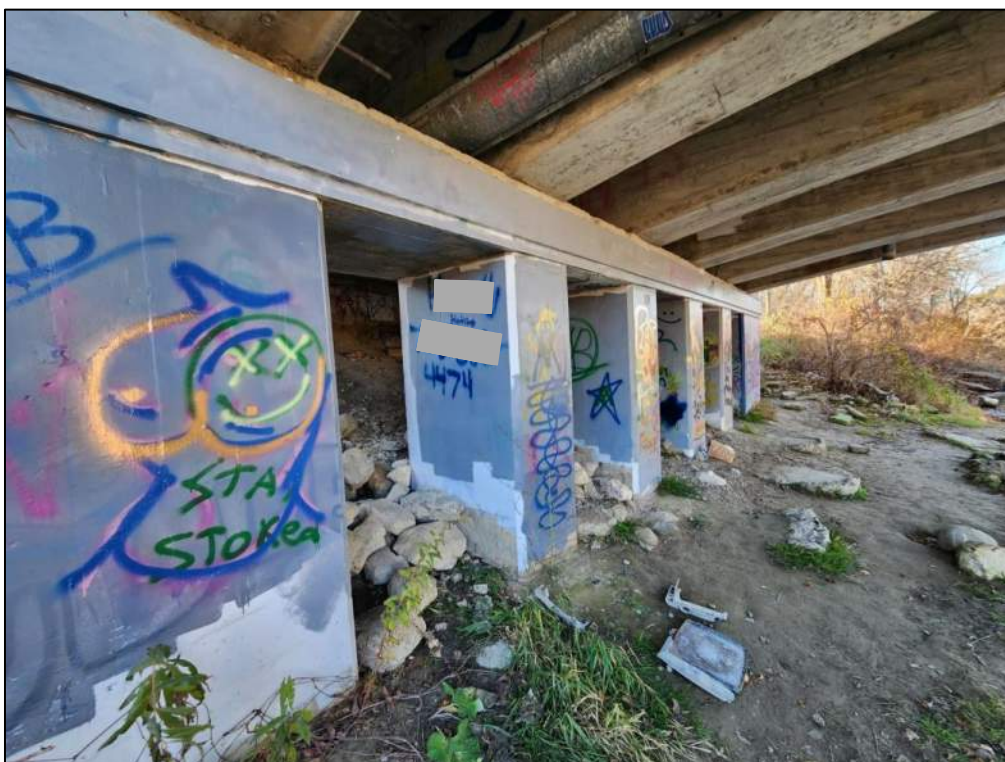
Photo P42 – Pier 1 – East Face (cracks, spall and exposed rebar)

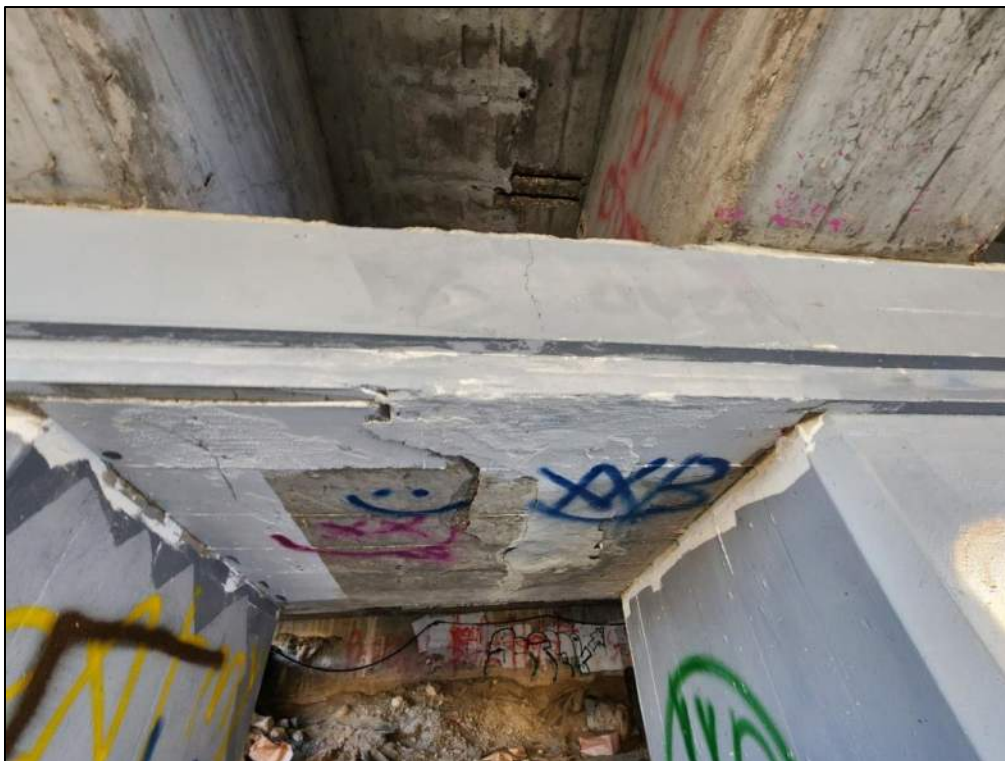
Photo P43 – Pier 1 – East Face (cracks, delamination at bottom face)

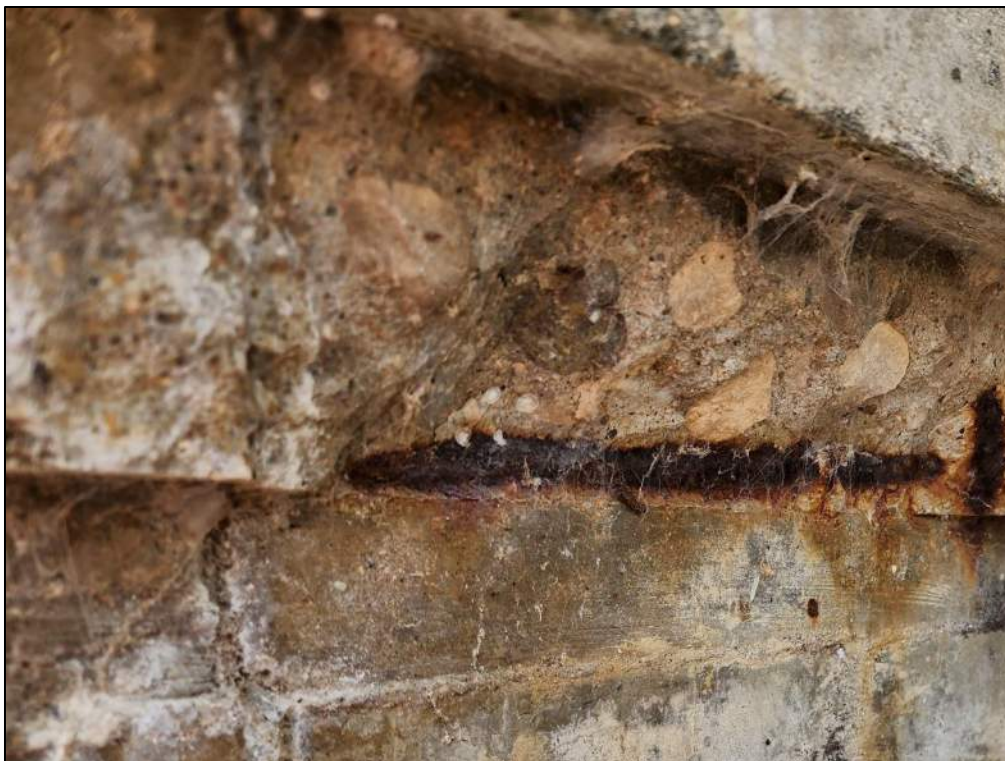
Photo P47 – Pier 2 – East Face (spall with exposed corroded rebar)

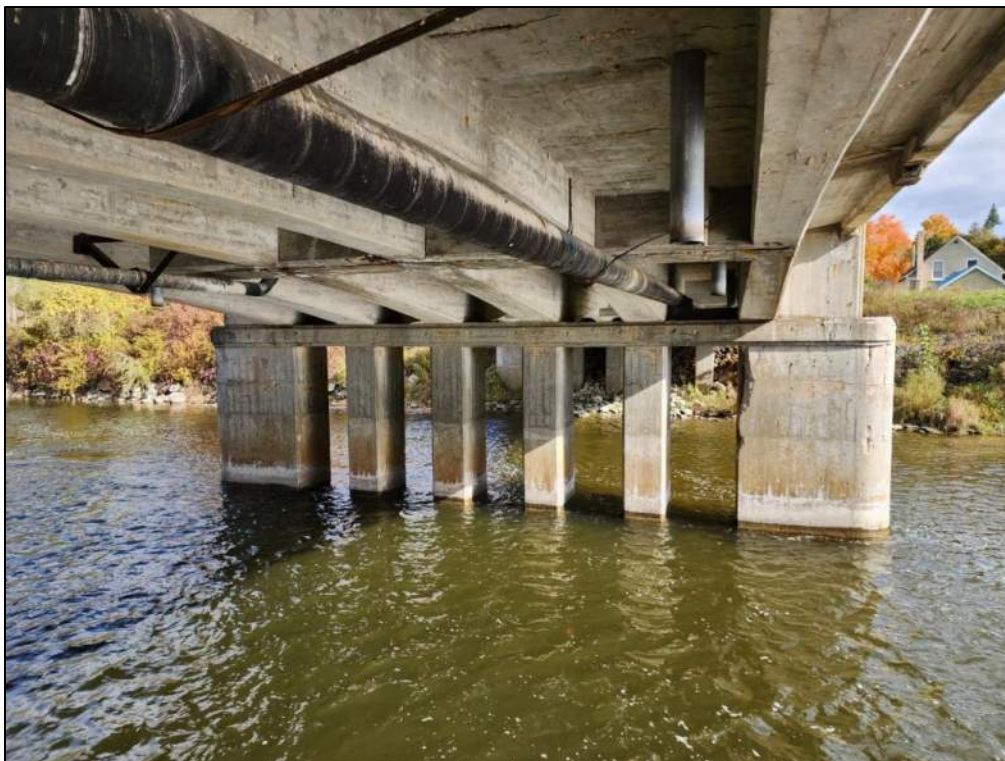
Photo P49 – Pier 3 – West Face (cracks, spall with exposed corroded rebar and delamination and light pattern cracks)

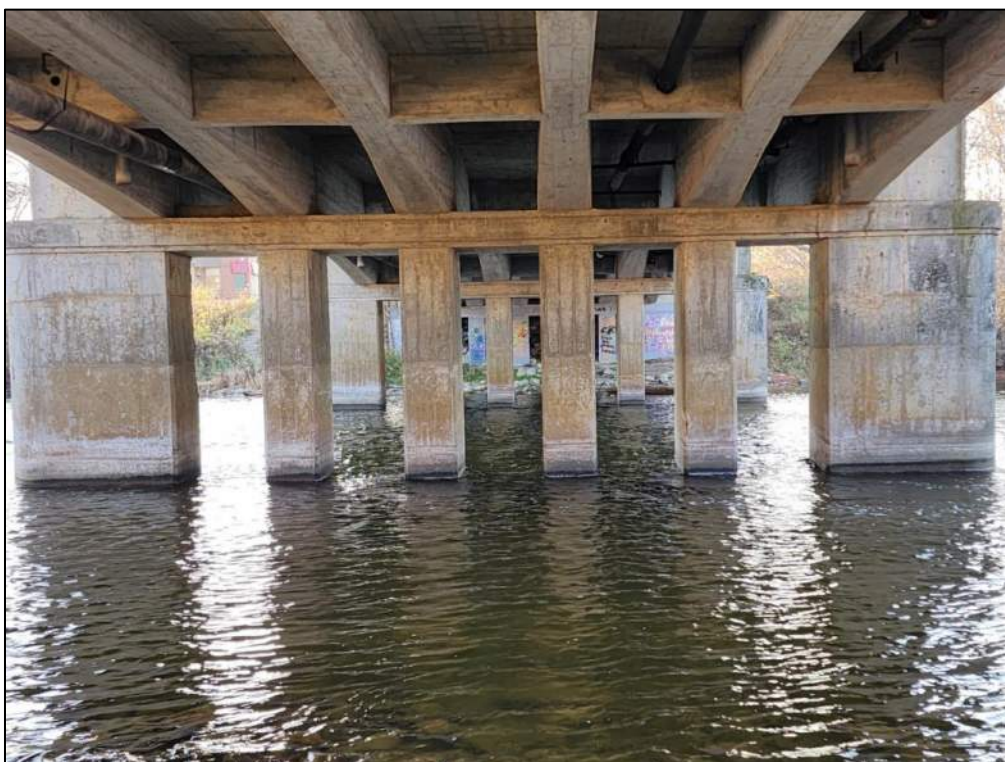
Photo P51 – Pier 3 – South Face (cracks, spall with exposed corroded rebar and delamination)

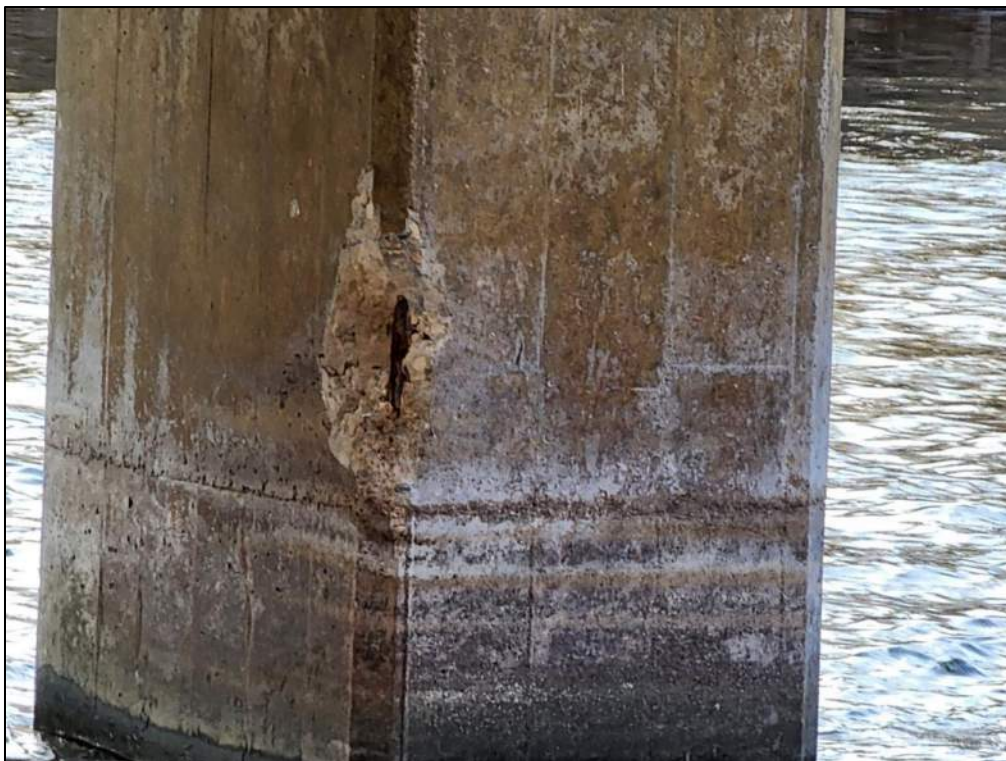
Photo P52 – Pier 3 – East Face (light pattern cracks, spall and light scaling)

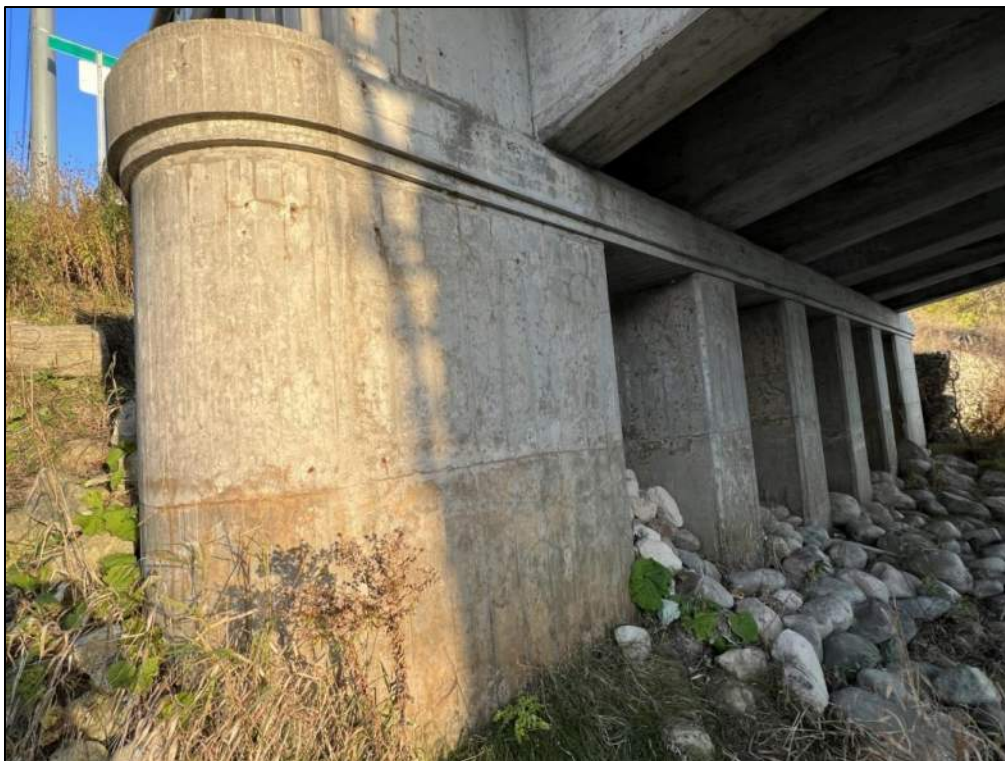
Photo P54 – Pier 4 – East Face (spall and delamination)

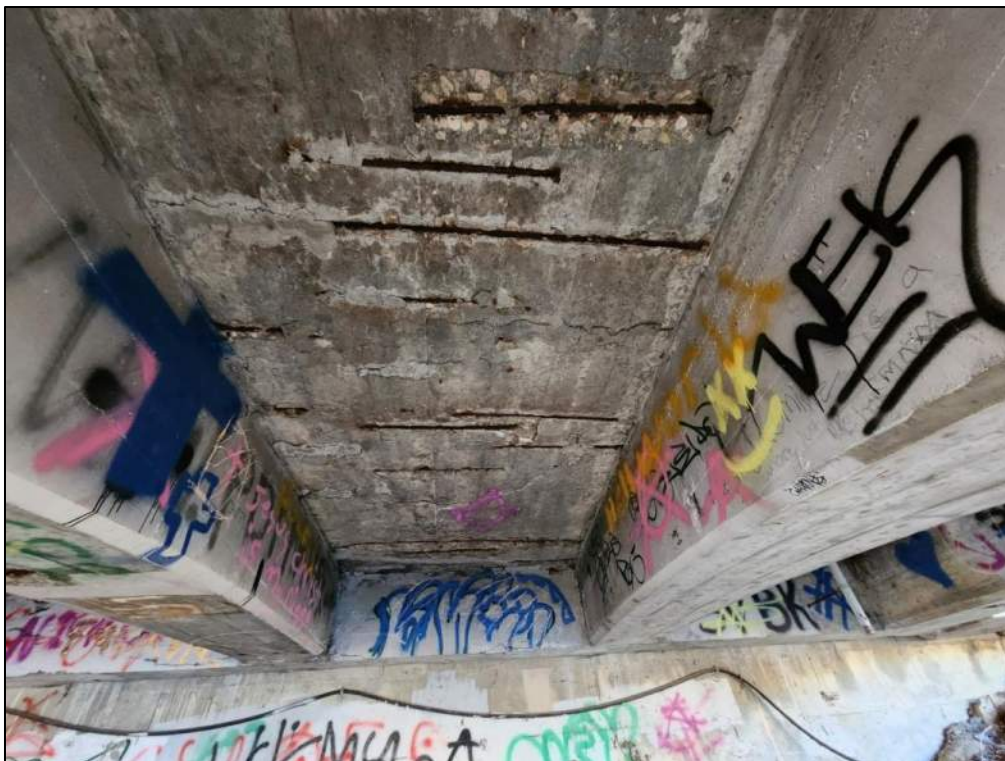
Photo P56 – Pier 4 – West Face (spall, delamination, and light scaling)

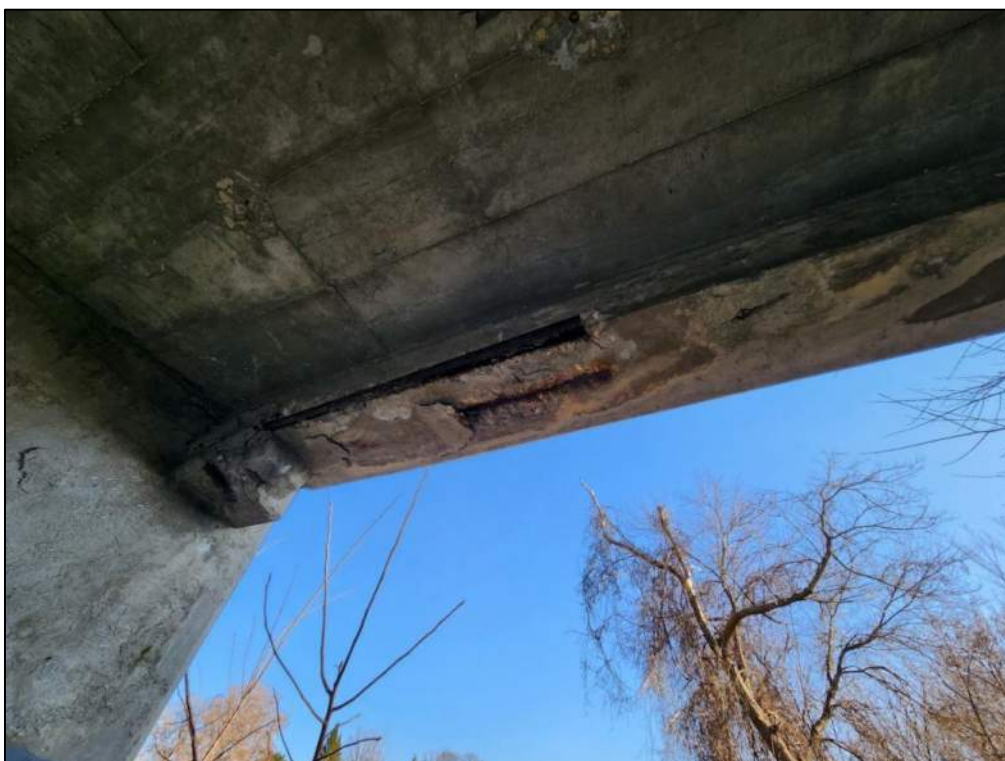
Photo P57 – Soffit between West Abutment and Pier 1 (poor condition – cracks, spall with exposed corroded rebar, delaminations and patched areas)

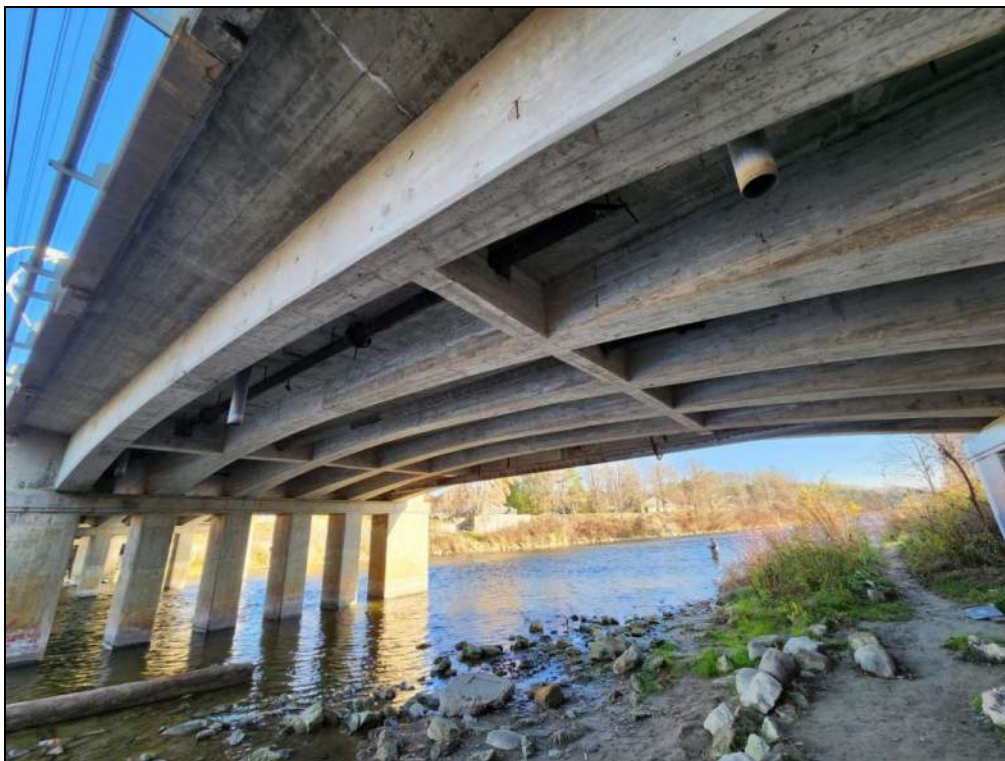
Photo P58 – Girder between West Abutment and Pier 1 (spall with exposed corroded rebar)

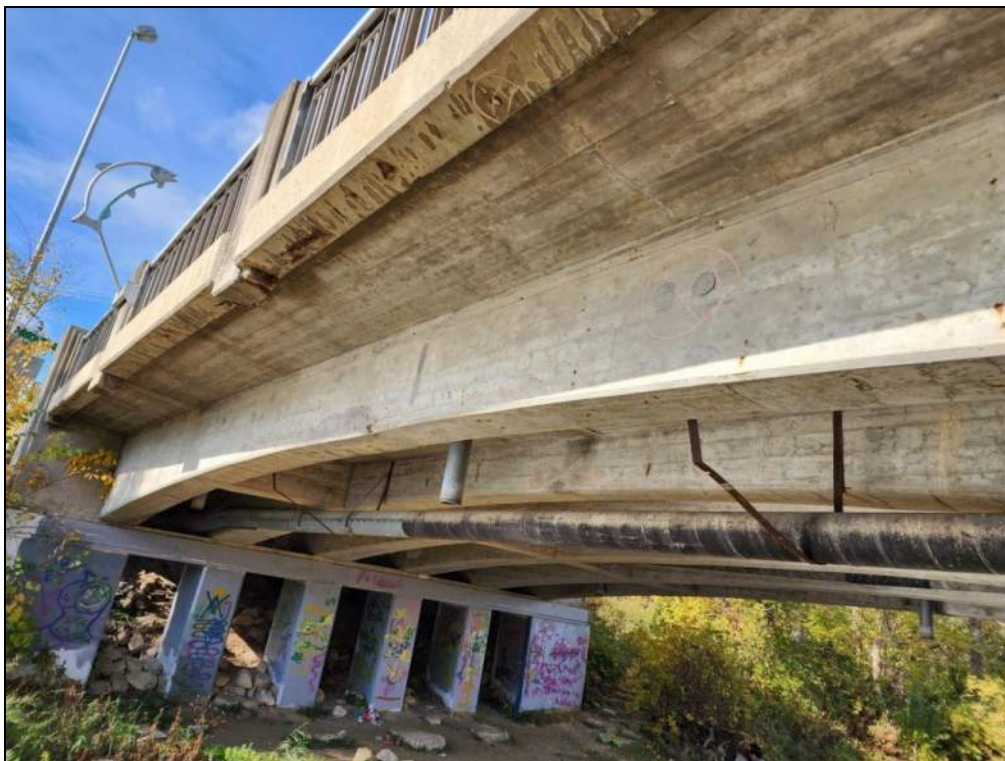
Photo P60 – Soffit between Pier 1 to Pier 2 (spall with exposed rebar, delamination and patched area) and Girder (delaminations and patched area)

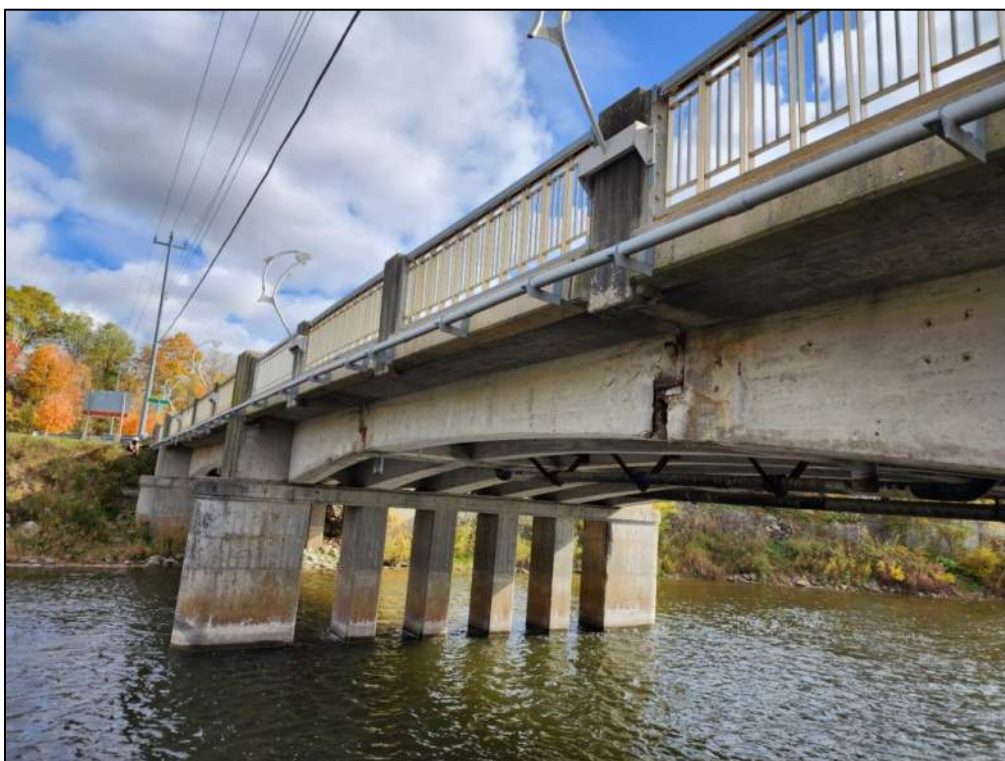
**Photo P61 – Soffit between Pier 1 to Pier 2 (spalls with exposed corroded rebar, delamination and patched areas) and Girders (delaminations and patched area)**

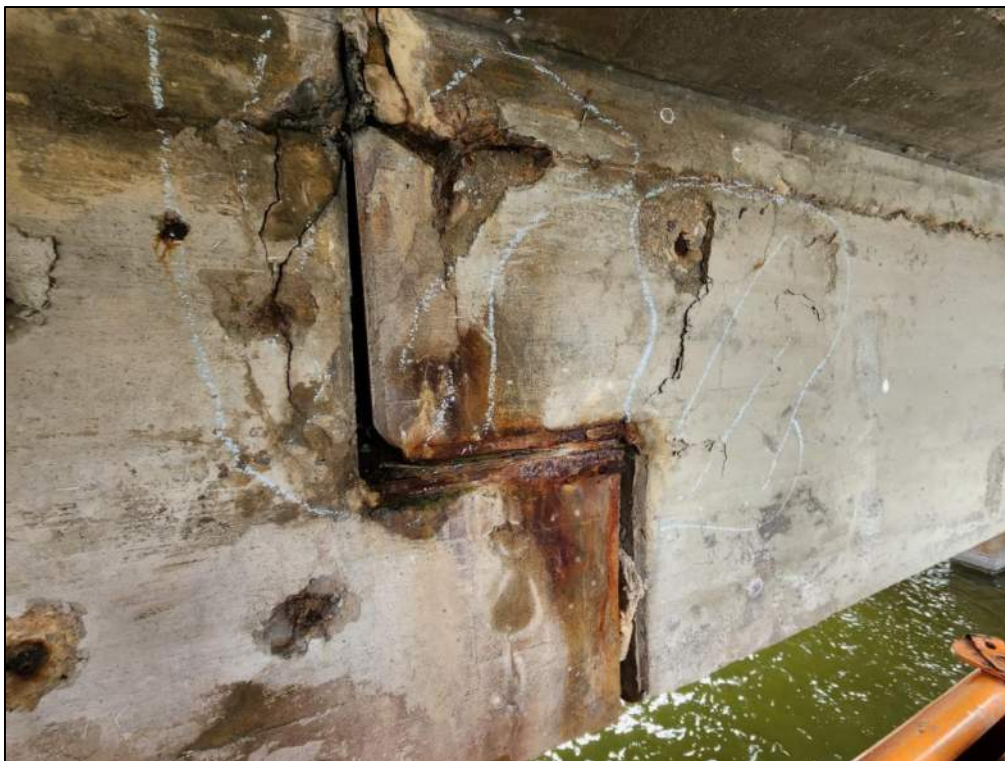
**Photo P62 – Soffit between Pier 2 to Pier 3 (spall with exposed rebar, delamination and patched area) and Girder (delamination and patched area)**

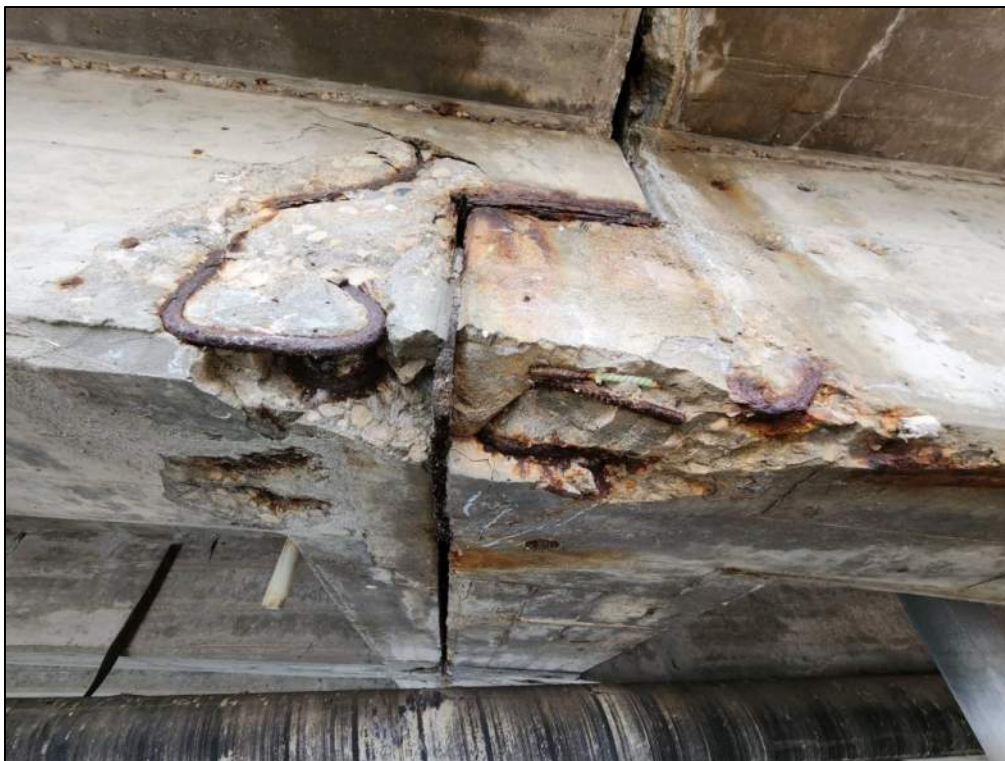
Photo P64 – Soffit between Pier 2 to Pier 3 (delamination, spall and rust staining at drop in span joint-severe rust on bearing plates; evidence of leakage)

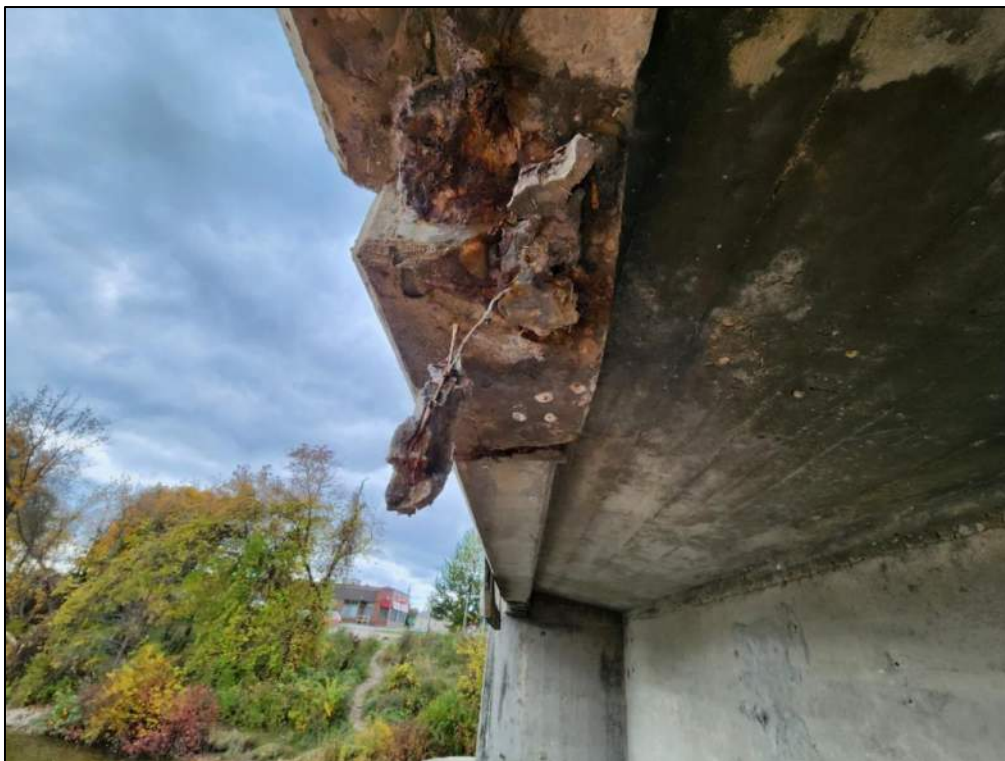
**Photo P66 – Soffit between Pier 2 to Pier 3 (spall with exposed corroded rebar and delamination at bottom face of diaphragm; evidence of leakage)**

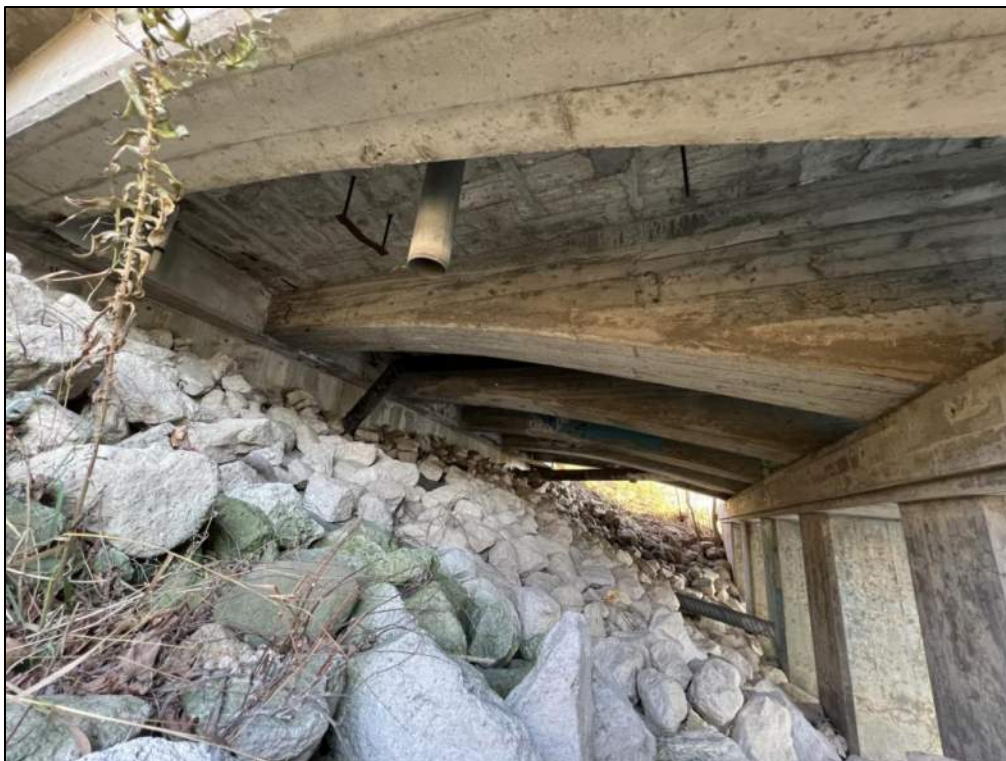
**Photo P72 – Soffit between Pier 3 to Pier 4 (spall with exposed corroded rebar, delamination and patched area)**
