## County of Bruce

### Class Environmental Assessment Durham Street Bridge, Walkerton Third-Party Review

Triton Engineering Services Limited and Burgess Engineering Inc.

February 20, 2024

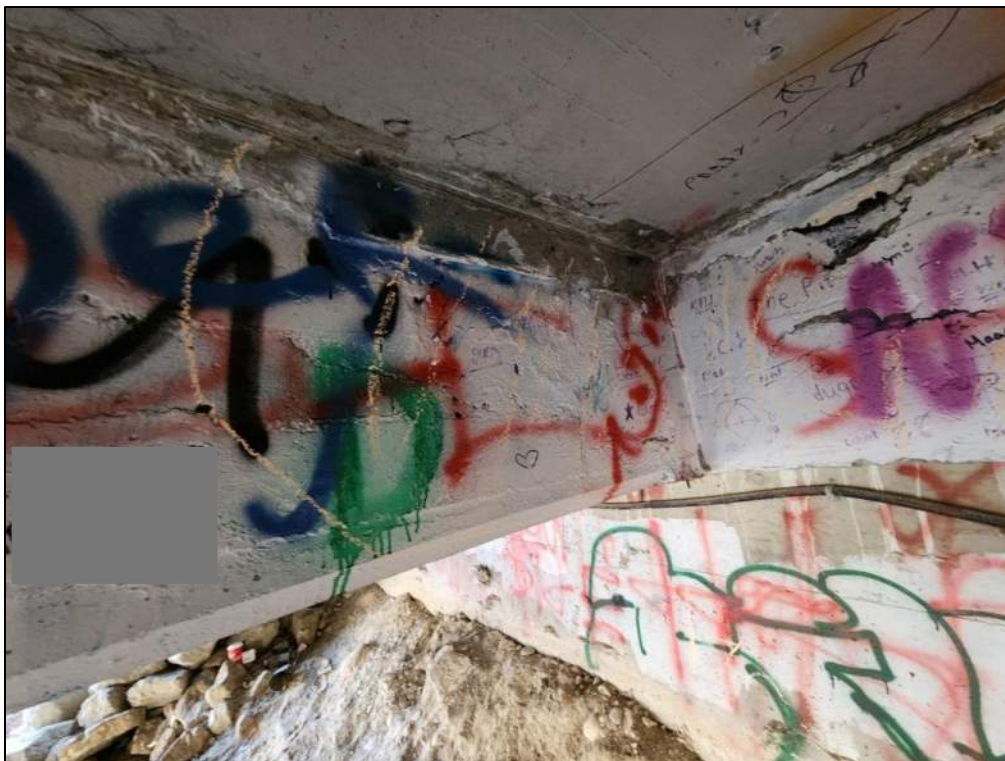
Photo P76 – Girder between West Abutment and Pier 1 (cracks, spall with exposed corroded rebar, delamination)

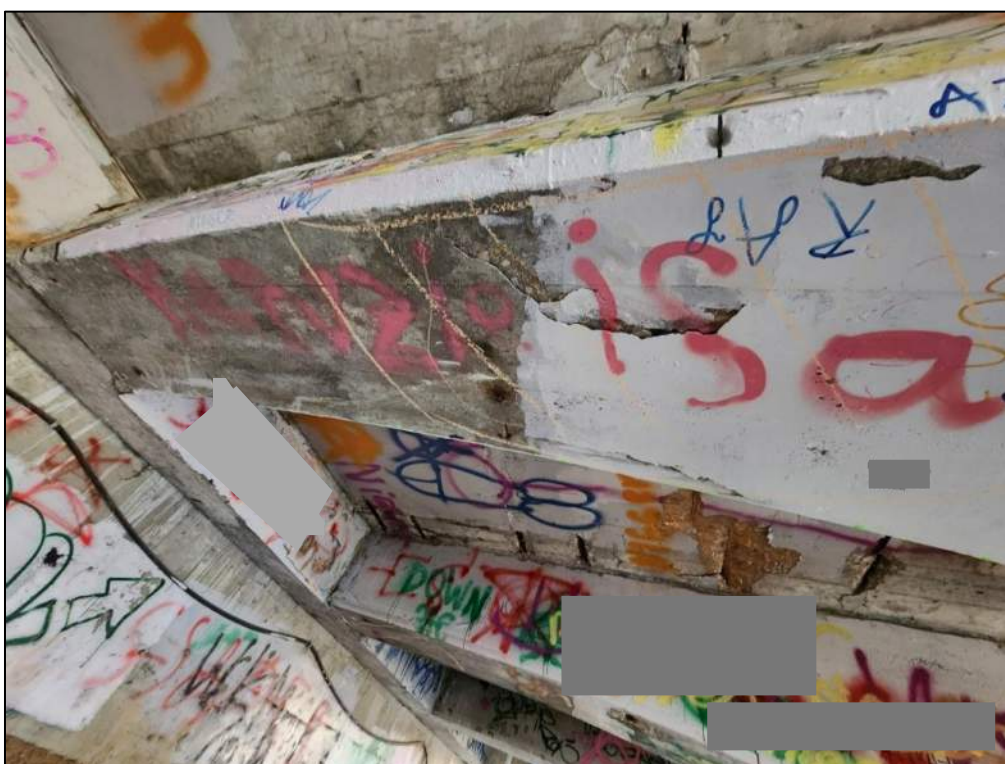
Photo P77 – Girder at West Abutment (delamination)

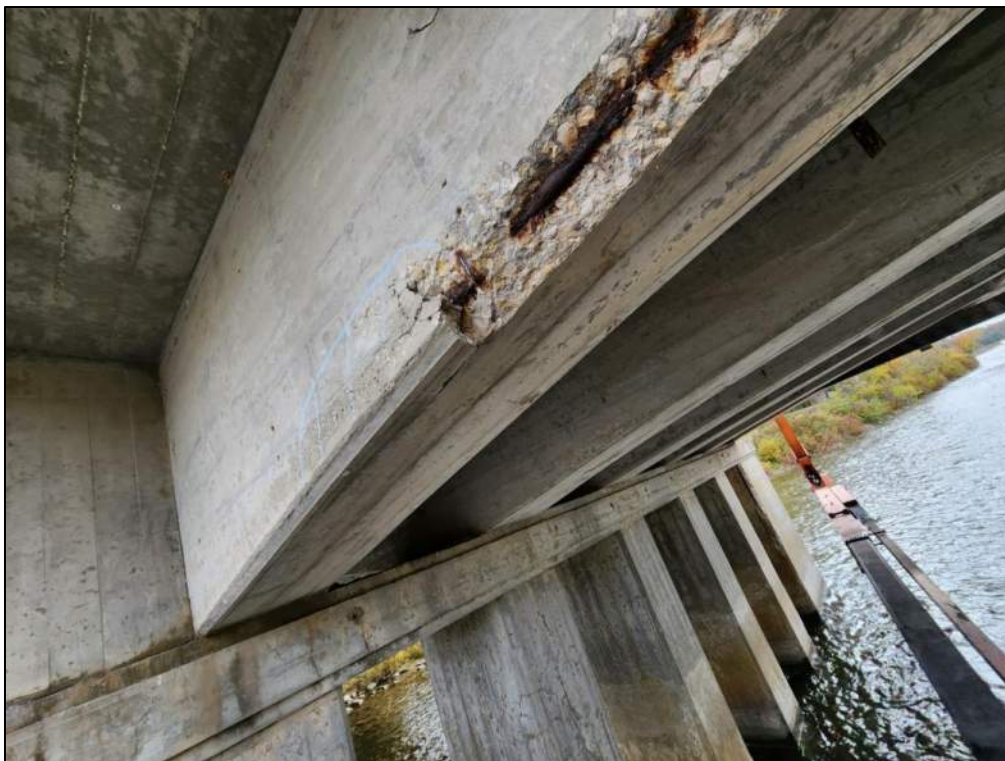
Photo P78 – Girder between West Abutment and Pier 1 (delamination)

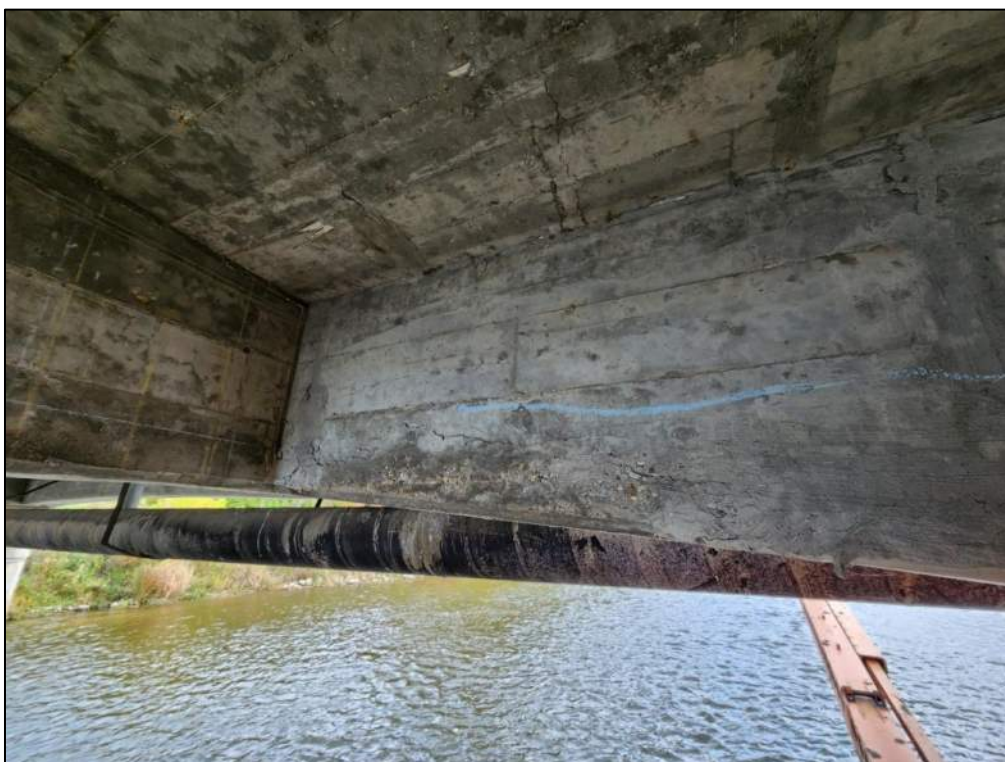
Photo P79 – Girder between Pier 2 and Pier 3 (spall with exposed corroded rebar, delamination)

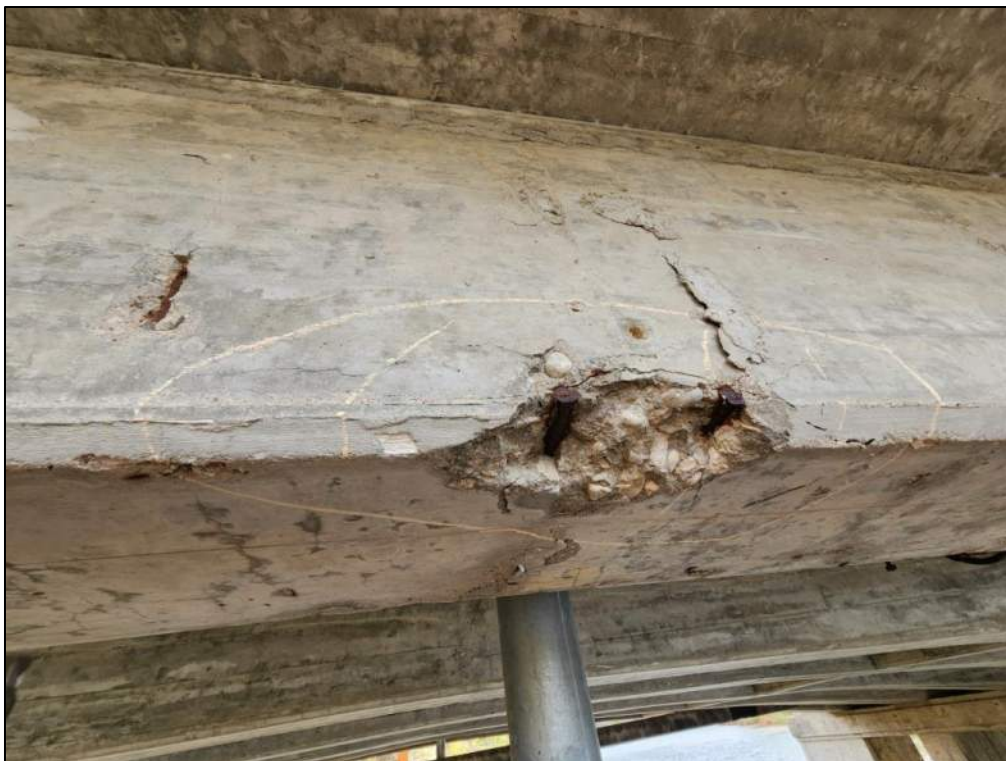
Photo P80 – Girder between Pier 2 and Pier 3 (delamination)

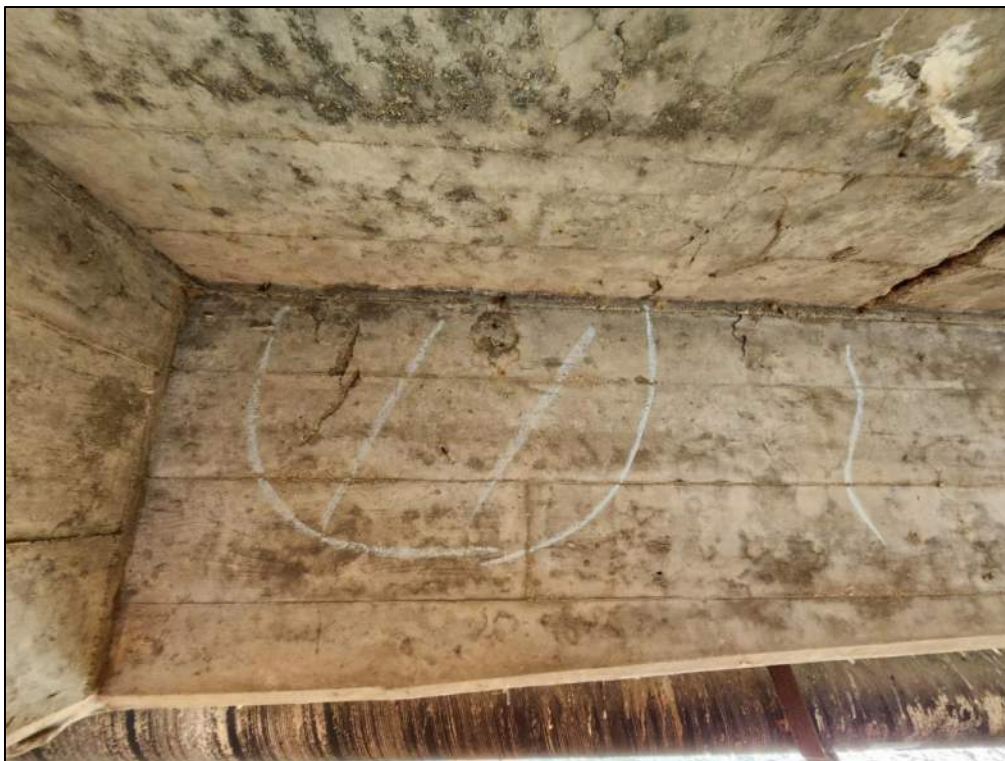
Photo P82 – Girder between Pier 3 and Pier 4 (wide crack)

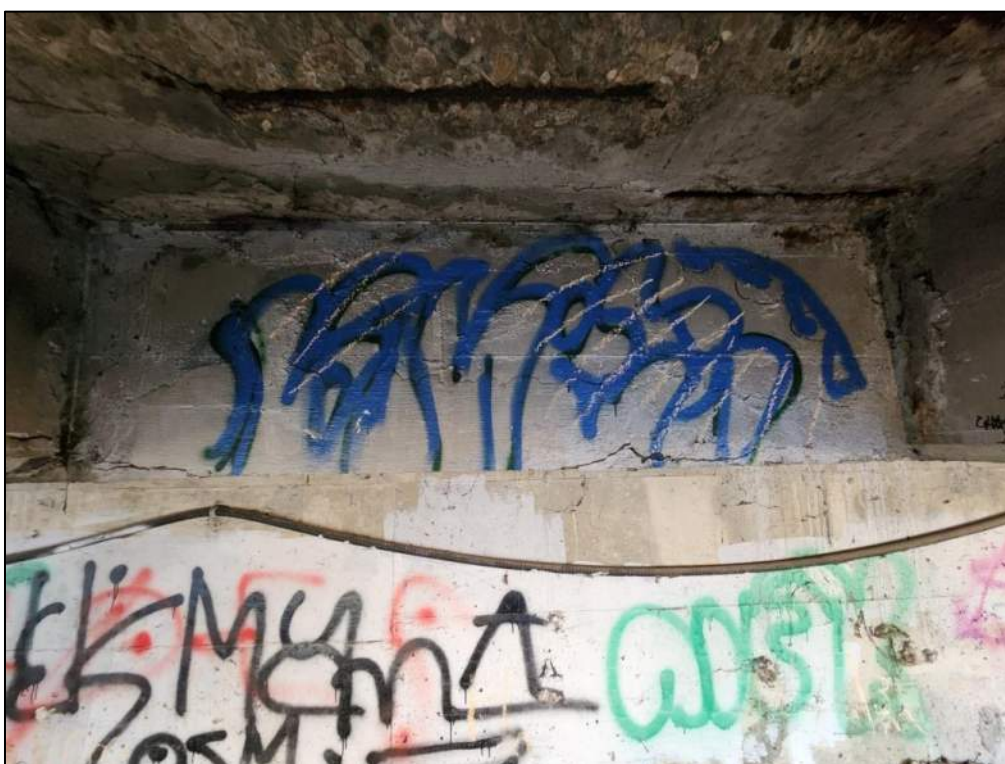
Photo P83 – Girder between Pier 2 and Pier 3 (delamination)

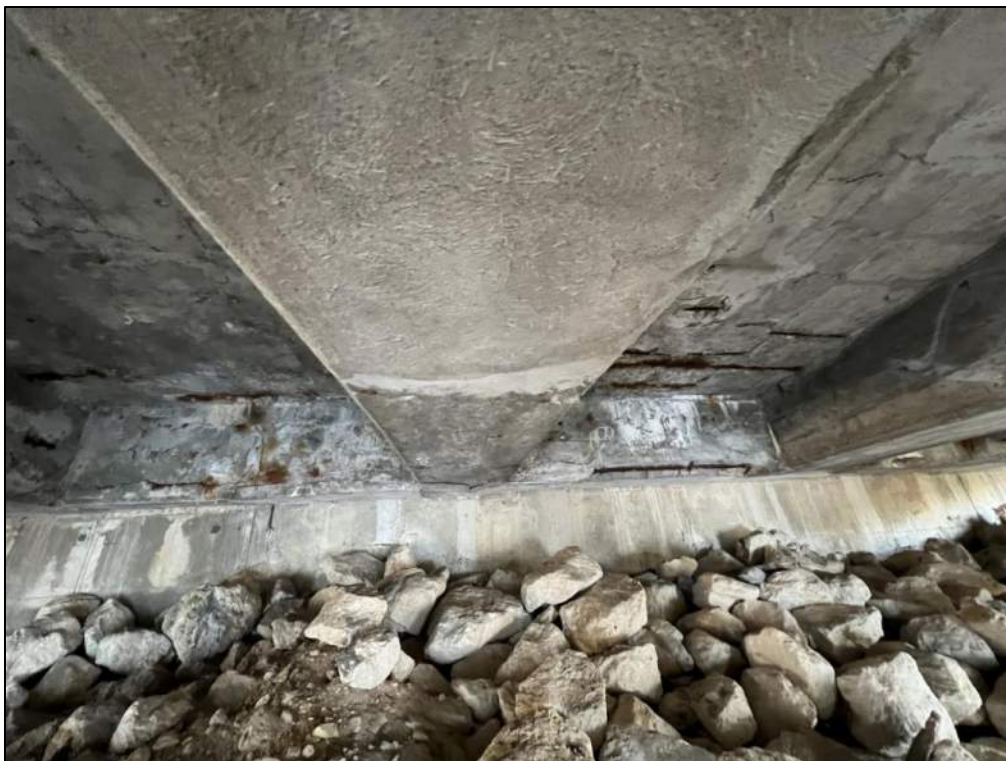
Photo P84 – West Abutment Diaphragm (delamination)

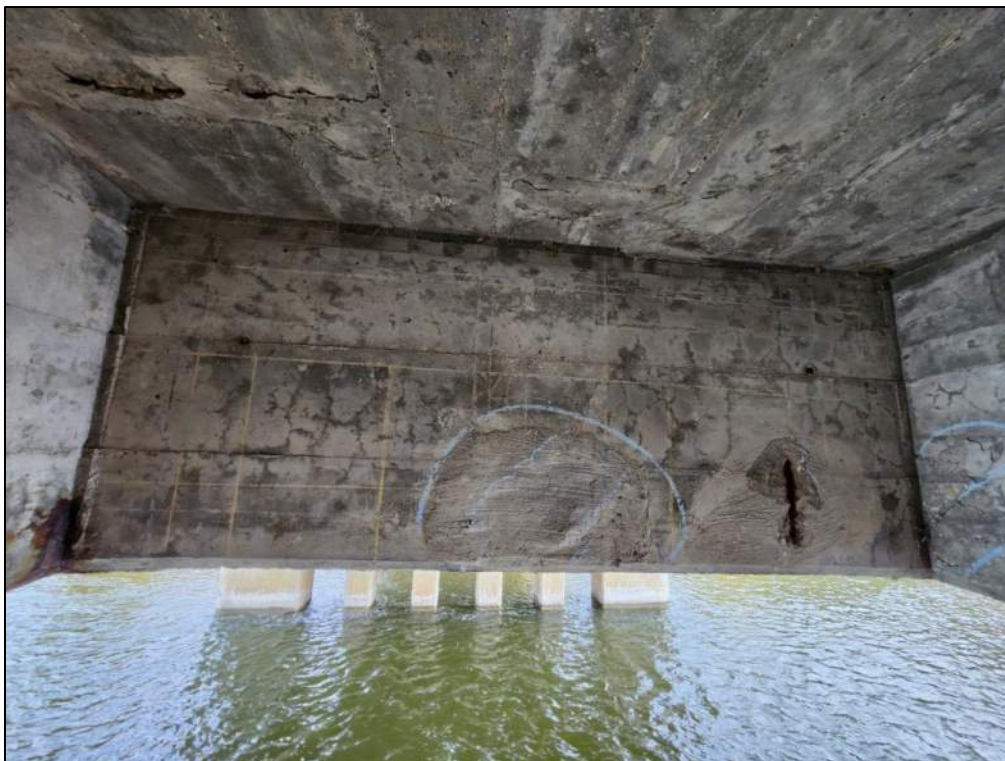
Photo P86 – East Abutment Diaphragm (delamination, rust stains)

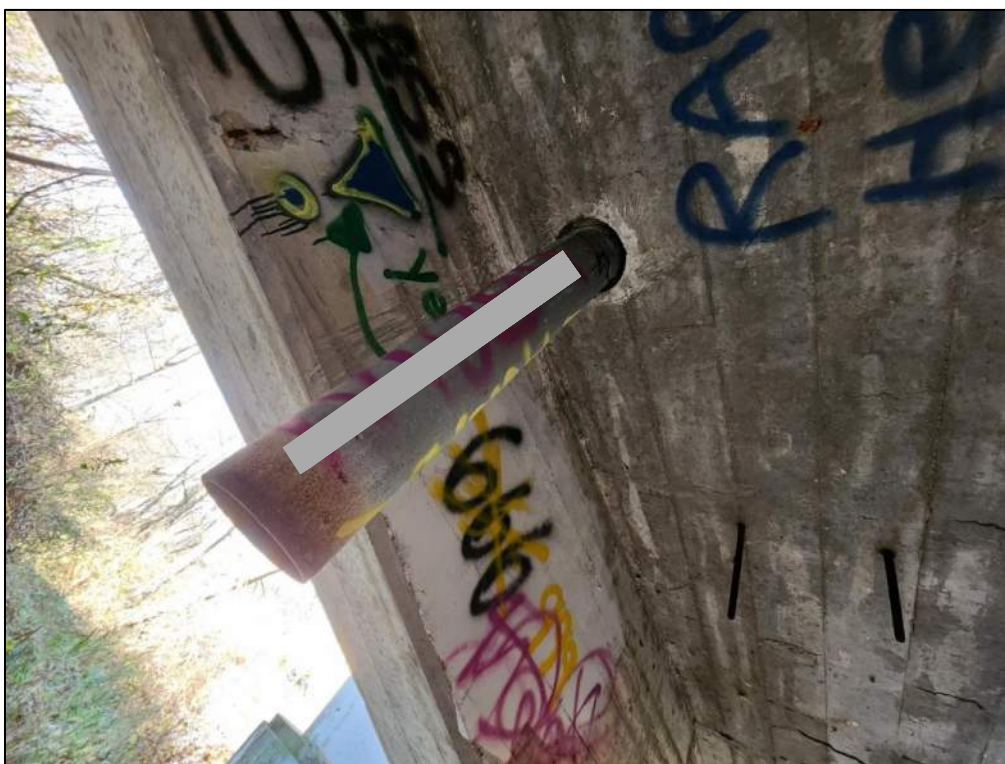
Photo P87 – Diaphragm Between Pier 2 to Pier 3 (spall with exposed corroded rebar and delamination)

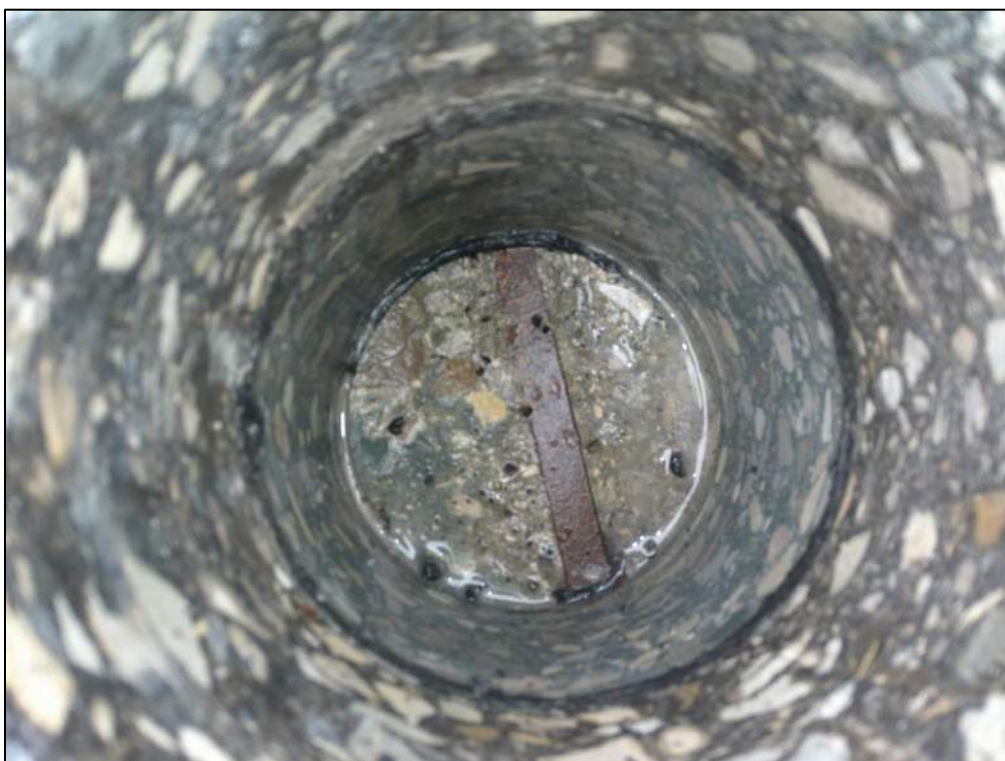
**Photo P91 – Inside Core C2**  
(partial delamination plane)

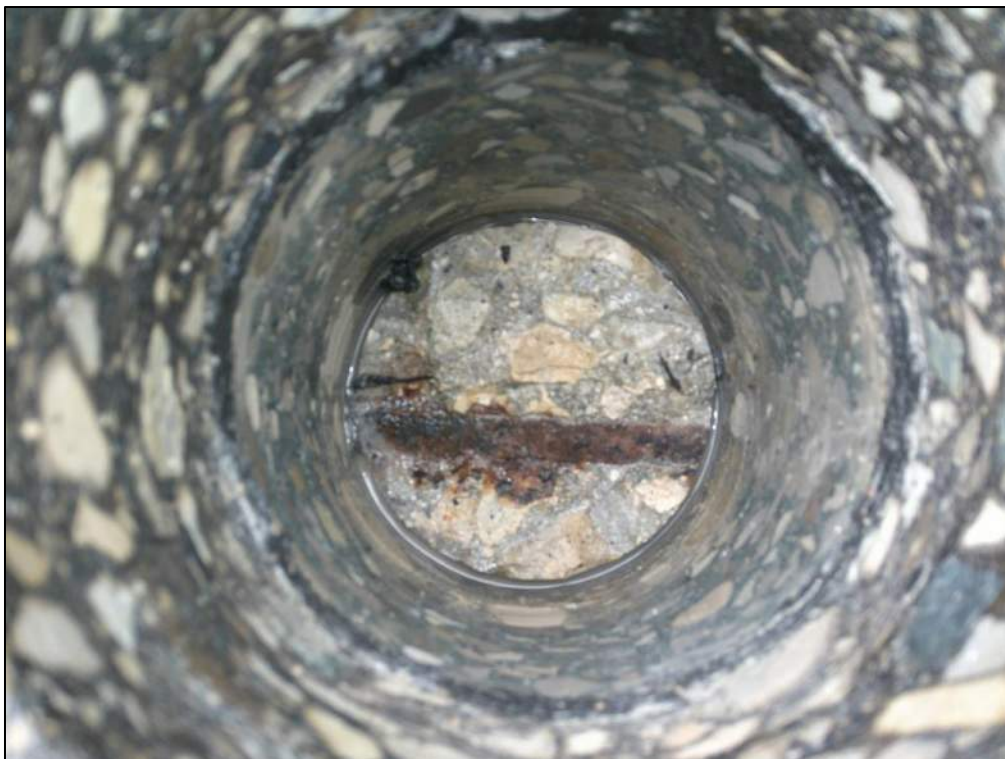
**Photo P92 – Inside Core C3**  
(square rebar-light rust)

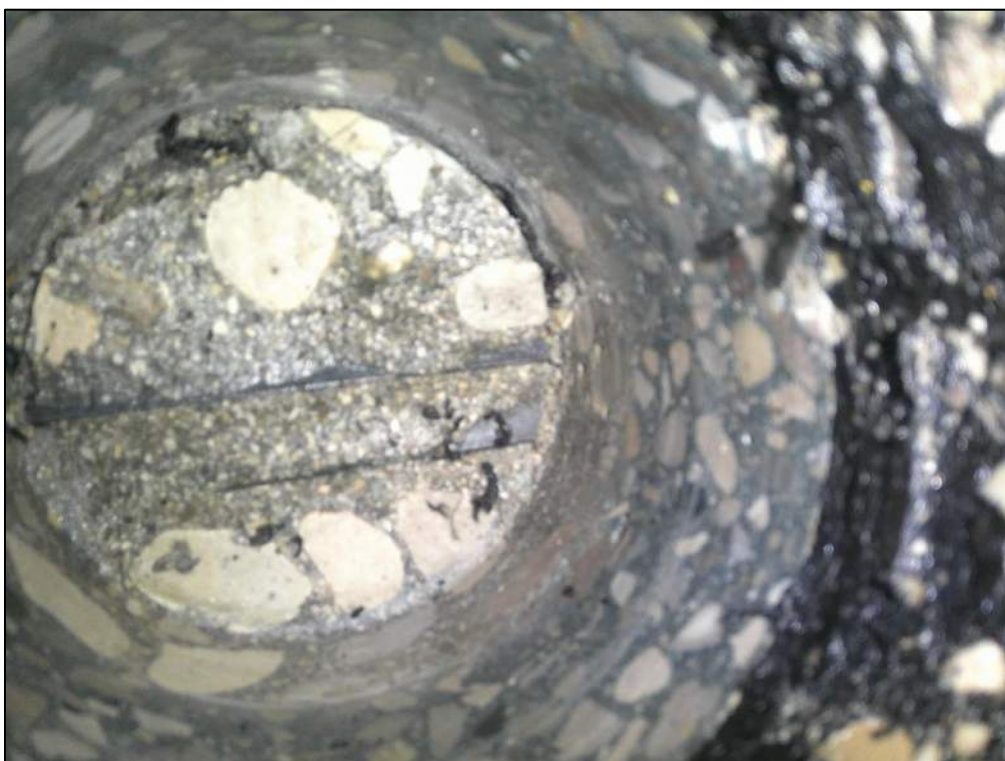
**Photo P93 – Inside Core C4**  
(square rebar-severe rust)

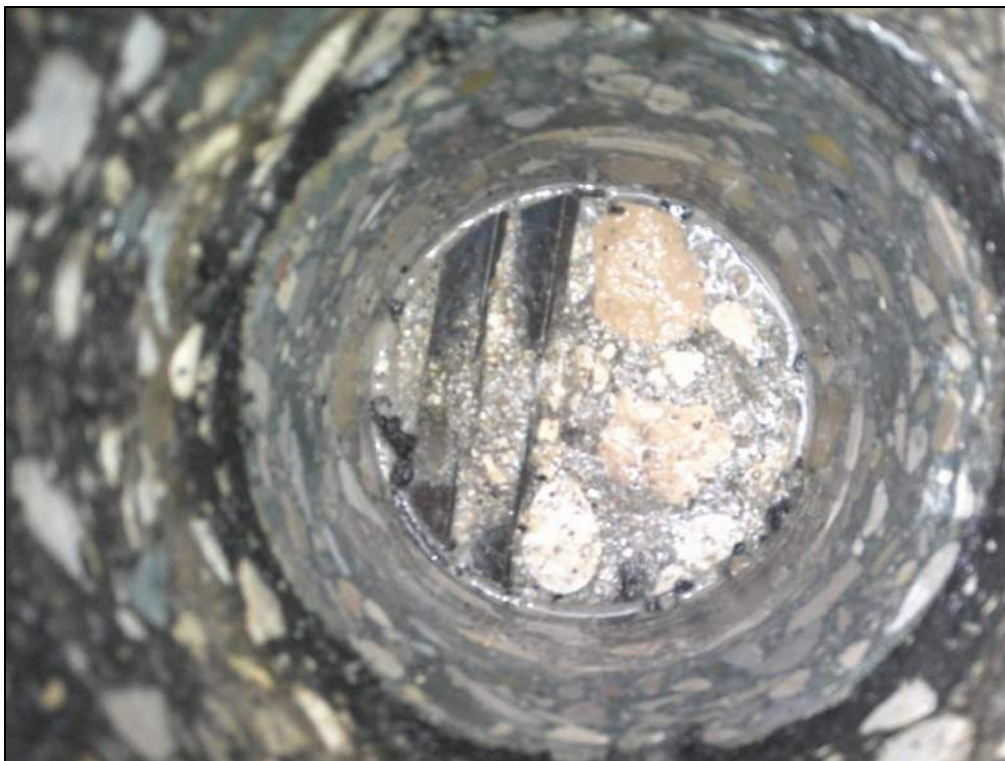
**Photo P94 – Inside Core C10**  
(debonded overlay; square rebar-good condition)

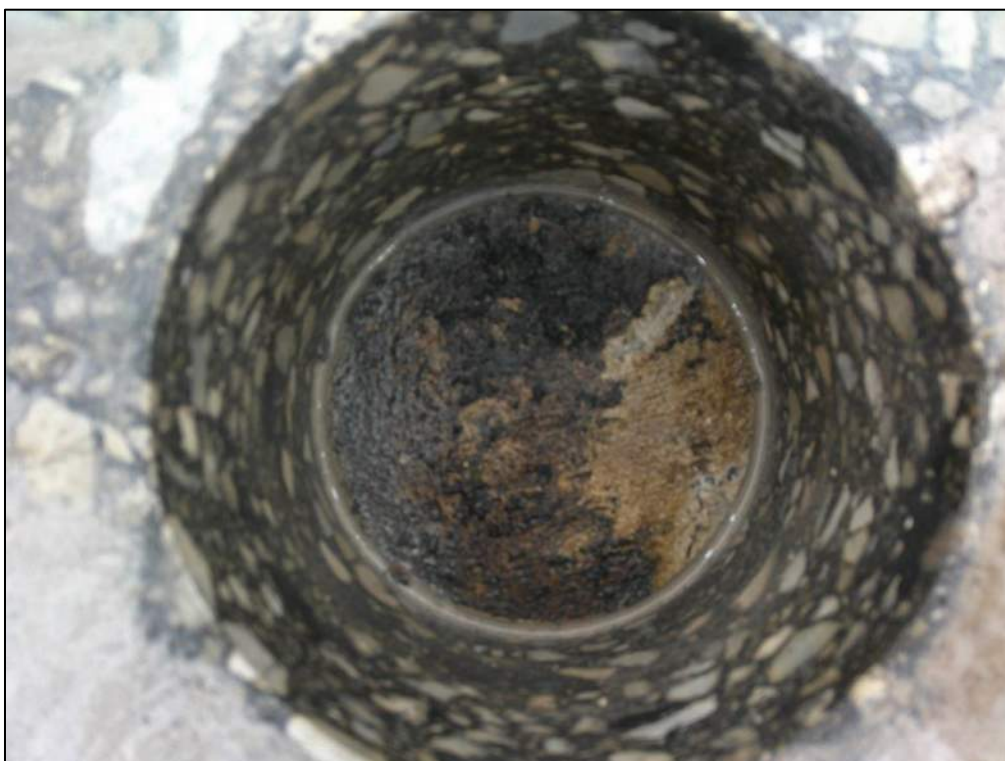
**Photo P95 – Inside Core C12**  
(square rebar-good condition)

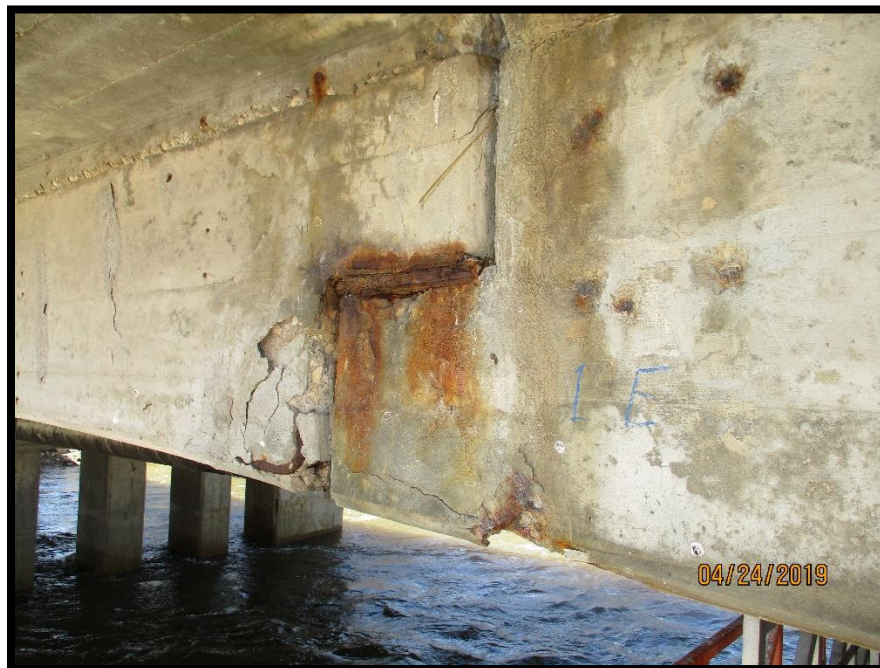
By way of this letter, we wish to report on the condition of the half-joints for the drop-in span of this bridge. This type of half-joint connection has been proven to be a problem because of sudden collapses with little or no warning. This style of bridge is no longer allowed to be built because it is a single load path structure. That is, failure of one element would result in a collapse. There is no redundancy in the structural support. A good analogy is the weak link in a chain causing a full and sudden breakage of the chain.

Elevation of connection showing support corbel on the right and dapped end of beam on the left

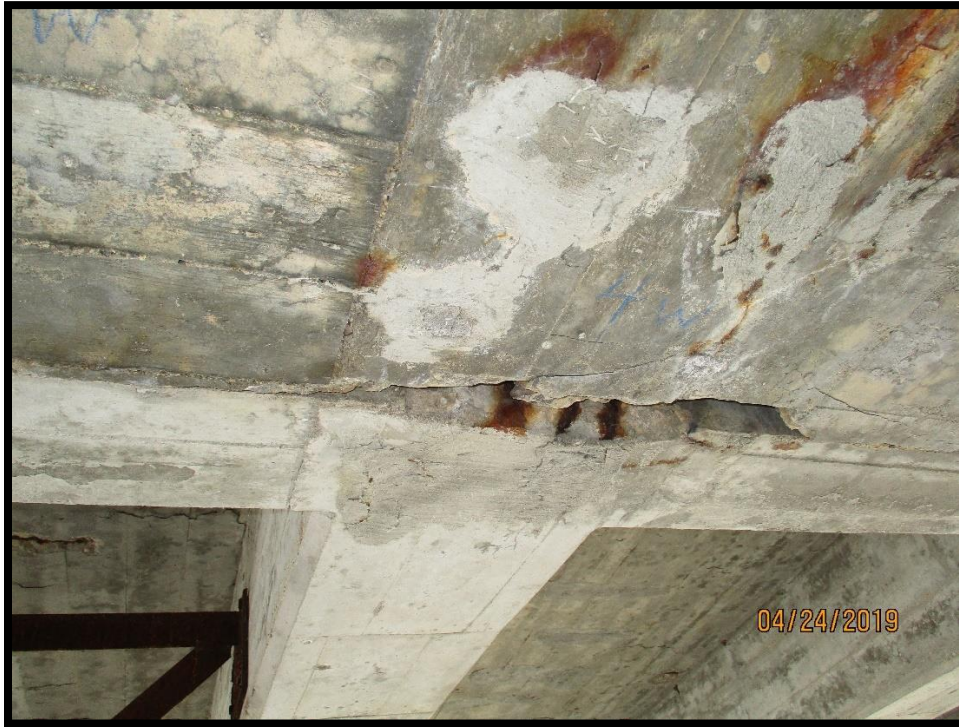
Typical pop-outs, corner spall from insufficient cover

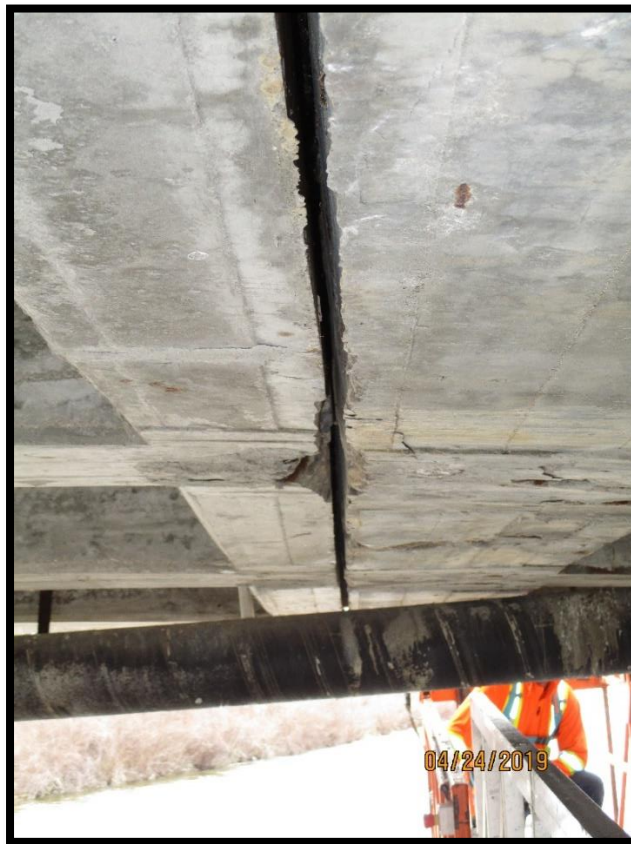
Soffit of west joint

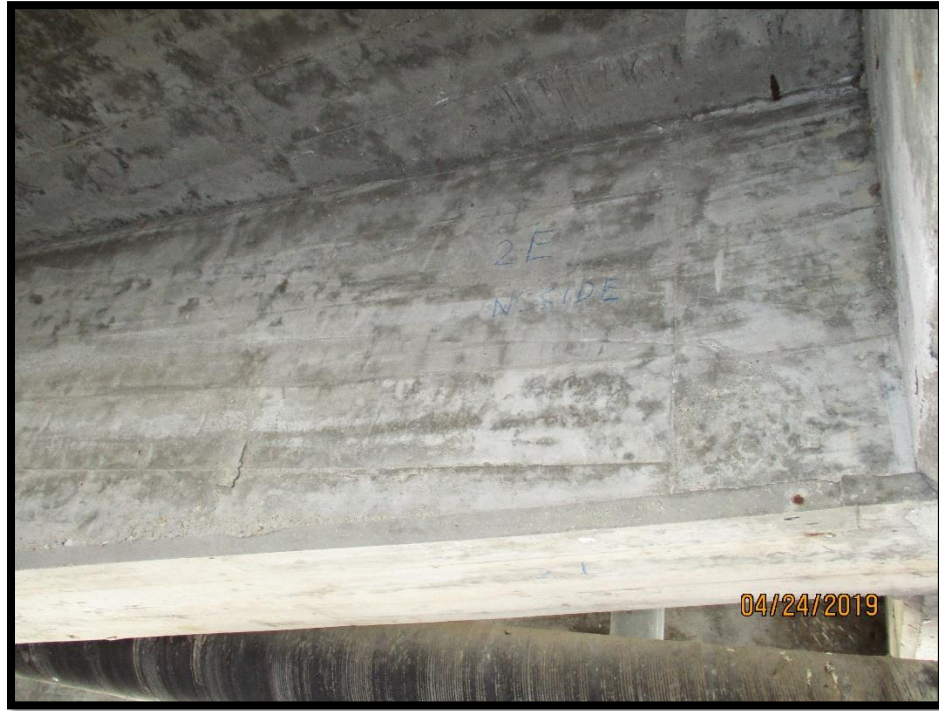
Typical cantilever beam face in good condition
