## County of Bruce

### Class Environmental Assessment Durham Street Bridge, Walkerton Third-Party Review

Triton Engineering Services Limited and Burgess Engineering Inc.

February 20, 2024

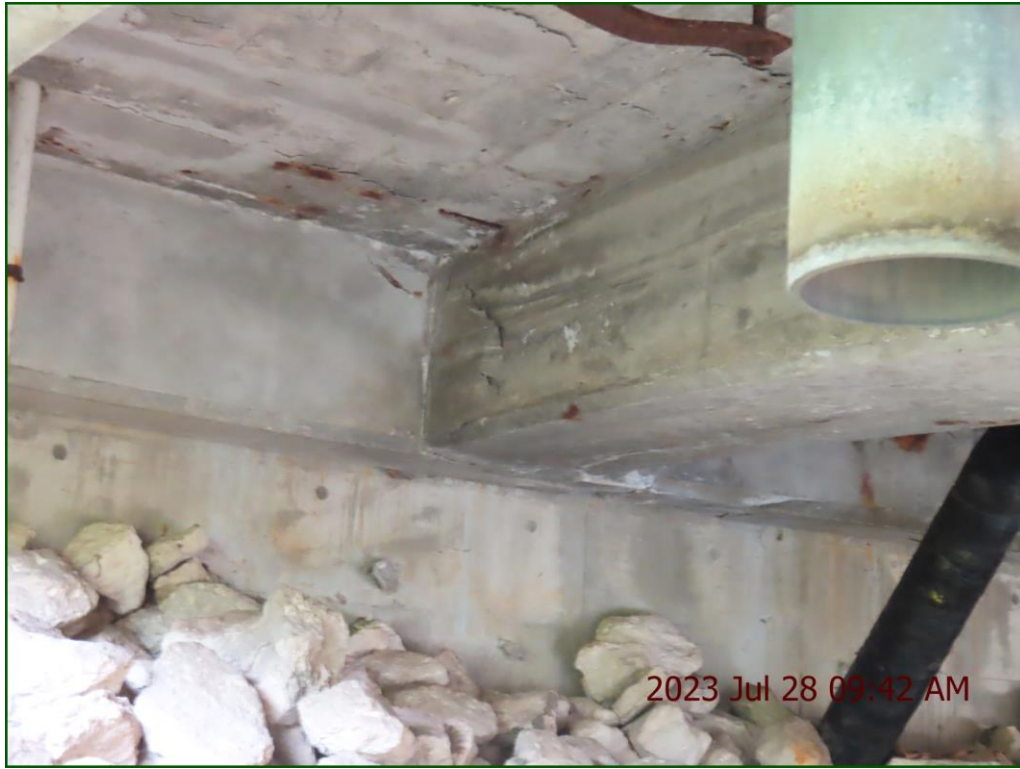
Description: Girders: Areas of shallow delaminations

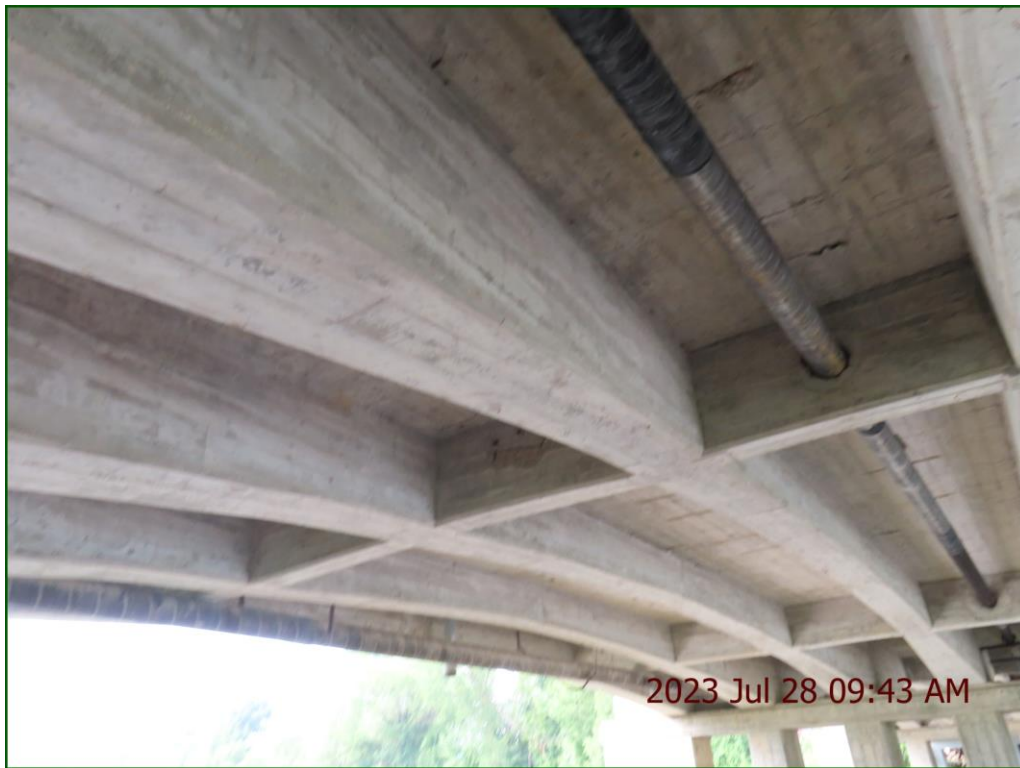
Description: Girders: General

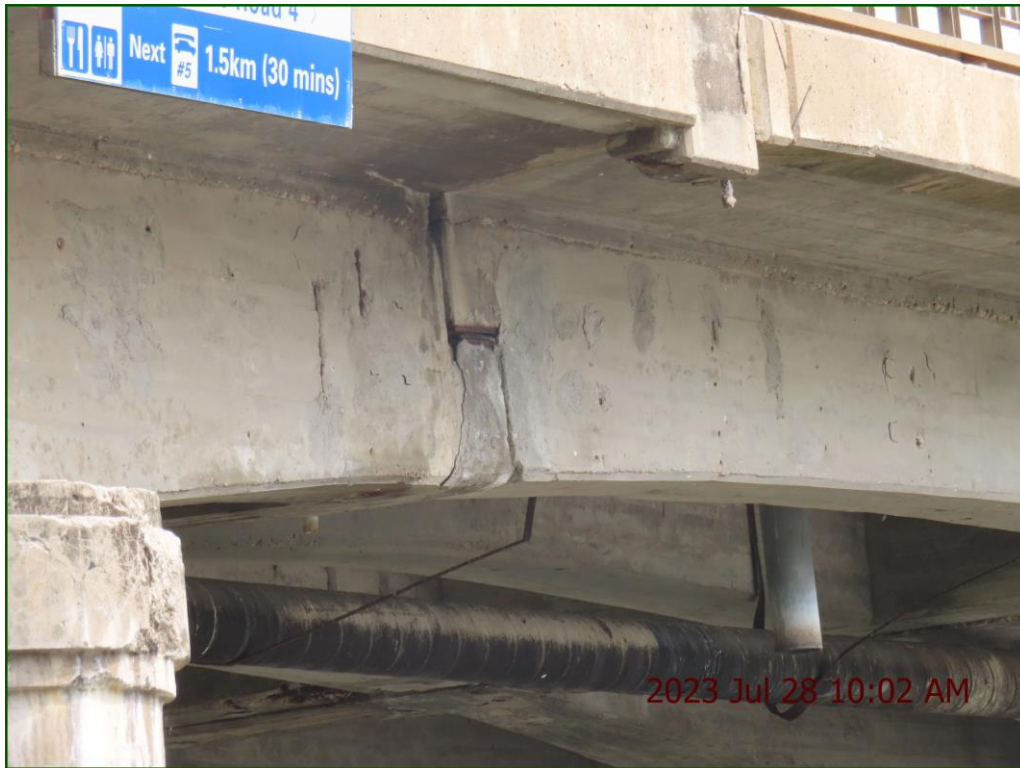
Description: Girders: Mid-span Joint

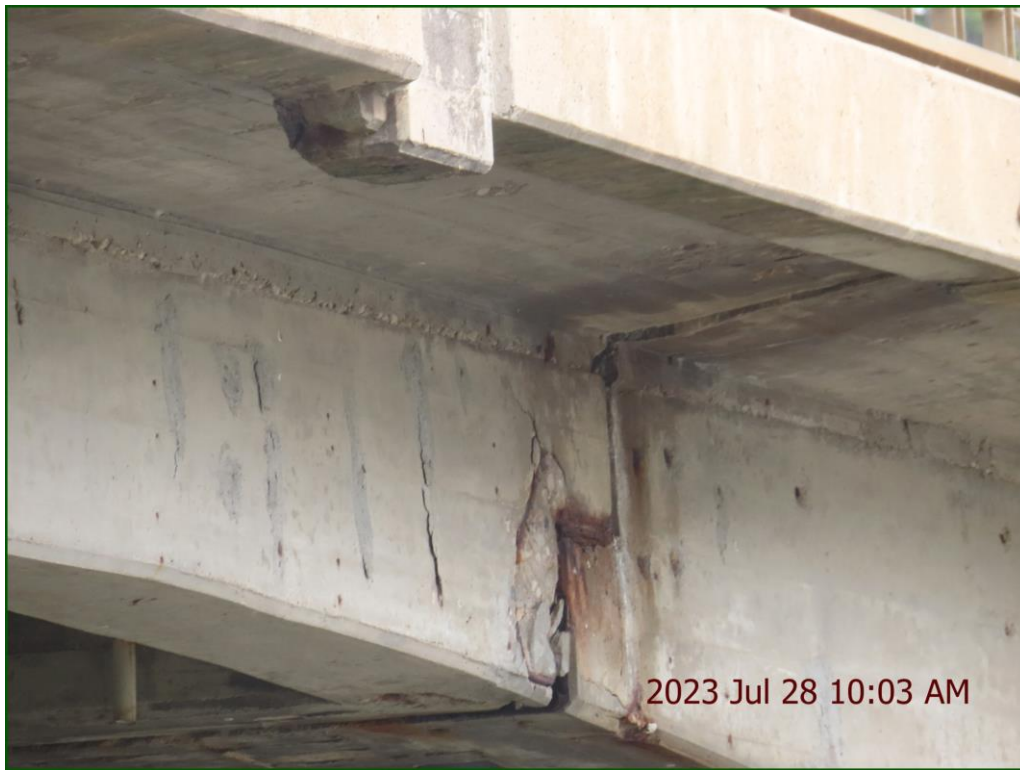
Description: Girders: Mid-span Joint

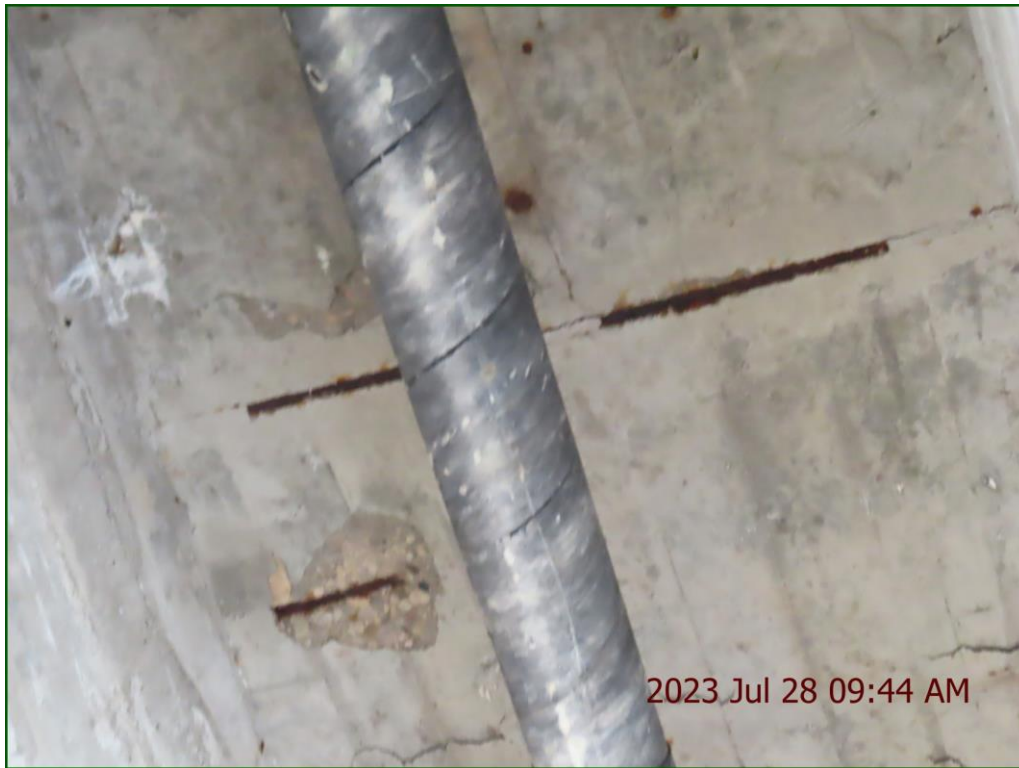
Description: Deck Soffit (int.): Shallow delaminations throughout with exposed reinforcing.

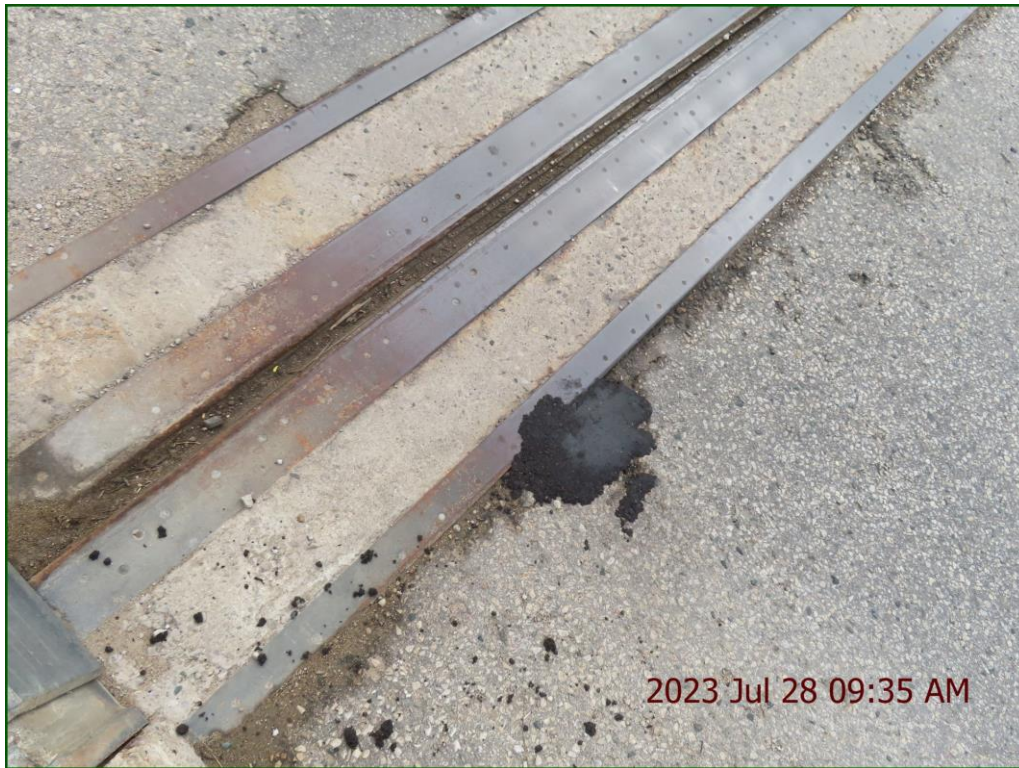
Description: Joint End Dams: Shallow popouts adjacent to armouring.

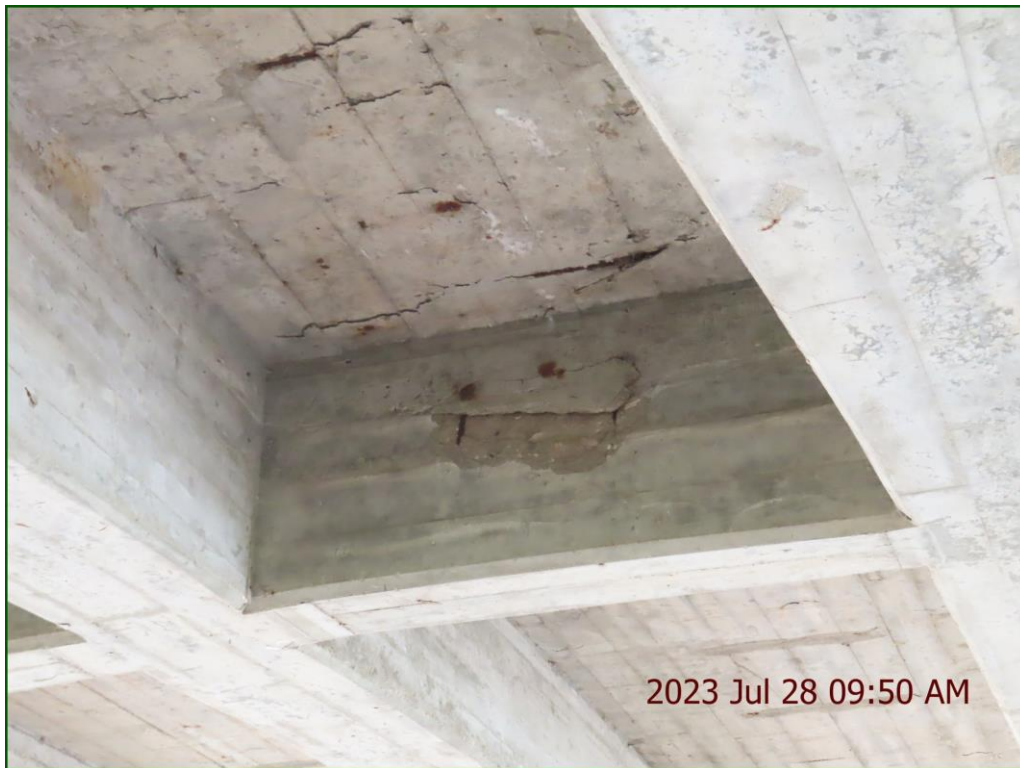
Description: Diaphragms: Shallow delaminations throughout.

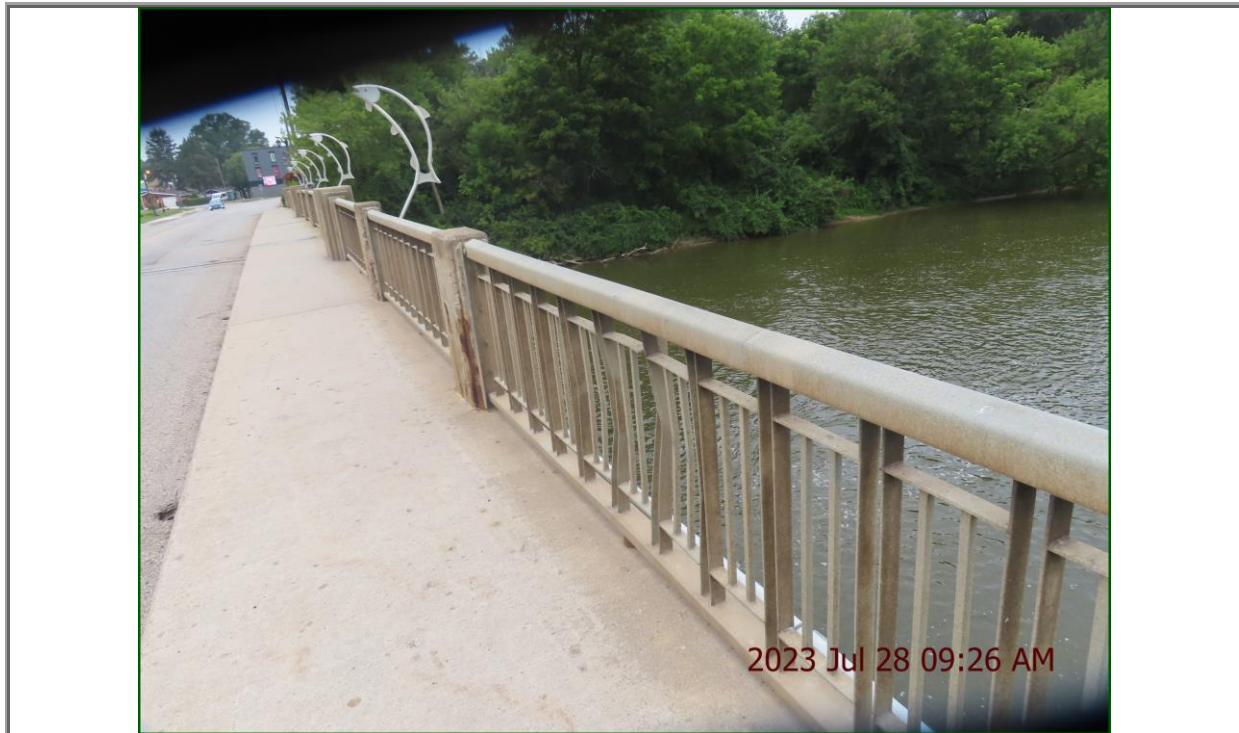
Minor impact damage NE. Major impact damage NW. Added structural reinforcing. A couple replaced sections.

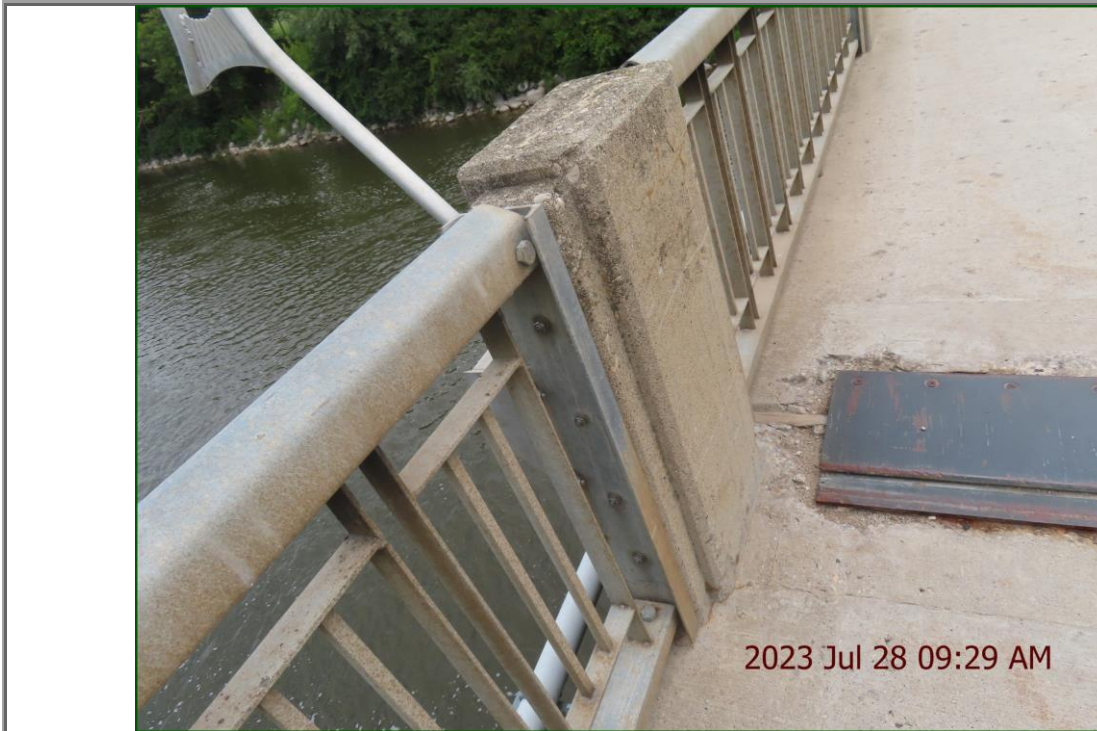
Areas of concrete deterioration.

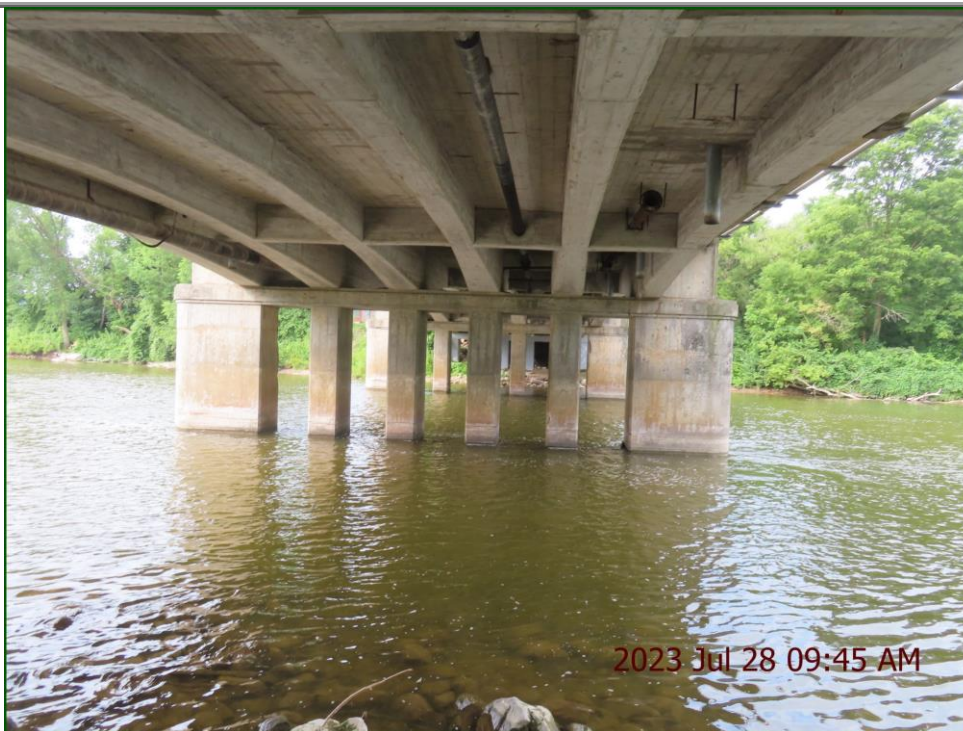
A couple spalls with exposed reinforcing.

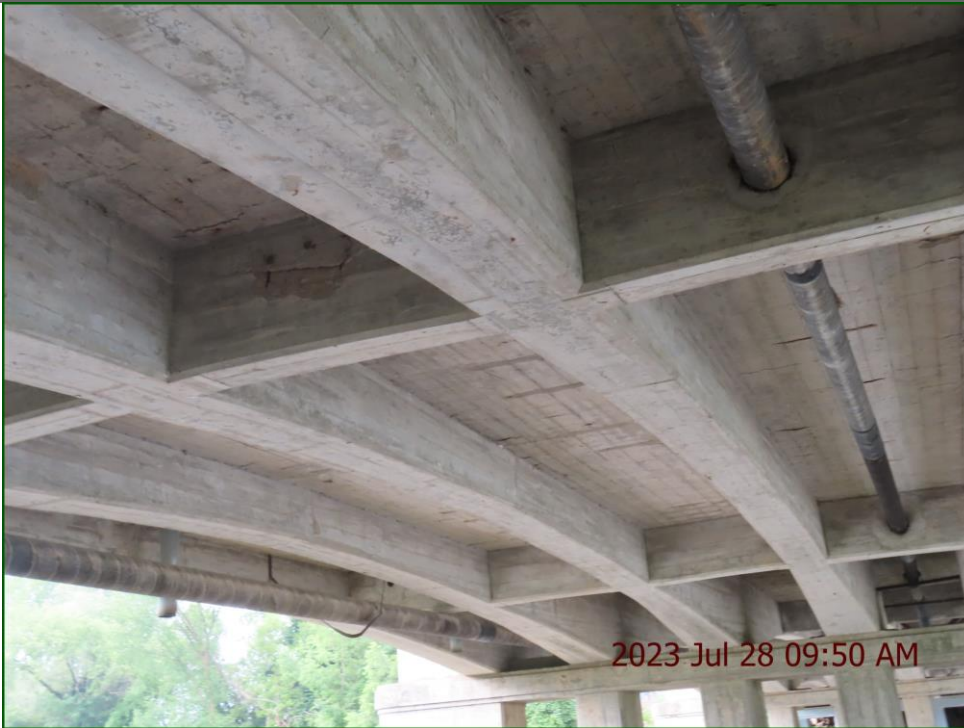
Shallow delaminations throughout.

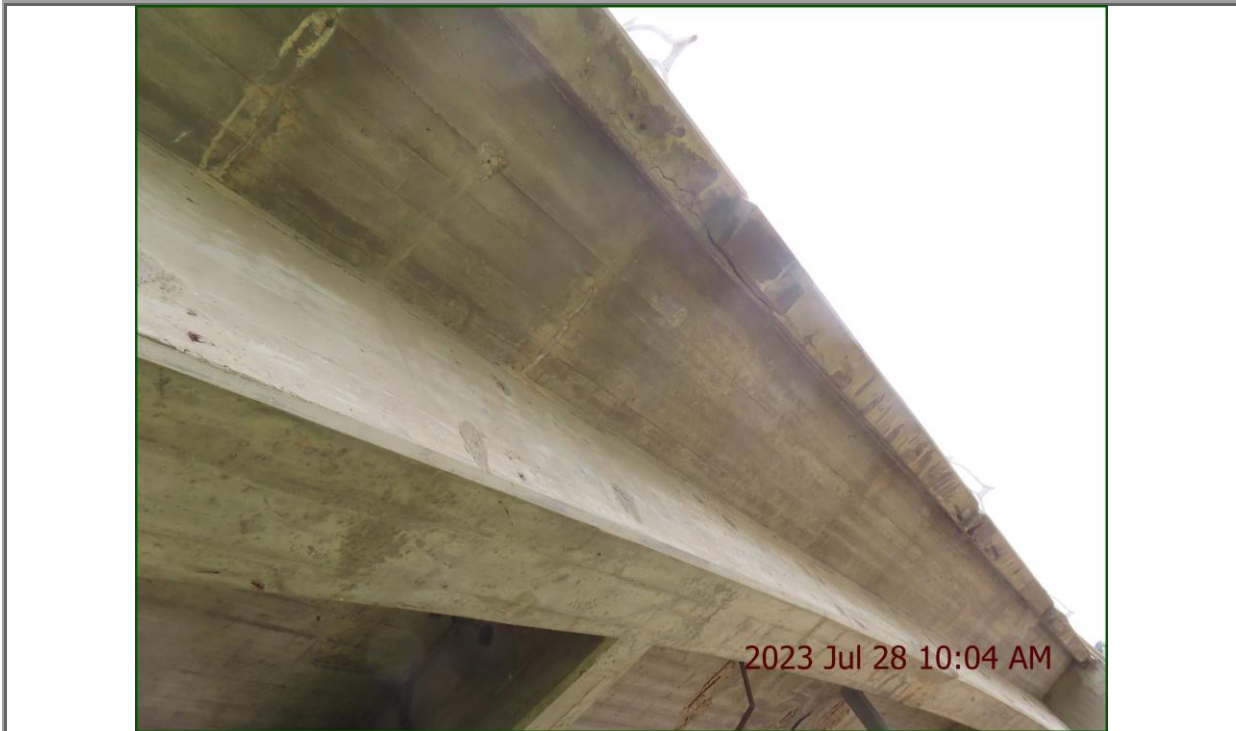
Wide cracking and delamination at posts.

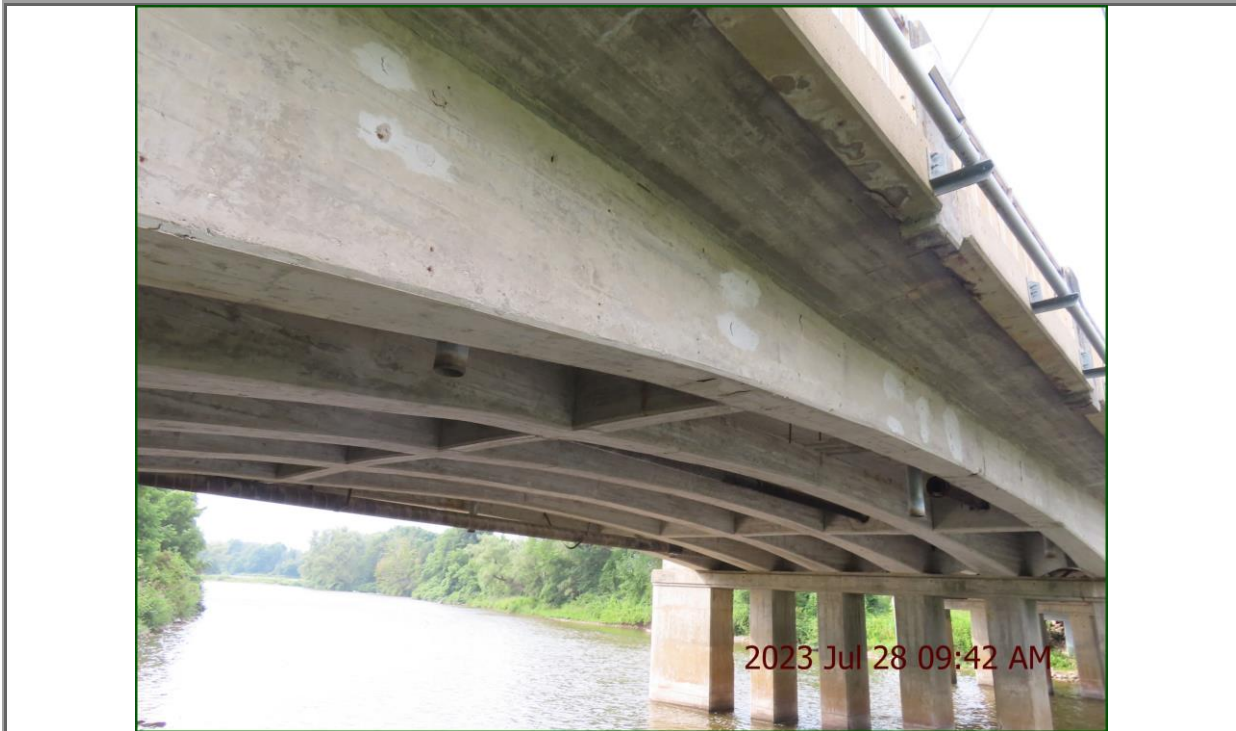
Areas of shallow delaminations. Delamination/cracking with rust straining at drop in span joints. Recommend reinforcing rehabilitation.

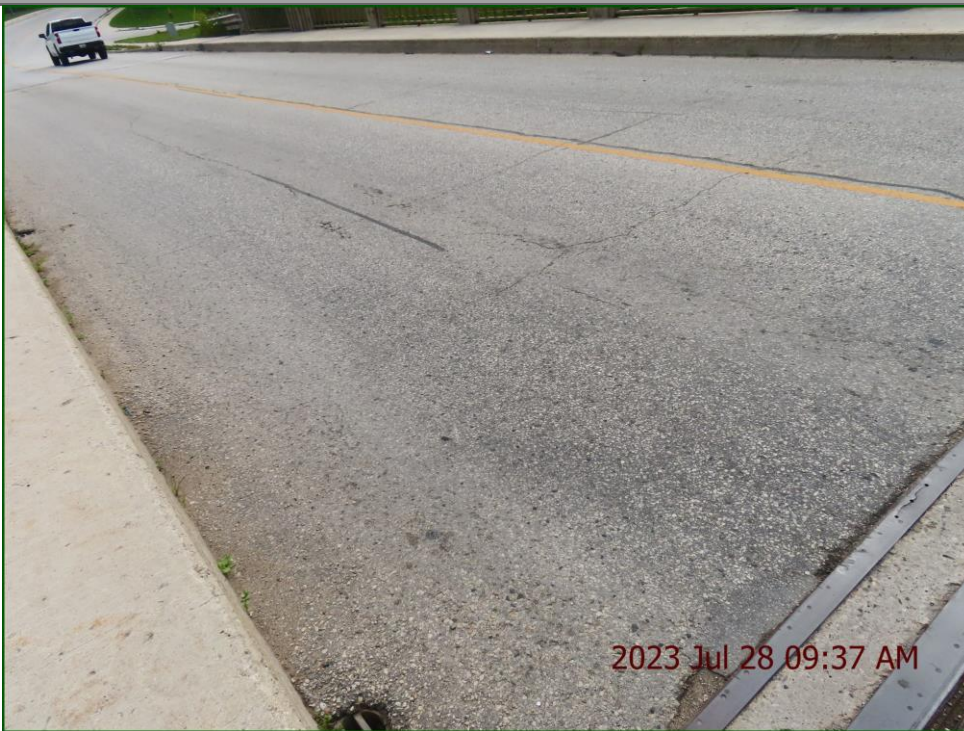
A couple patched areas. Light cracknig. Light ravelling.

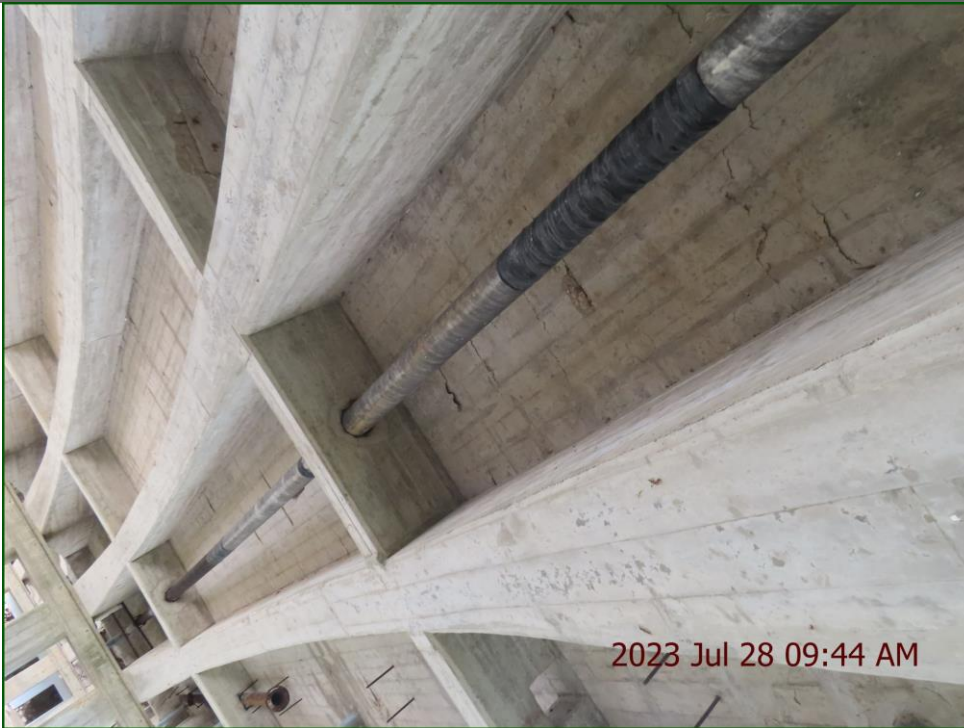
Shallow delaminations throughout with exposed reinforcing.

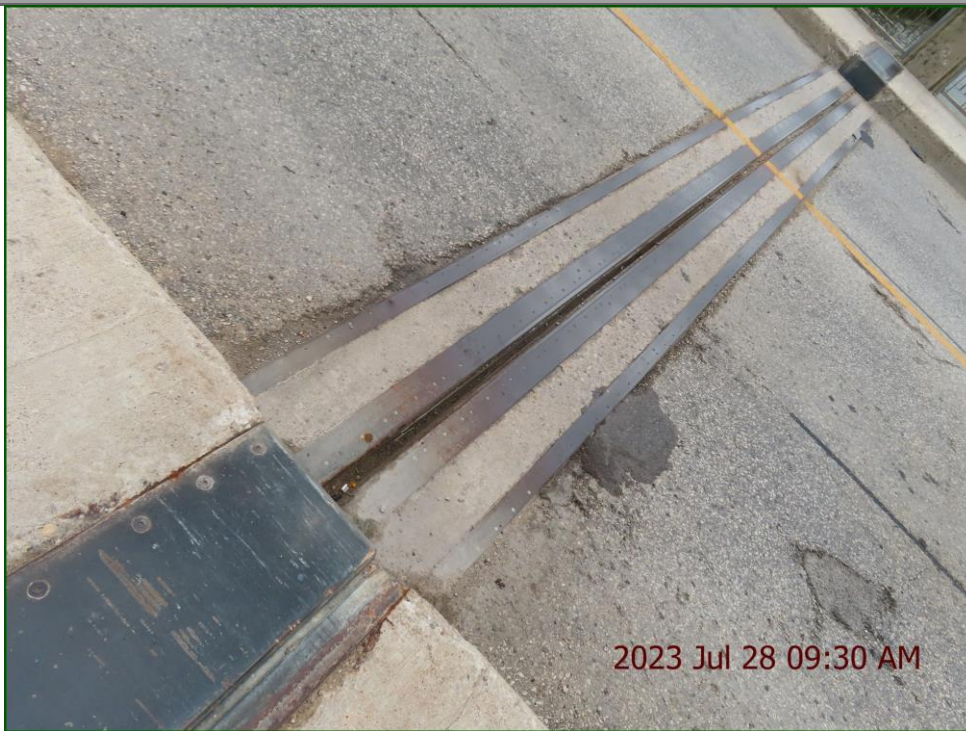
Joints filled with debris, recommend cleaning. Evidence of seal separation.

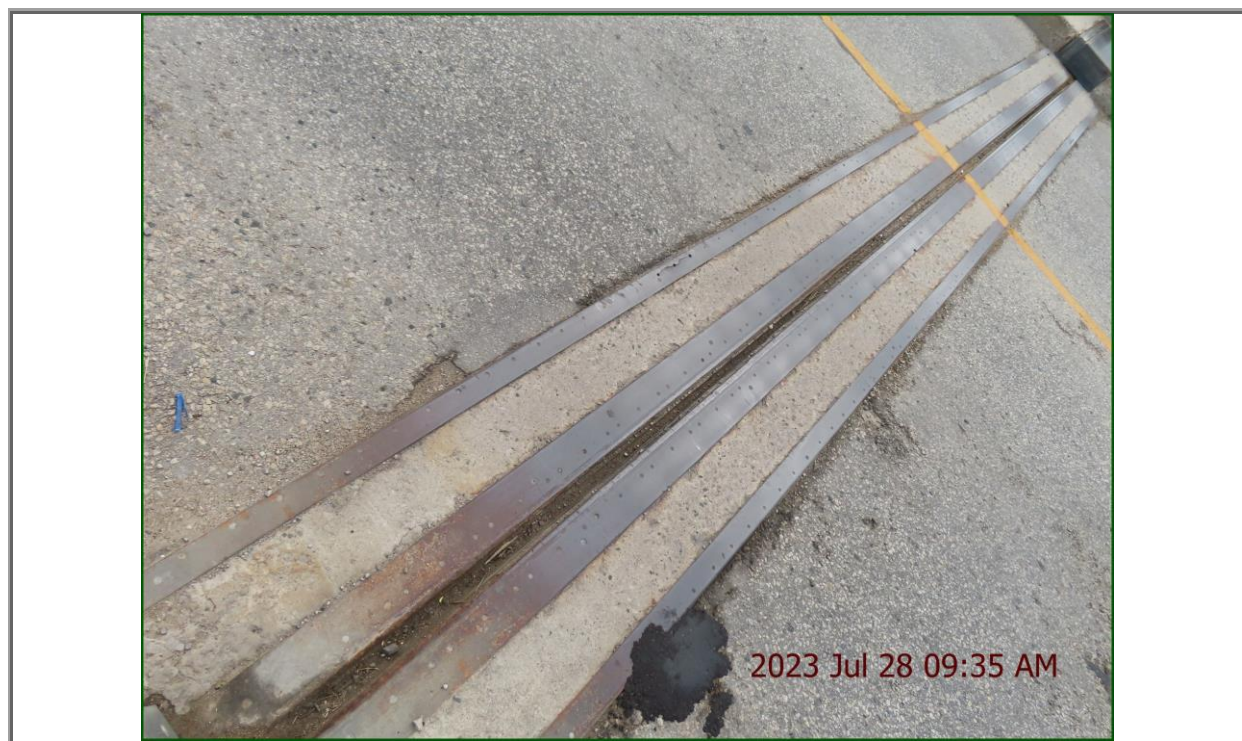
Shallow popouts adjacent to armouring.

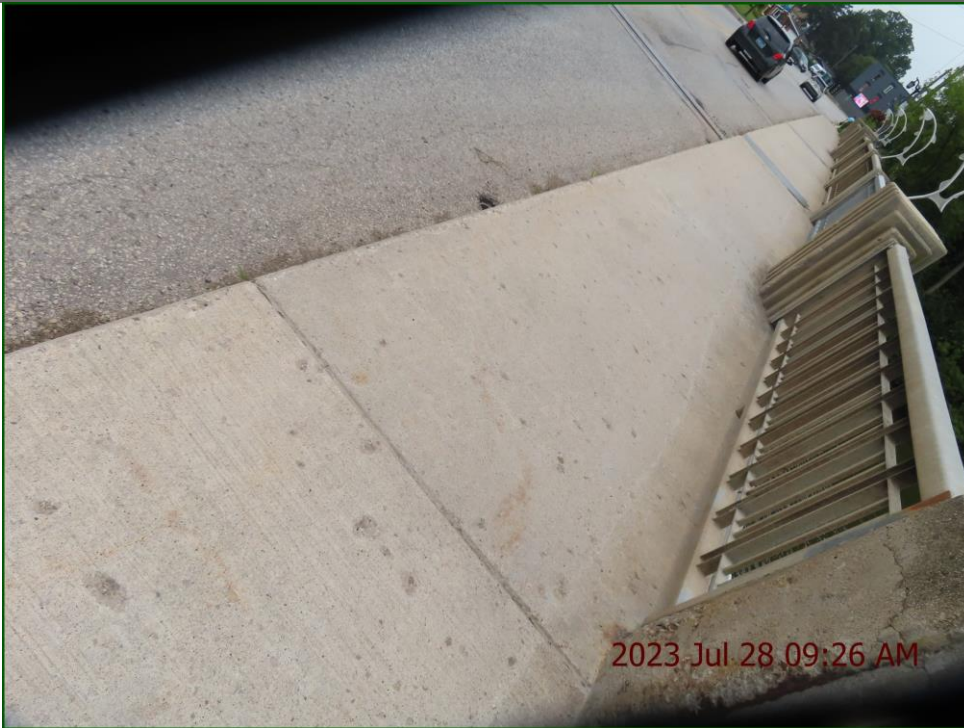
Typical light cracking. Shallow popouts.

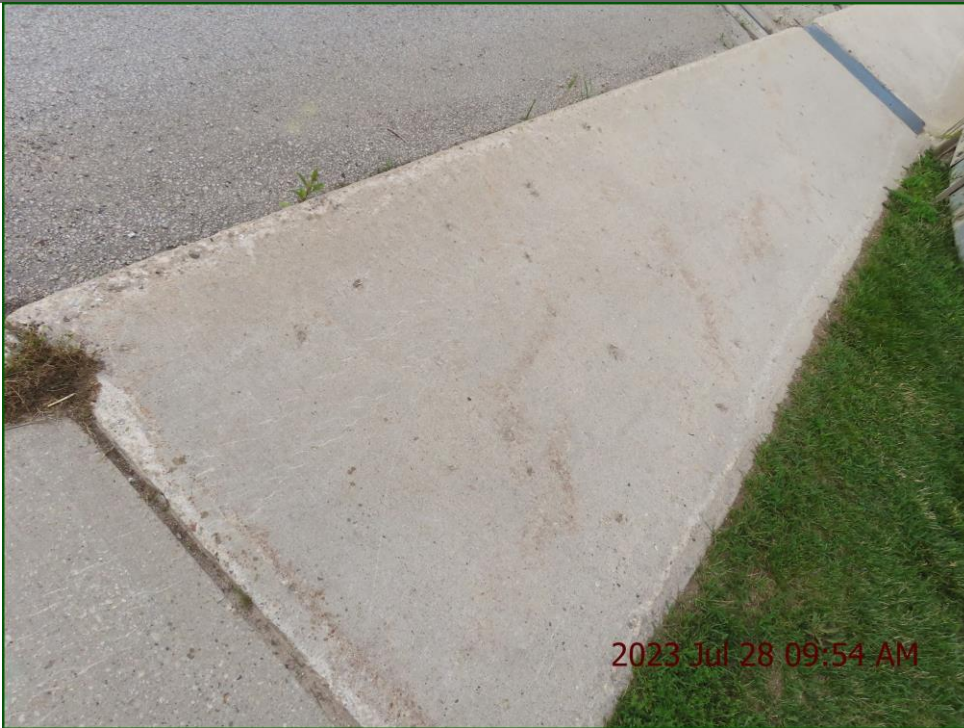
Medium abrasion south. Wide cracking NW.

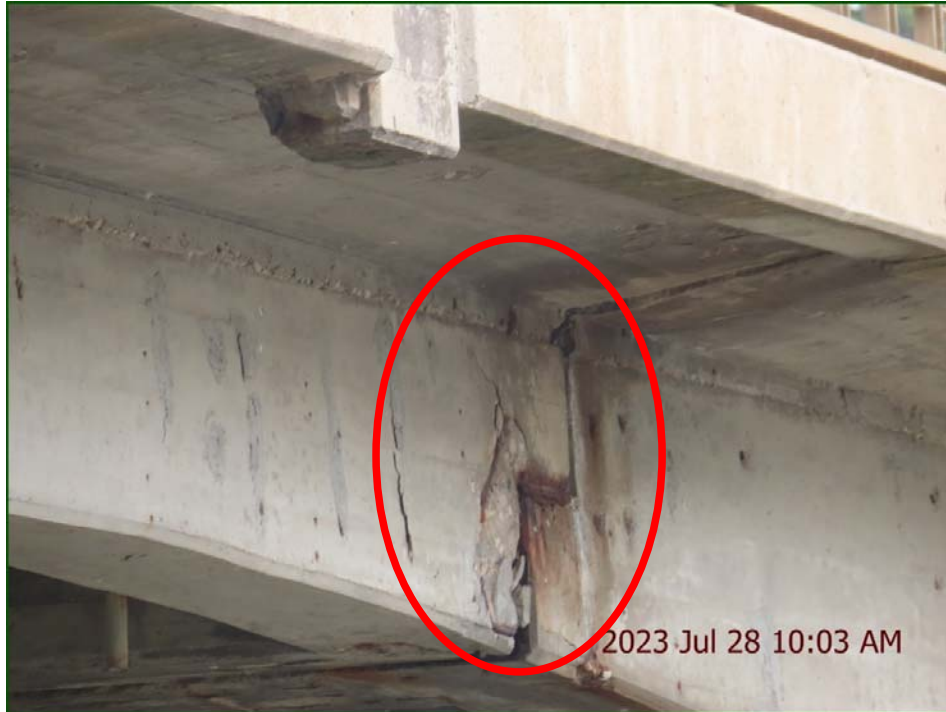
However, when reviewing the condition of the drop in span half joints, there is a major structural concern regarding the integrity of these joints, as depicted below.

Due to the age of the bridge (circa 1936), the environment of the constantly leaking joints and the localized spalling in this area (observed visually and noted in the bridge condition survey) the half joints show signs of significant degradation which is a major concern.

As this is a major road corridor within the County, Durham Street experiences a significant volume of heavy truck traffic on this bridge. As a result, the area of concern in the half joints, is exposed to a relatively large repetitive and constant impact load. It is important to note that this type of repetitive loading to the half joint can cause a concrete shear failure which is instantaneous with little or no advanced warning.

As time has elapsed since the initial 2019 structural analysis based on the condition of the half joint as reported by HAL Group Inc. there is sufficient evidence that at least 2 of 3 of the above factors are present in the Durham Street Bridge and repetitive impact loading by heavy vehicles to these joints is a major cause for concern and if left unrepaired can lead to instantaneous failure.

In order for the bridge to remain in service, we recommend correcting the half joints by either temporary repair or rehabilitation. Since repair or rehabilitation of the joints will take time and we feel time is of the essence to maintain public safety, we recommend a load limit be implemented for the bridge. The intent is to minimize the repetitive impact load caused by heavy truck traffic while maintaining bridge access to light traffic and EMS vehicles. The posted

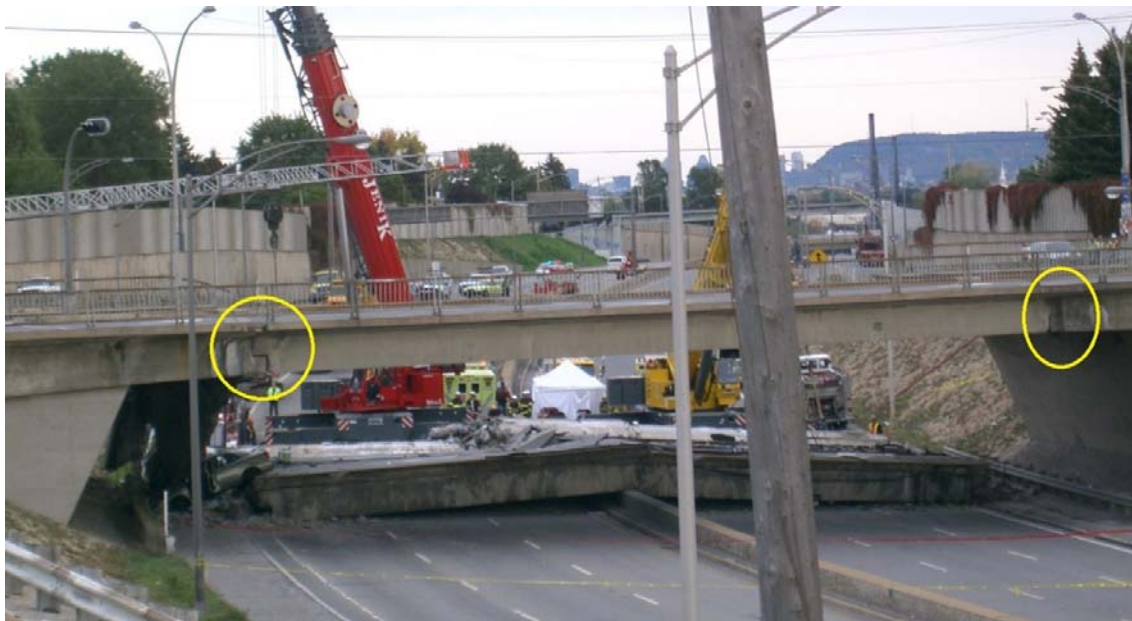
As previously noted in the BM Ross letter, this is a poor detail and has caused various issues and failures in other municipalities. An example of this is the total span collapse of the bridge in Laval, Quebec (2006), depicted below.

Upon review of this failure, it was determined that the following factors played a major role in the collapse.

- Poor construction practices (quality)
- Deterioration of the concrete
- Repetitive High Loading

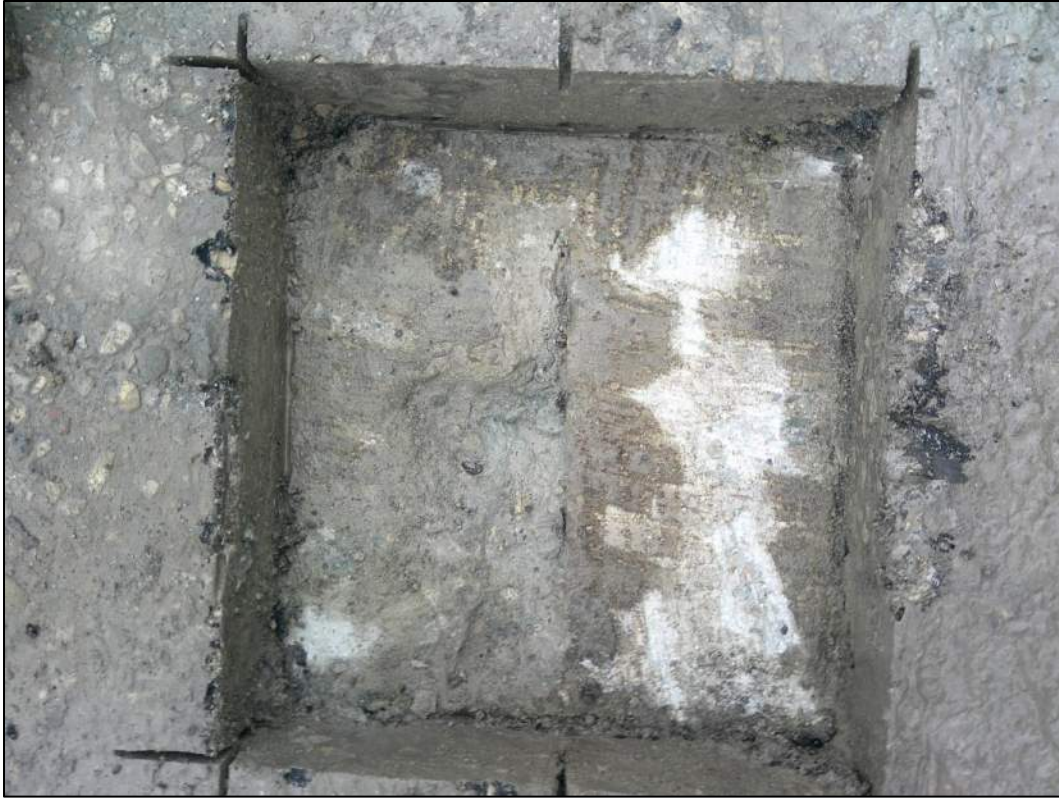
**Sawn Sample SS9 (spall)**

Sample No.	SS7	SS8	SS9
Location (between gridlines)	'F' and '19'	'E' and '25'	'E' and '29'
Size, mm X mm	350 X 310	310 X 320	305 x 325
Thickness of Asphalt, mm	80	90	75
Thickness of Asphalt @ Nearest Grid Point	80	90	75
Condition of Asphalt <sup>(1)</sup>	P	F	G
Waterproofing (W/P) Type	Hot rubberized asphalt with protection board	Hot rubberized asphalt with protection board	Hot rubberized asphalt with protection board
W/P Thickness, mm	4 to 8 mm	4 to 8 mm	4 to 8 mm
Condition of W/P <sup>(1)</sup>	G	G	G
Bond of W/P to Asphalt	G	G	G
Bond of Asphalt or W/P to Concrete	F	G	F
Concrete Cover to Reinf., mm	104	111	110
Defects in Concrete Surface <sup>(2)</sup>	-	-	S
Corrosion Potential on Concrete Surface	-0.053	-0.052	-0.061
Remarks			Spall on concrete surface.

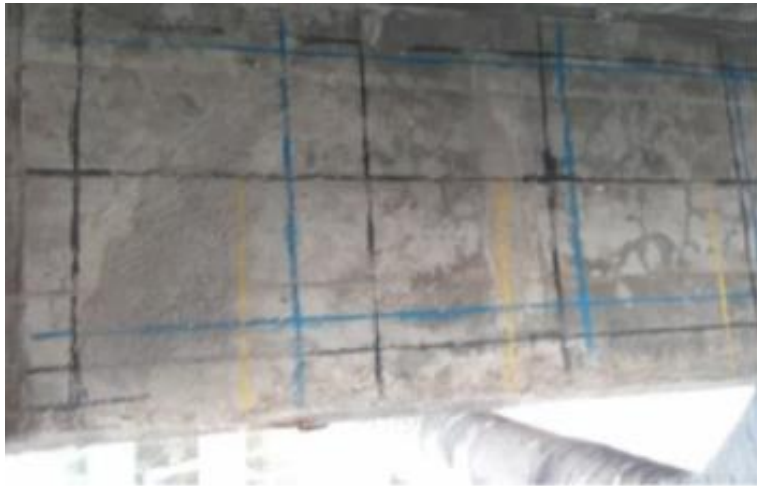
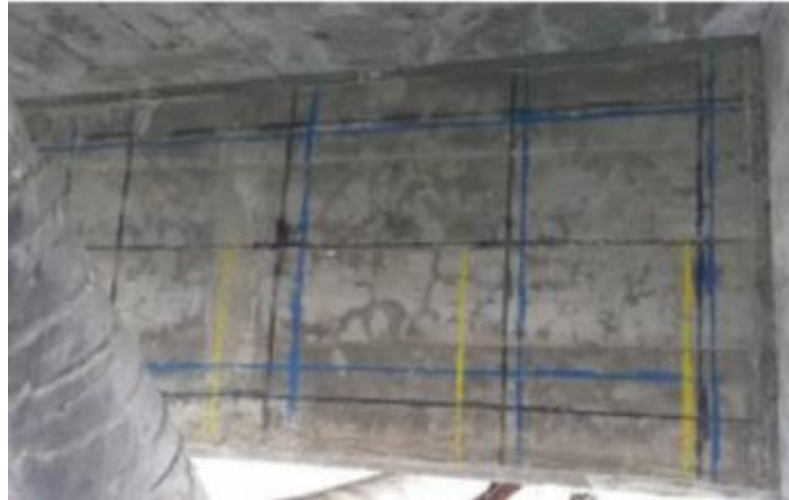
**Location #1**  
**5-4 West Beam**

**Depth of Cover Range**  
 Vertical Black Lines 2" to 4"  
 Vertical Yellow Lines 1" to 2"  
 Vertical Blue Lines 10" to 11"  
 Horizontal Black Lines 3" to 4"  
 Horizontal Blue Lines 10" to 11"

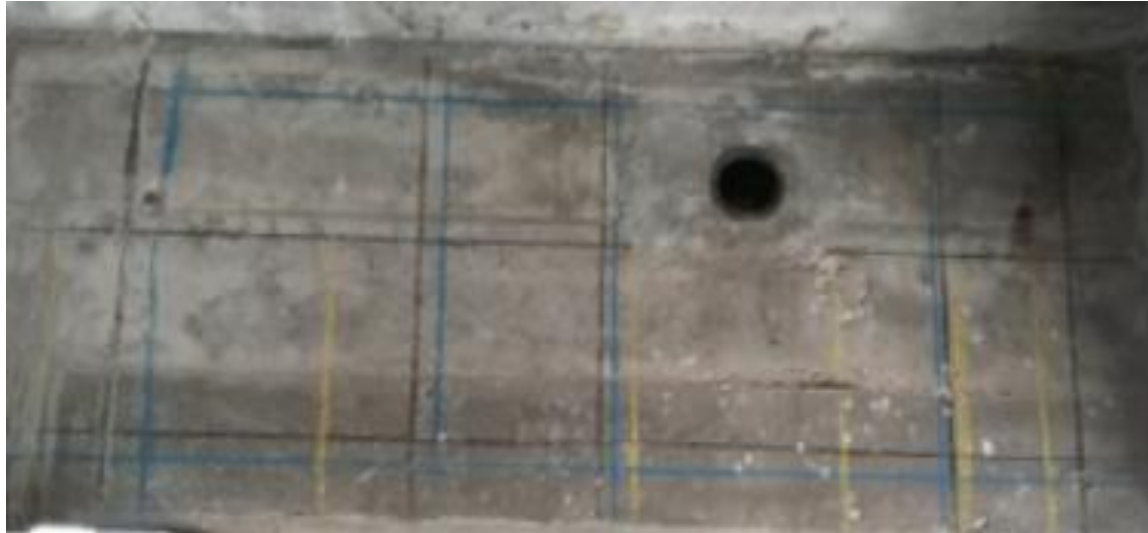
**Location #4  
2-1 West Beam**

Vertical Black Lines	1" to 2"
Vertical Yellow Lines	1" to 2.5"
Vertical Blue Lines	10" to 11"
Horizontal Black Lines	3" to 4"
Horizontal Blue Lines	10" to 11"

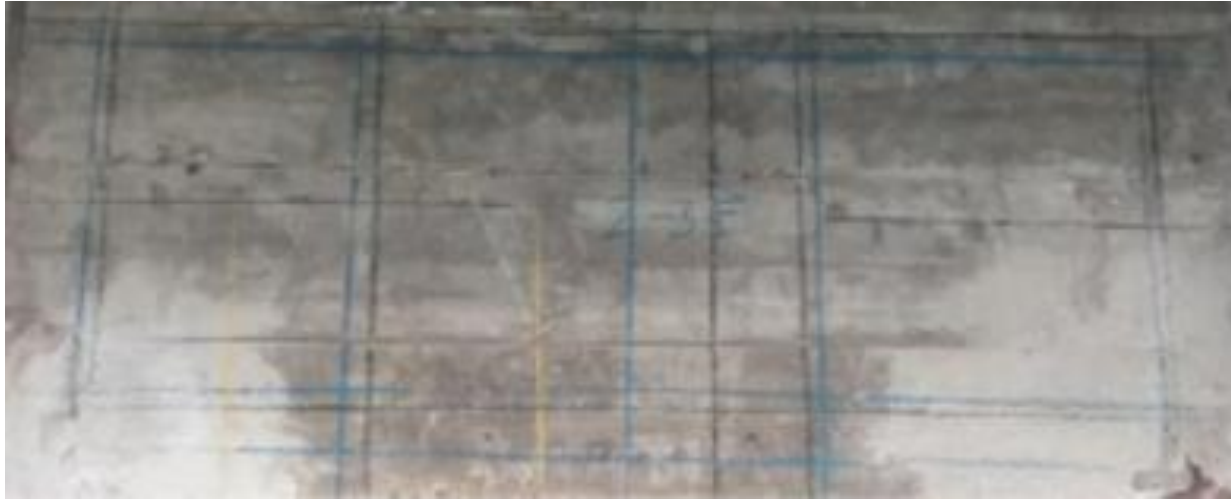
**Location #7  
2-3 East Beam**

Vertical Black Lines	0.5" to 1.5"
Vertical Blue Lines	10" to 11.5"
Vertical Yellow Lines	1" to 2"
Horizontal Black Lines	3" to 4"
Horizontal Blue Lines	8" to 11"
